A rare cause of tube arcing artifact seen in computed tomography image of a positron emission tomography/computed tomography scanner

Technical Note

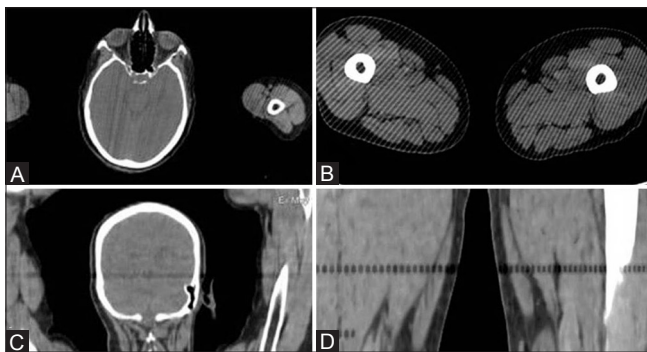
Our department has a positron emission tomography/computed tomography (PET/CT) scanner (Discovery IQ PET; GE Medical Systems, Milwaukee, USA). This equipment is used to perform PET/CT as well as routine CT procedures. On a busy afternoon, we encountered an artifact on two to three consecutive slices of the CT transaxial images of a patient, which showed near-parallel streaks across the transaxial image and a hypodense band with parallel bars on the corresponding sagittal and coronal images [Figure 1]. On careful examination and, in particular, viewing the CT images in the "lung window," it became apparent that the streaks in the transaxial slices were not parallel, but appeared to converge at a point outside the circumference of the gantry. The remaining slices did not show this kind of artifact. When we measured the HU of the tissues, we found that it was lower than that of neighboring slices. We felt that the probable reason for the artifact could be disruption of X-ray production in those slices possibly because of failure of voltage generation. Literature search suggested this could be the rarely encountered tube arcing artifact. For confirmation of the artifact, we reviewed CT series of all other PET/CT studies performed on that day. However, none of the other images had any such artifact. We immediately brought this occurrence to the vendor's support team, who also suspected voltage failure to be the possible cause. The next day, we were more vigilant and found more frequent occurrences of this artifact. We also observed something new which intrigued us. These artifacts had not occurred in any other dedicated CT images. Preliminary investigation by the vendor's support personnel revealed very short-lived, erratic drops in voltage corresponding in time with the seen artifacts. This

Figure 1 (A-D): Clinical image: CT tube arcing artifact seen in the head region on the transaxial image (A) and corresponding coronal image (B); in the thigh region on the transaxial image (C) and corresponding coronal image (D)

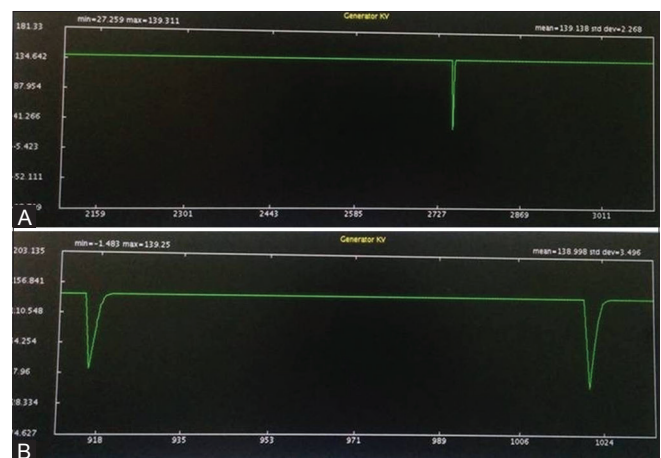
drop in voltage as seen on a graph did not touch zero at any of the instances; the voltage graph showed high standard deviations in the voltages [Figure 2], and hence, the system did not generate any error or abruptly stop scanning. However, this observation still did not explain why these artifacts were not occurring in any of the other CT images acquired. We performed repetitive phantom scan in dedicated CT protocol and did not observe such an artifact. So, we performed the phantom CT scan in PET/CT whole body protocol and streak artifact was observed [Figure 3A and B]. Thus, we decided to review the CT acquisition parameters for diagnostic CT and CT in PET/CT protocols. Our review revealed a difference in kV used in both protocols, i.e., 140 kV used in PET/CT protocol and 120 kV used in diagnostic CT protocol. Service engineer changed the HEMIT tank (which is a transformer supplying voltage to the rotor of the rotating anode), considering the faulty current supply to the CT tube. After replacement, we performed repetitive CT scans of phantom in PET/CT protocol at 140 kV and did not observe any tube arcing artifact [Figure 3C and D].

X-ray tubes used in medical devices work at high voltages and are susceptible to electrical breakdown or short circuits. Various sources of arcing are mentioned in the literature, namely, insulator surface flashover, insulator breakdown, and vacuum flashover. Insulator surface flashover is tube design dependent; vacuum flashover is a very common phenomenon and is generally caused due to the presence of particulate impurities resulting from tungsten evaporation or imperfect surface of the target.^[7] Overheating of the focal spot and tungsten evaporation can result due to faulty anode rotor.^[8] In this particular case, short circuit was caused due to the defective transformer supplying voltage to the rotor of the rotating anode (HEMIT tank). There were sudden drops in the voltage causing disruption of X-ray output. However,

Figure 2 (A and B): Plot of generator kV versus time in images showing drop of voltage corresponding to appearance of tube arcing artifact (A and B)

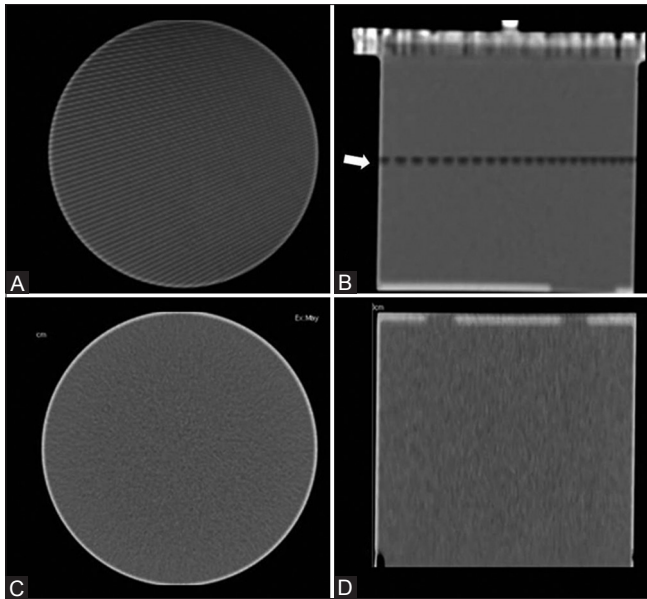
Figure 3 (A-D): Phantom image: CT image of uniformity phantom in PET/CT whole body protocol showing streak artifact, transaxial image (A); arrow shows alternating lucent bands seen on the coronal image (B). CT images, transaxial image (C) and corresponding coronal image (D) of uniformity phantom in PET/CT whole body protocol after replacing the HEMIT tank (no tube arcing artifact seen)

there was no abrupt termination of the CT scan as there was no error generated by the system. This was because at no point did the drop in voltage reach the threshold (0 kV) to generate an error. The resulting artifact was seen as alternating hypodense streaks throughout the transaxial image, which corresponded with a horizontal hypodense band in sagittal and coronal images also. Tube arcing artifact can normally be corrected by applying correction algorithms. The correction algorithm could either use synthesized projections generated by using the neighboring unaffected slices or an adaptive filtering scheme or a partial data interpolation method.^[6,9] However, these methods are capable of correcting only moderate streak artifacts and not to the extent mentioned here.^[5] Frequent tube arcing or tube spit of this magnitude can only be resolved by replacing the tube,^[5] which would have been very costly, considering that it had only been 6 months since installation of the PET/CT. However, in our case, the reason for disruption of X-ray was different. The most probable reason for disruption in X-ray production leading to the artifact was the disrupted current supply to the rotor of the rotating anode at 140 kV. Hence, simply replacing the HEMIT tank could resolve the issue. Although tube arcing artifact and its causes have

The described tube arcing artifact seen in CT images was caused by a fault with the transformer supplying voltage to the rotor connected to the anode in the X-ray tube, which involved sudden transient drops in voltage generated whenever acquisition was done at 140 kV. Using the CT at a relatively lower voltage of 120 kV could prevent such an occurrence, and in case such an artifact does occur, it would save time and cost if this reason is ruled out before proceeding to tube replacement.
