# Repair of a fractured implant overdenture gold bar: A clinical and laboratory technique report

Fahim Vohra<sup>1</sup>, Amani Al Fawaz<sup>1</sup>

<sup>1</sup>Department of Prosthetic Science, SDS, College of Dentistry, King Saud University, Kingdom of Saudi Arabia

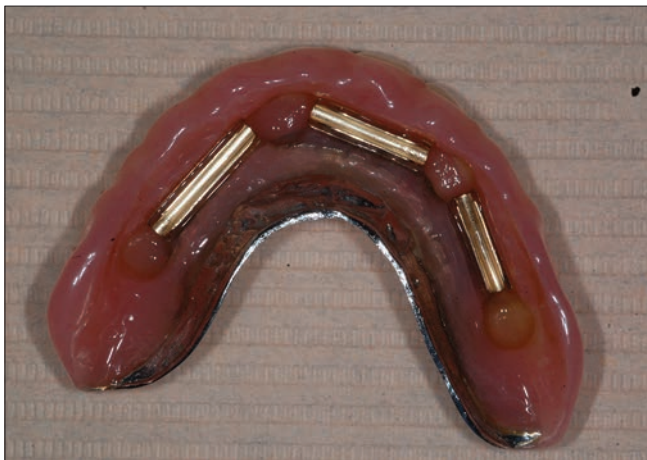
**Figure 1:** Intaglio surface of the metal framework reinforced maxillary implant overdenture with reduced palatal coverage showing three metal riders

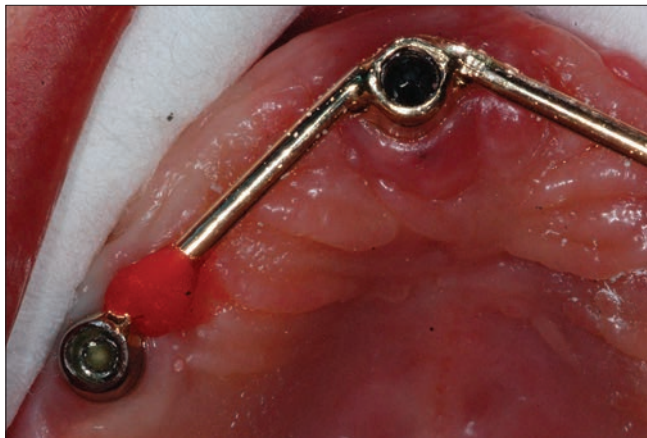
**Figure 3:** Intra-oral splinting of the fracture ends using chemical cured pattern resin (Duralay, Reliance Dental Mfg. Co.)

2. Intra-orally, the fracture was initially stabilized using sticky wax (Sticky wax, Ainsworth Dental Company, Marrickville, Australia) and fixated using chemically cured inlay pattern resin (Duralay, Reliance Dental Mfg. Co, Worth, Illinois, USA). Employing the bead-on method, both the ends of the fracture line and few millimeters beyond was covered by the pattern resin [Figure 3].

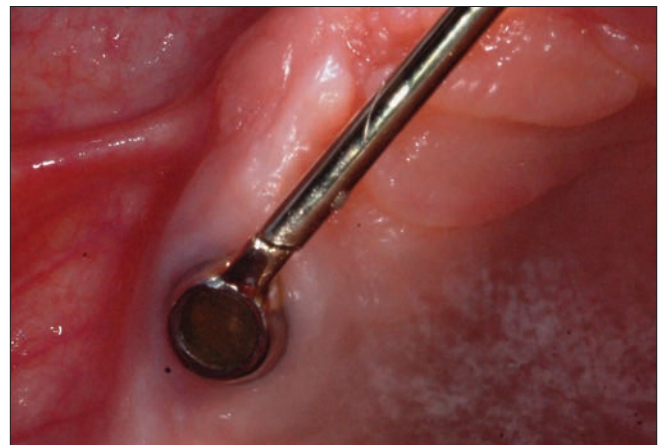
1. Complete seating of the gold copings on the implant platform was verified using periapical radiographs after the screws were torqued at 30 Ncm. The fracture on the Dolder bar, which was approximately 4 mm mesial to the coping on the most distal left maxillary implant, was found to be undisplaced [Figure 2].

**Figure 2:** Gold bar fracture mesial to implant coping at tooth position no. 24, near the solder joint

the outcome of inherent weakness of the metal alloy, inadequate dimensions and design of the bar retainer, magnitude of occlusal forces and the antagonist<sup>[16]</sup> (fixed, removable prosthesis or natural dentition), inferior solder joints,<sup>[17]</sup> and fatigue failure.<sup>[18]</sup> The fracture was located at the solder joint mesial to the left distal maxillary implant coping. Repeated complain of loose bar retainer and soft tissue inflammation indicates incomplete seating of the coping on the implant platform,<sup>[19,20]</sup> i.e., a non-passive implant coping connection. Also, a diagonal discrepancy in approximation of the fracture line was observed, reinforcing the potential for non-passive fit. The problem was compounded further by comparatively apical placement of left distal maxillary implant. The continuous stress at the implant/coping connection due to non-passive fit, apical position of implant, high occlusal forces, and inferior solder quality resulted in fatigue failure.

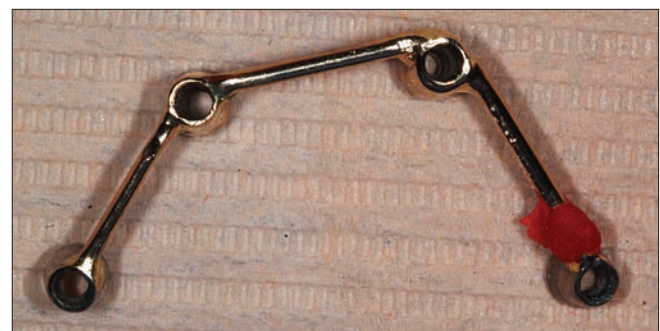
**Figure 4:** Splinted gold bar and coping assembly removed from the mouth to undertake laboratory procedure

3. Once the pattern resin had completely polymerized (5-7 minutes), the Dolder bar retainer was unscrewed and removed from the mouth using a SCS screw driver (Straumann, Basel, Switzerland) [Figures 4 and 5]. Regular neck healing abutments (Straumann 4.5Ø, 2 mm height)

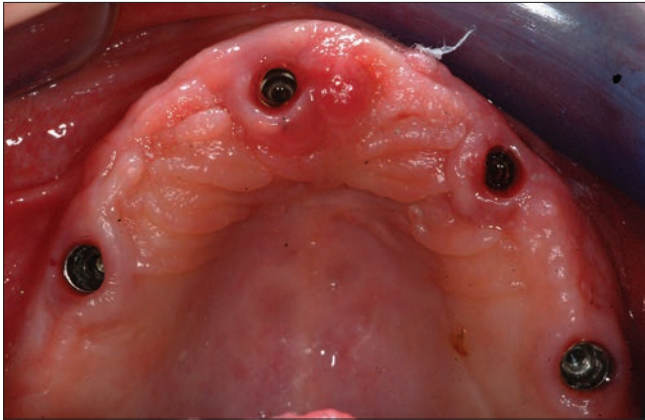
**Figure 5:** Intra-oral occlusal view of the maxilla after removal of the gold bar retainer

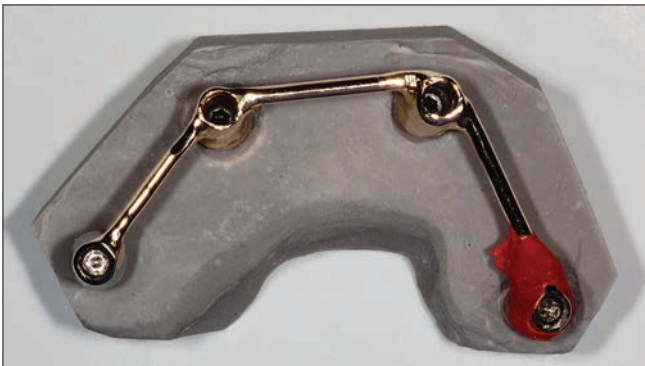
**Figure 7:** The gold bar retainer and implant analog assembly mounted in dental stone for positioning stability of fractured segments

4. Four implant analogs (Straumann RN syn Octa) were secured to the gold copings [Figure 6] on the overdenture Dolder bar, and the assembly was mounted in dental stone (Vel-Mix, Kerr Co, Orange, CA, USA) in the laboratory [Figure 7] to provide positioning stability.

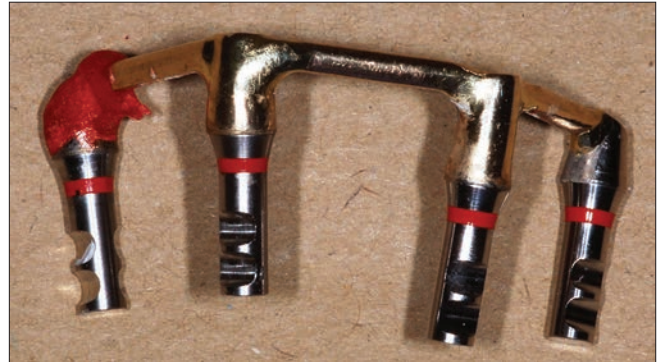
**Figure 6:** Compatible implant analogs (replica) secured to the gold copings on the bar retainer prior to mounting

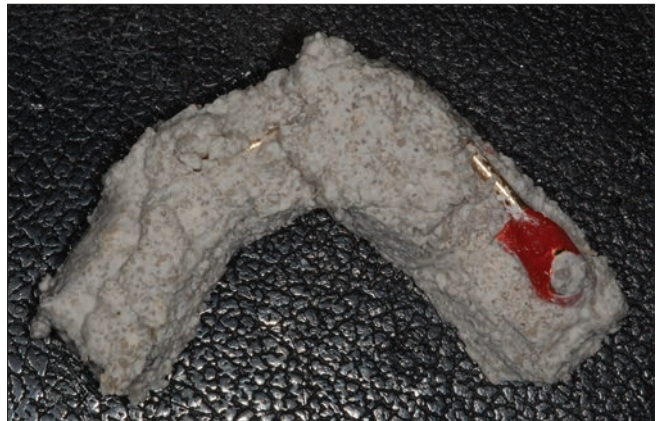
**Figure 8:** The mounted assembly of gold bar is invested (embedded in investment material), except the resin covered area around the fracture line for performing soldering

5. Next, the complete assembly was embedded in the solder investment material (Heravest L, Heraeus Kulzer, Germany) excluding the resin-covered portion [Figure 8].

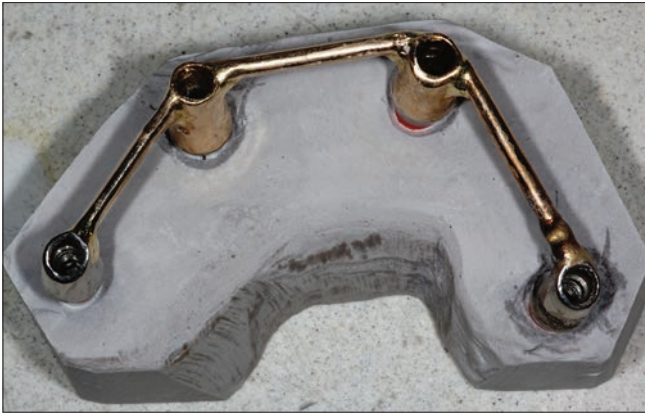
**Figure 9:** The soldered and divested gold bar assembly, prior to finishing and polishing

8. After bench cooling, the assembly is divested [Figure 9] using sandblasting and the gold solder was adjusted using coarse rubber disc and polishing was completed using a burlew/gold lustre blue disc (Shofu Dental Corp, St Marcos, CA, USA) [Figure 10].
9. The repaired bar and coping assembly was removed from the implant analogs and placed intra-orally after adequate disinfection and were found to connect passively on all four implants.
10. The maxillary implant overdenture prosthesis was stable on fit, and the patient was delighted with the excellent result. The repaired Dolder bar/gold coping assembly was fitted the same day, and the patient was able to wear a stable overdenture within just four hours.

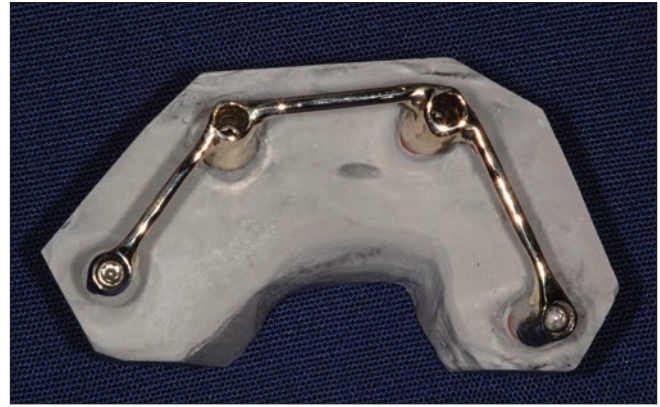
**Figure 10:** Repaired, finished, and polished gold bar retainer assembly, ready for intra-oral fit
