Kirschner Wire Migration after the Treatment of Acromioclavicular Luxation for the Contralateral Shoulder – Case Report*

Rev Bras Ortop 2019;54:202–205.

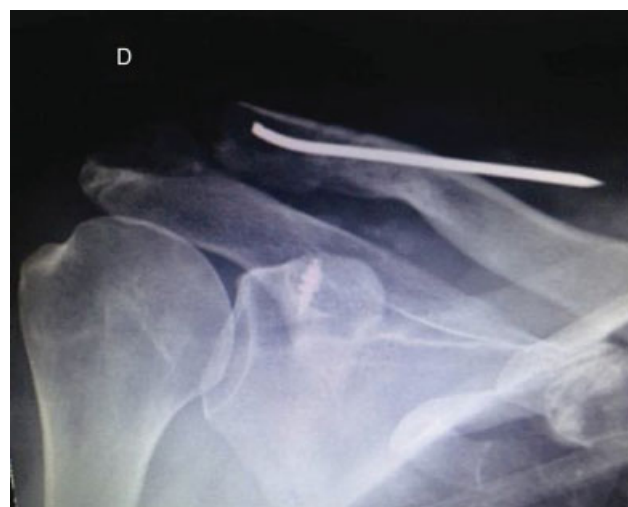
Fig. 1 Fifteen days postsurgery, right shoulder.

Four days after the trauma (►Fig. 1), the acromioclavicular dislocation was surgically treated using ligatures with anchor wires, coracoacromial ligament transfer, and fixation with Kirshner wires from the acromion to the clavicle.

At the 12-day follow-up visit, the migration of the Kirschner wire to the acromion was identified. The patient was informed of the need for a more frequent follow-up and that the wire would be removed 45 days after the surgery. At the 20- and 30-day follow-up visits, radiological findings remained similar to the ones observed at the 12-day visit, with no migration progress.

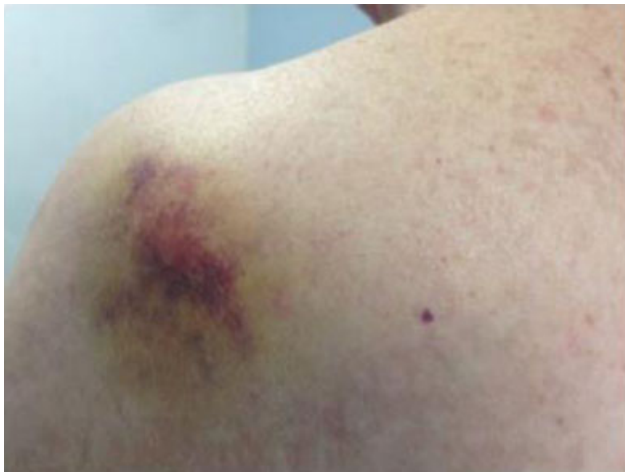
Fig. 2 Hematoma and a small skin protuberance, left shoulder, 9 months after the procedure.

The patient did not show up for his 6-month visit. Nine months after the surgical treatment, the patient started to present with pain on the left shoulder (contralateral side), reduced arc of movement, ecchymosis, and a protrusion (►Figs. 2 and 3). Bilateral radiographs showed that the Kirschner wire originally from the right shoulder was in the left shoulder (►Figs. 4 and 5).

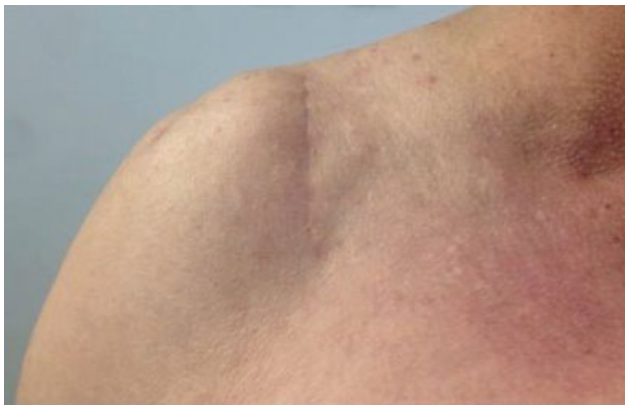
Fig. 3 Surgical approach, 9 months after the procedure.

Thus, a new surgical procedure was performed to remove the metallic wire from the left shoulder.

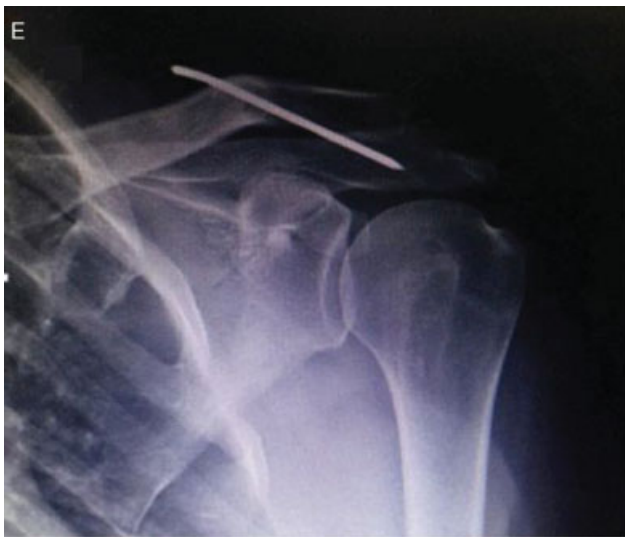
Fig. 4 Nine months postsurgery, left shoulder.

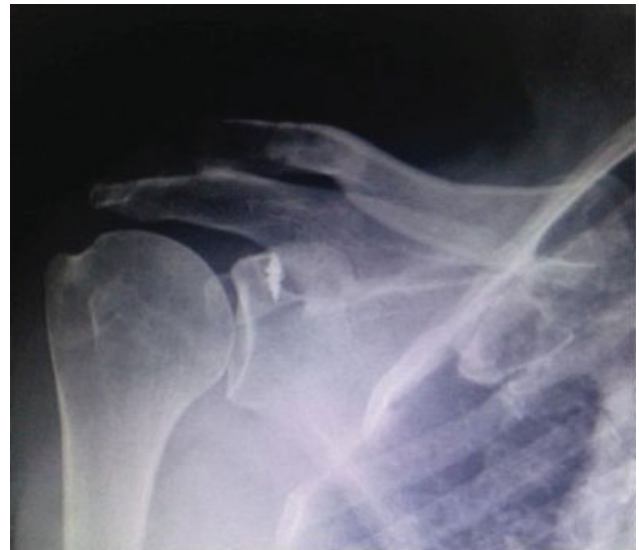
Fig. 5 Nine months postsurgery, right shoulder.

The present case was followed-up with serial radiographs; moreover, the metal wire was folded to difficult its migration, the patient was properly oriented when the metal wire migration was noticed and at the end of the treatment period. However, the fold at the distal end of the wire did not reach the necessary angulation to prevent migration, allowing this complication to occur.
