Gastric penetration of epicardial pacemaker leads 8 years after cardiac surgery

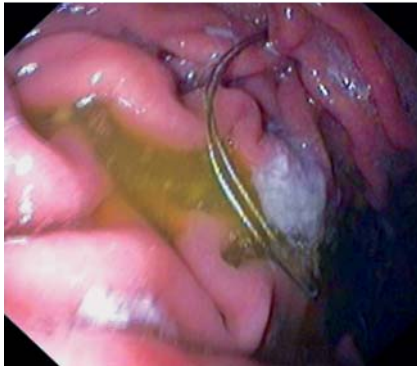
Fig. 1 Pacemaker electrodes penetrating through the gastric wall.

The cardiac surgery consultation came to the conclusion that iatrogenic perforation of the gastric wall had occurred during insertion of the temporary epicardial pacemaker electrodes after the open heart surgery. Normally the redundant loop is brought out through the skin and removed by traction on the day before discharge. In our patient's case the percutaneous extraction was unsuccessful. Presumably the leads were led out to the skin through an accidental iatrogenic incision of the gastric wall and they dislocated into the stomach over the years. The tips of the leads injured the gastric mucosa leading to recurrent oozing bleeding. During the repeat gastroscopy one of the leads was removed with a loop, while the other was bent back with biopsy forceps to avoid further injury to the mucosa (● Fig. 3). No complications occurred after the procedure. Temporary pacing leads cause such complications such as infections, arrhythmias, and perforation [1,2]. Iatrogenic gastric

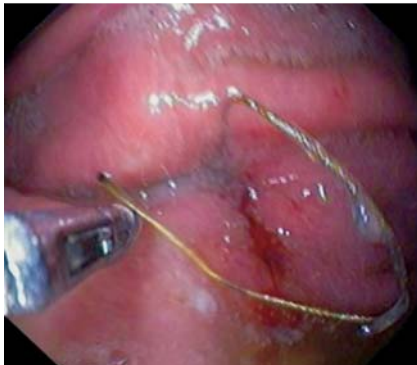
Fig. 3 Bending back the pacemaker lead to avoid further injury to the gastric mucosa.

perforation caused by pacing leads and diagnosed by endoscopy has not been reported previously. This case is also unusual because the leads were discovered 8 years after the unsuccessful removal. The chronic bleeding caused by the tips of the leads and the subsequent melena were managed endoscopically.

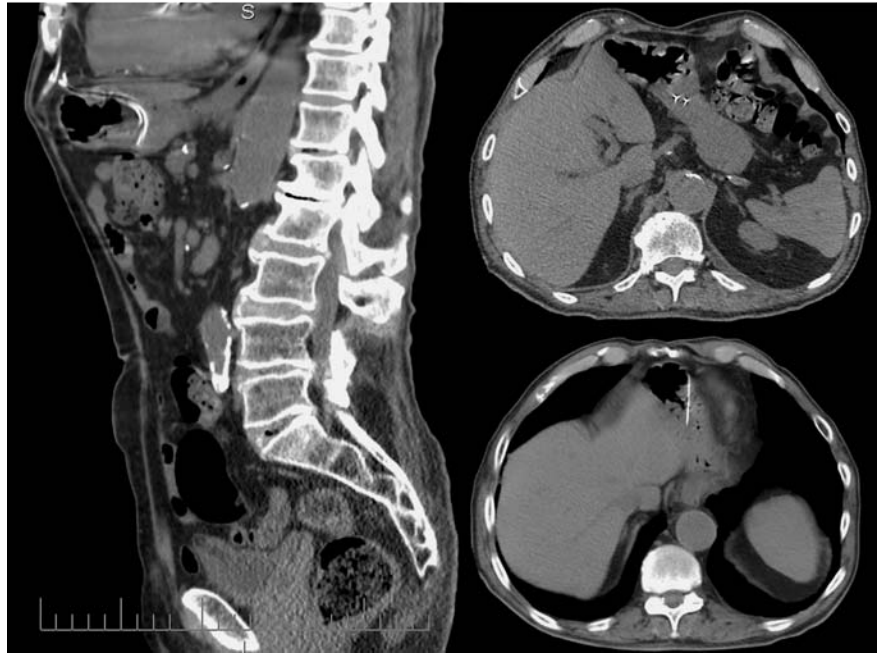
Fig. 2 Chest and abdomen CT scan visualize the wires projecting towards the thoracic cavity.

Foreign bodies penetrating the gastric wall from the serosal side occur infrequently in endoscopic practice. A 79-year-old man with a 1-month history of weakness and black stool was referred to our department. He had undergone an aortic valve replacement and coronary artery bypass grafting in 2001. Laboratory findings showed anemia. Diagnostic gastroscopy revealed erosions on the anterior wall of the body of the stomach, in the middle of which two wires were detected penetrating into the gastric lumen (● Fig. 1). The CT scan visualized the wires (suspected to be the electrodes of a temporary epicardial pacemaker implanted 8 years earlier) projecting towards the thoracic cavity (● Fig. 2).
