Endoscopic removal of a biliary covered metallic stent with the invagination method

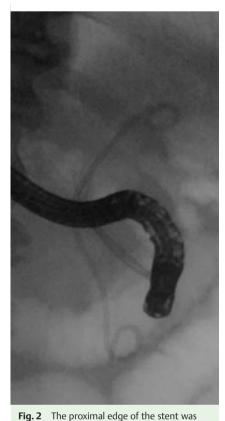
failed.

firmly embedded in the bile duct, and stent removal with a snare failed.

Stent removal was attempted. The stent could not be removed by grasping the looped distal ends with a forceps or grasping the distal edge with a snare (> Figs. 1 and **2**, **>** Video 1).
