Endoscopic removal of a broken self-expandable metal stent using the stent-in-stent technique

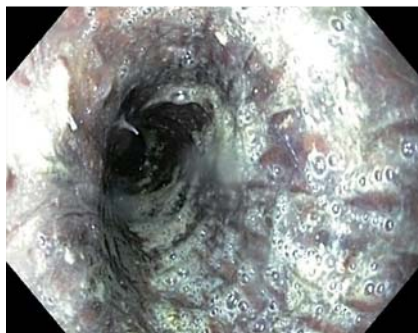
Fig. 2 The broken wires of the first self-expandable metal stent (SEMS) have perforated the covering of the second SEMS.

ted the covering of the fully covered SEMS, and the radial pressure of the fully covered SEMS had succeeded in detaching the partially covered SEMS from the esophageal wall and tumor (Fig. 2). By pulling the proximal retrieval lasso of the fully covered SEMS, both SEMSs were extracted simultaneously without the need to exert much force. Examination of the retrieved stents showed they were strongly attached to each other, indeed with loose struts of the first stent perforating the covering of the fully covered SEMS (Fig. 3). Immediately after removal of both stents, no esophageal stenosis was observed. The post-procedural course was uneventful, and the patient is currently without dysphagia. Spontaneous fracture with collapse of an esophageal SEMS is a rare complication [1,2]. However, if a SEMS is extracted by
