# Imaging of Hip Arthroplasty

Semin Musculoskelet Radiol 2013;17:316–327.

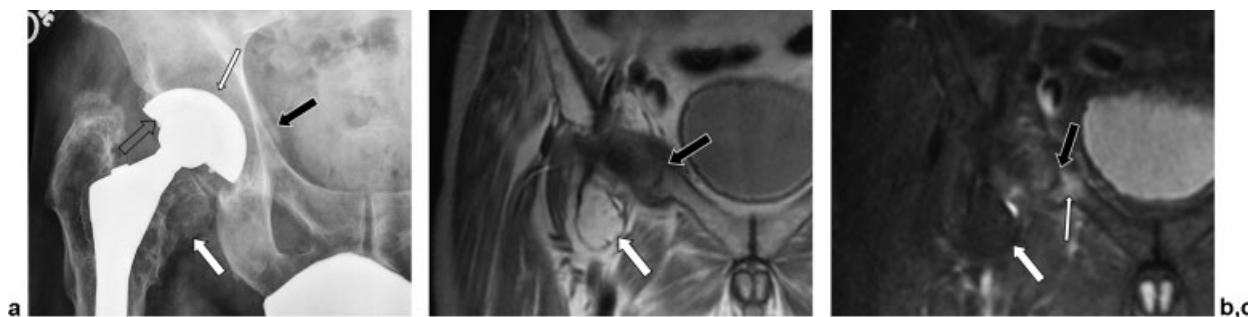
**Figure 11** Superior ramus fracture in a 44-year-old man with metal-on-polyethylene hip arthroplasty. (a) Anteroposterior radiograph demonstrates a subtle periosteal reaction along the iliopectineal line (black arrow). Note heterotopic ossification medial to the femoral neck (white arrow), eccentric liner wear (gray arrow), and geographic periacetabular radiolucency (thin white arrow). (b) Coronal intermediate-weighted multi-acquisition variable-resonance image combination (MAVRIC) MR image demonstrates a fracture line through the superior ramus (black arrow). Note the high signal intensity focus of heterotopic ossification (white arrow). (c) Coronal inversion recovery MAVRIC MR image demonstrates edema pattern (thin white arrow) adjacent to the fracture line (black arrow). Note suppression of the fatty marrow of the focus of mature heterotopic ossification (thick white arrow).

the ability to demonstrate stress reactions (►Fig. 10) and subtle and nondisplaced fractures (►Fig. 11). MR imaging signs include a localized bone marrow edema pattern, periosteal reaction, and hypointense fracture lines that may be complete or incomplete<sup>53</sup> (►Fig. 11).
