# Unusually High Rate of Early Failure of Tibial Component in ATTUNE Total Knee Arthroplasty System at Implant–Cement Interface

J Knee Surg 2017;30:435–439.

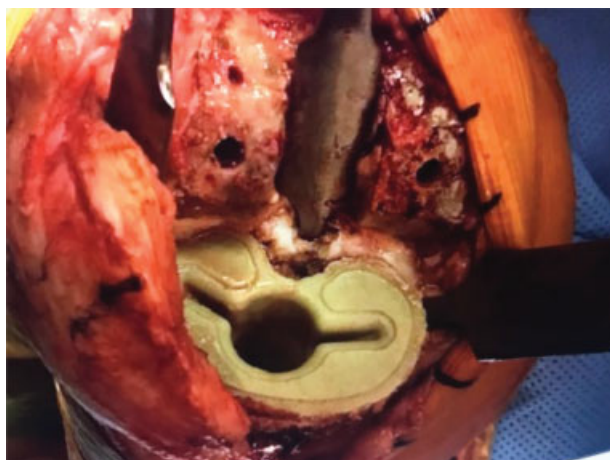
In all revision cases described in this study, there was an apparent loosening of the tibial component with gross implant motion between the tibial tray and tibial bone cement. In one patient, the tibial tray would piston 4 mm as the knee was brought from flexion to extension, and would lift off from the tibial bone cement when the leg was manually distracted intraoperatively. All patients underwent revision of both tibial and femoral components. In all tibial cases, the tibial component had debonded and was easily separated from the cement mantle. Upon removal of the tibial baseplate, the inferior surface of the tibial baseplate was clear of cement (–Fig. 2), while all the cement was strongly adherent to the tibial bone (–Fig. 3). The femoral components were securely attached to the femoral bone with no apparent loosening. Upon explantation of the femoral components, the cement was strongly adherent to the implant surface in all cases (–Fig. 4).

**Fig. 3** Cement adherent to the tibial bone after explantation of tibial component.
