Unusually High Rate of Early Failure of Tibial Component in ATTUNE Total Knee Arthroplasty System at Implant–Cement Interface

J Knee Surg 2017;30:435–439.

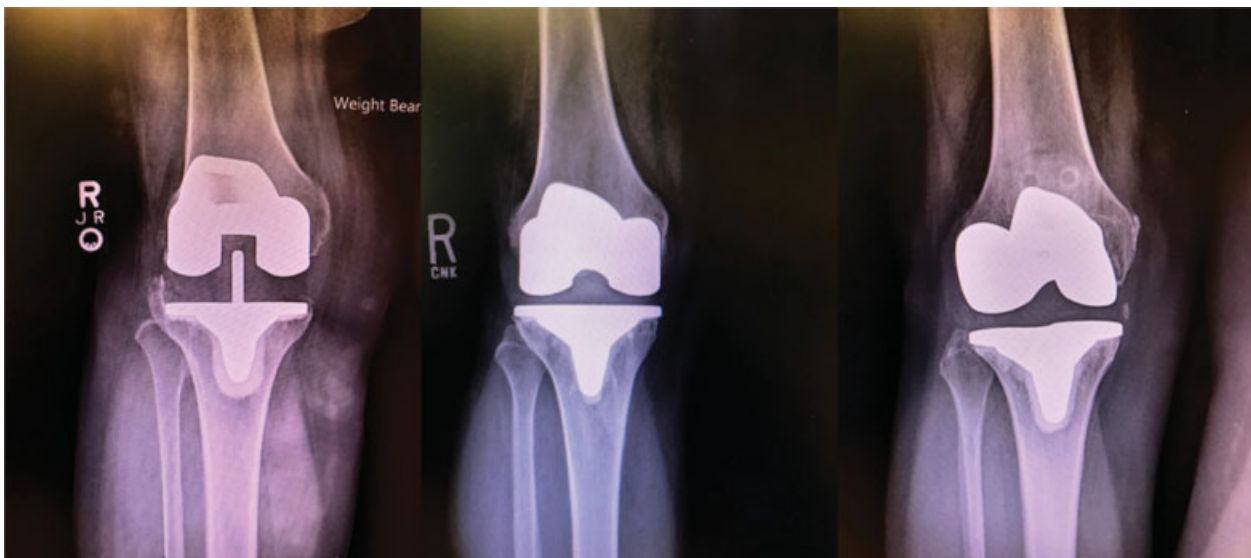
Radiographic evaluation of the 15 knees that received this implant demonstrated only 2 (13%) to have evidence of radiolucencies. In the first case, on the AP radiograph, there was evidence of radiolucency in zones 1 and 2. On the lateral radiograph, there was evidence of radiolucency in zone 3A. For the second case, there was evidence of radiolucencies in zones 1, 2, and 3L on AP radiograph, and zones 1, 2, and 3A on lateral view (→ Fig. 1).

Fig. 1 Anteroposterior radiographs prior to revision surgery.
