# Stress Fracture of Proximal Femur after Hip Resurfacing Treated with Cannulated Screw

Joints 2018;6:128–130.

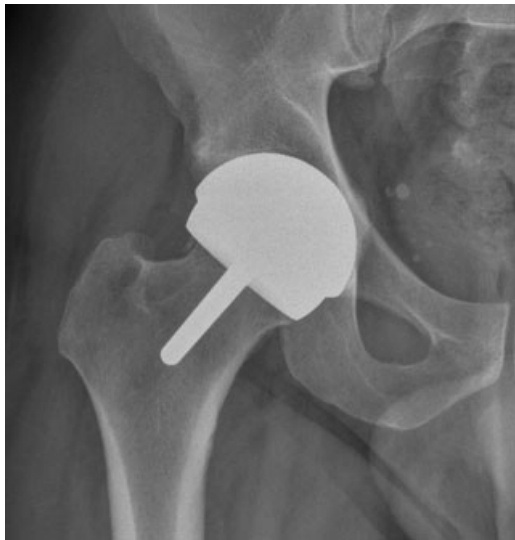
**Fig. 1** Postoperative anteroposterior X-ray after hip resurfacing.

time of surgery, body mass index (BMI) was 23.7 and T-score at dual energy X-ray absorptiometry was 0.5. The postoperative X-ray showed a well-positioned implant (▶ Fig. 1).

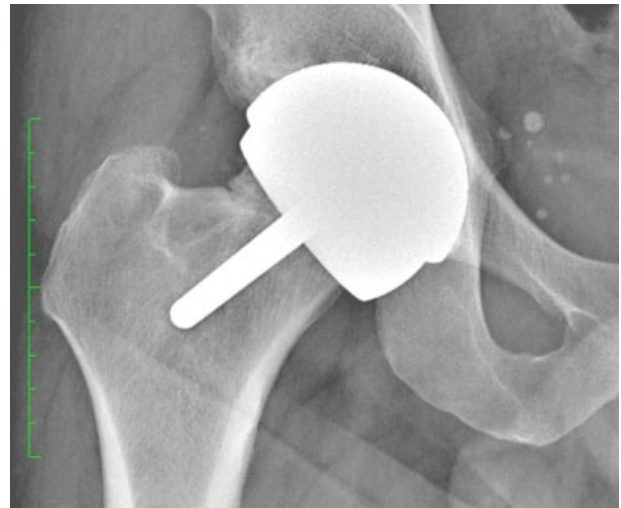
**Fig. 2** Anteroposterior X-ray at 2-year follow-up after hip resurfacing showing a stress fracture of the femoral neck.

The anteroposterior X-ray showed a stress fracture of the femoral neck with a slight variation (4 degrees) of the prosthetic component compared with the postoperative X-rays (▶ Fig. 2). No magnetic resonance imaging was required

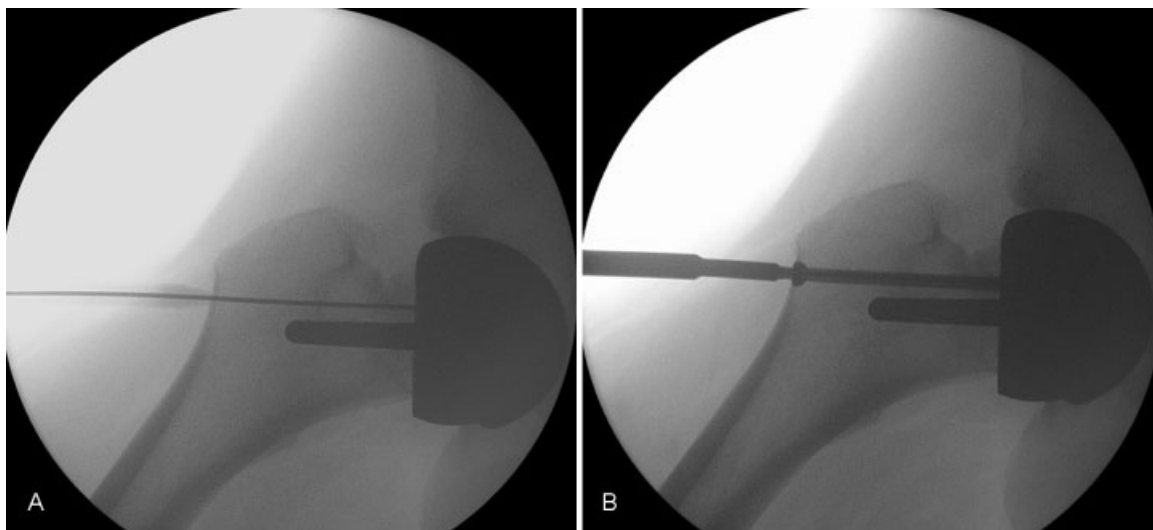
**Fig. 3** Image intensifier during surgery: K-wire is used to check the correct position after (A) reduction maneuver. (B) Screw introduction.

The day after, the patient underwent surgery under spinal anesthesia in the supine position. As the fracture was incomplete, it was treated like undisplaced femoral neck fracture, with reduction maneuver. A lateral incision was made and under observation from the image intensifier a guidewire was passed superior to the stem of the femoral component of the BHR. One 6.5 mm cannulated screw 75-mm long was placed into the superior neck. The image intensifier was used to confirm that the threads were beyond the fracture line and that the fracture was compressed (**Fig. 3**).

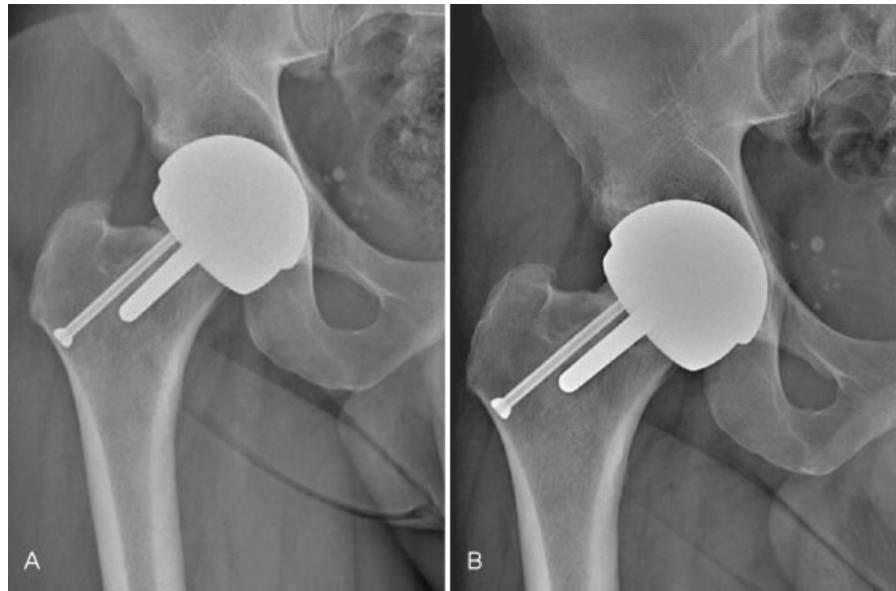
**Fig. 4** Anteroposterior radiograph at (A) 6 months and (B) 18 months after fracture fixation.

at last follow-up showed a good consolidation of the fracture (**Fig. 4**). No differences were found compared with the exams prior to fracture. At the last follow-up, the patient was asymptomatic.
