Surgical Management of Cervical Vertebral Fractures in Two Dogs with Severe Concurrent Vertebral Venous Plexus Hemorrhage

VCOT Open 2018;1:e1–e7.

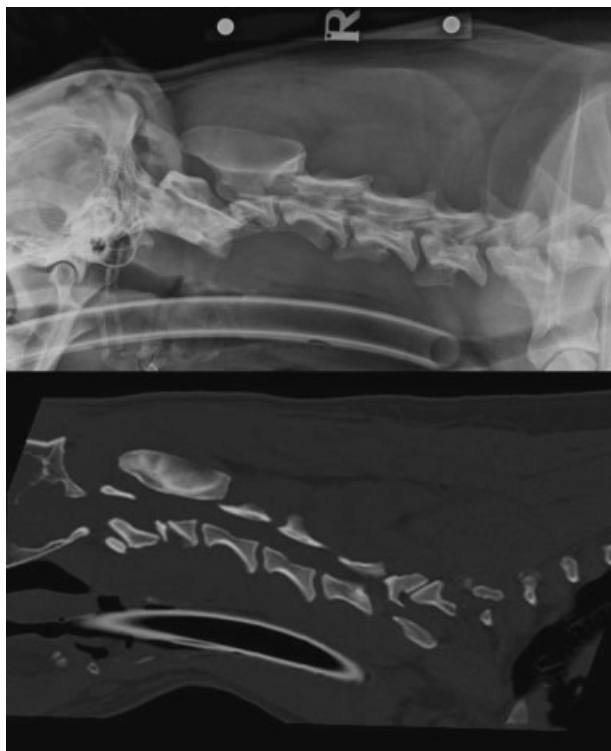
Fig. 1 Preoperative lateral radiograph and sagittal CT image of the cervical spine demonstrating displaced comminuted fracture of the C2 vertebra (case 1).

The patient was premedicated with acepromazine (ACP; Novartis Animal Health UK Ltd, Camberley, UK; 0.02 mg/kg IM) and methadone hydrochloride (Martindale Pharmaceuticals, Romford, UK; 0.3 mg/kg IM), induced with propofol (Abbott Laboratories Ltd, Maidenhead, UK; 4 mg/kg IV), and maintained with isoflurane (Isoflo; Abbott Laboratories Ltd) in oxygen. Preoperative radiography (Elkin Medical Systems Inc, Santa Clara, California, United States) of the cervical spine (lateral) and computer tomography (CT; Siemens Somatom Emotion, Siemens AG Medical Solutions, Germany) images in multiple planar reconstructions demonstrated a moderately displaced, comminuted fracture of the vertebral body of C2 (► Fig. 1).

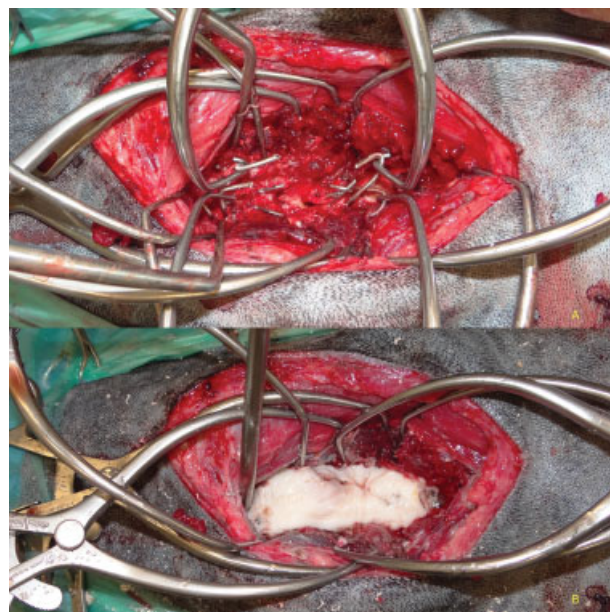
Fig. 2 Intraoperative photograph showing (A) pin and Gelpi retractor placement prior to graft and cement placement, and (B) after the cement bolus had cured and hooked pin tips used for distraction excised (case 1). Cranial is to the left of the photograph.

Pins (INTERFACE Fixation Half-pins; IMEX, Longview, Texas, United States; 2.0 mm diameter) were embedded into the vertebral bodies of C2 (both cranial [$n = 2$] and caudal [$n = 3$] to the fracture) and C3 ($n = 2$) and into the base of the wings of C1 bilaterally ($n = 4$). The four most cranial and caudal pins of the construct were left extruding further than the others and were bent to form a “hooked” end. Two pairs of Gelpi self-retaining retractors were preplaced between the hooked ends of the cranial and caudal pins (► Fig. 2). The Gelpi retractors were positioned so that they were raised above the spine, ensuring that they were not encased within the cement when it was later applied. Absorbable lyophilized bovine collagen fleece (Lyostypt; B. Braun Aesculap, Tuttlingen, Germany) was packed directly over the nonreduced fracture and around the occipital fossa. Following this, a large quantity of autogenous cancellous bone graft collected bilaterally from the proximal humeral metaphysis was overlaid onto the entire ventral surface of C2

and packed into the articular facets of C1–C2 following cartilage debridement (► Fig. 2).

After curing, the cement bolus and pin tips were contoured in situ with a high-speed burr and small pieces of cement at the periphery removed with rongeurs to avoid impingement on the occipital condyles or cervical soft tissues (► Fig. 2). Moistened gauze swabs were laid over the surrounding soft tissues to limit contamination with cement debris prior to burring. The surgical site was thoroughly lavaged. Soft-tissue closure in several layers was routine.

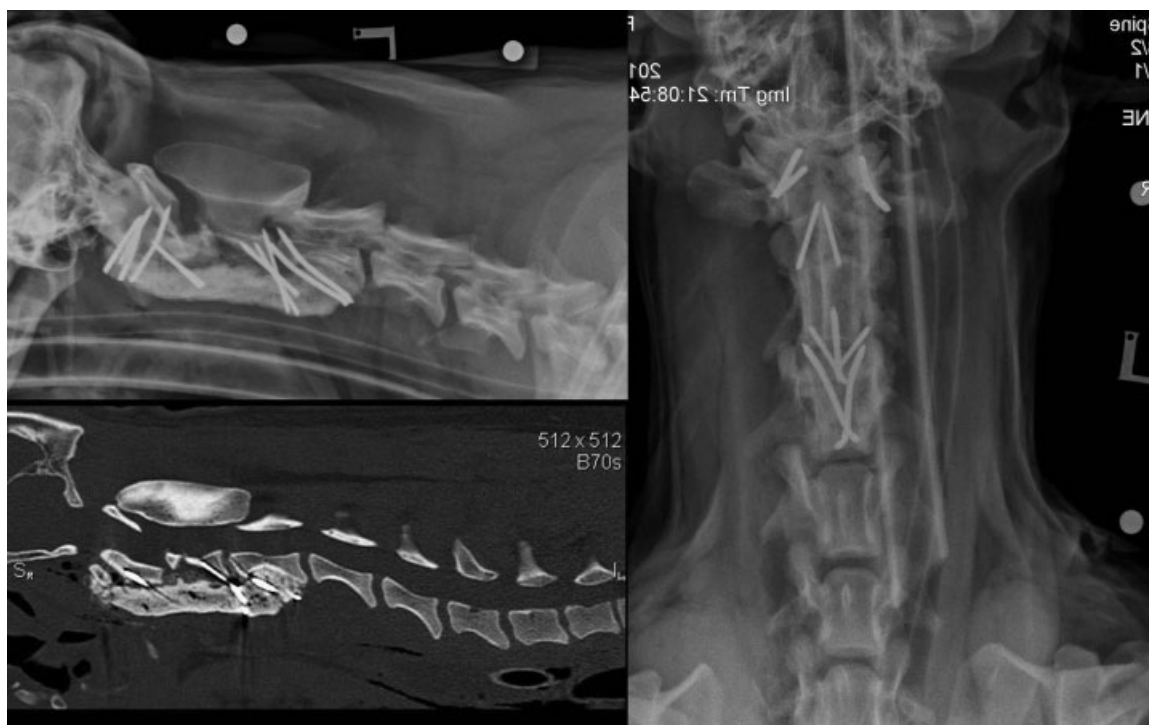
Fig. 3 Immediate postoperative lateral and ventrodorsal radiographs and sagittal CT image of the cervical spine demonstrating fracture reduction and implant position (case 1).

Postoperative radiography and CT confirmed appropriate implant placement and reasonable fracture reduction (► Fig. 3).

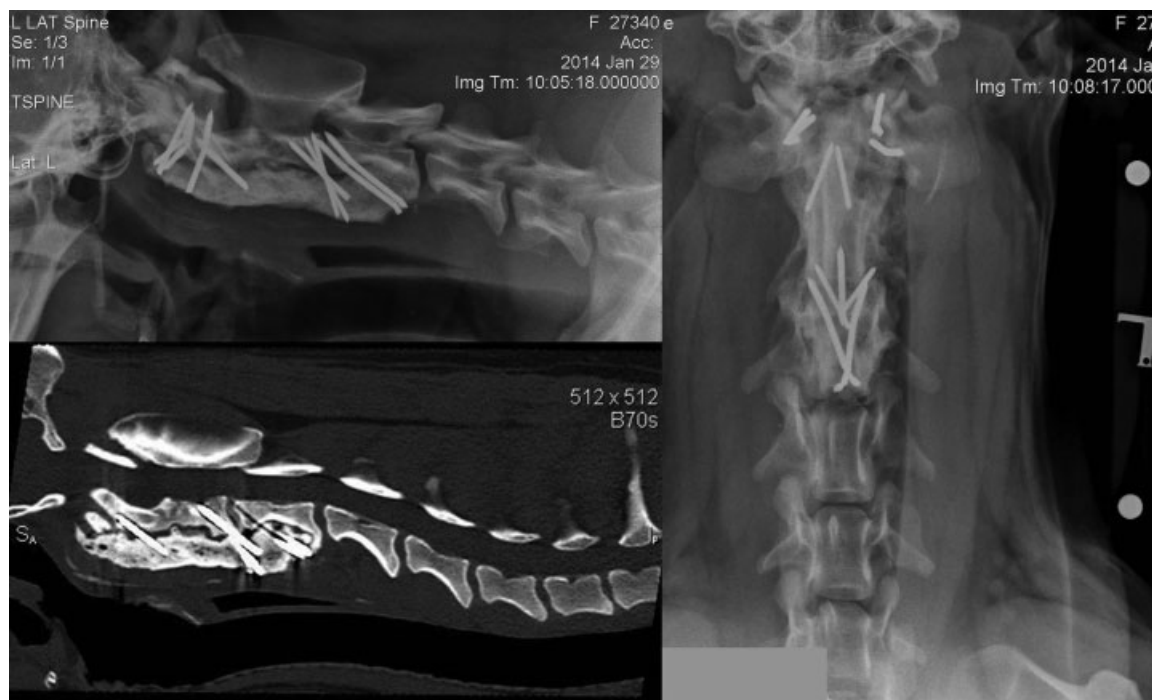
Fig. 4 Six months' postoperative lateral and ventrodorsal radiographs and sagittal CT image of the cervical spine demonstrating fracture union. Two pins in C1 were noted to have fractured as an incidental finding (case 1).

There was no decline in neurological status following surgery and by 6 weeks postoperatively, the patient was considered to be clinically normal; radiographs and CT demonstrated no implant disruption and progression toward osseous union of the fracture. Radiography and CT at 12 weeks postoperatively demonstrated osseous union. As an incidental finding, two of the pins placed into the wings of C1 had broken, presumably as a result of incomplete intervertebral fusion between the C1 and C2 vertebrae. There was no evidence of pin migration. Exercise was restricted to controlled lead walks of increasing duration for the first 12 weeks using a harness. Follow-up examination 6 months after surgery documented a neurologically normal patient; radiographs and CT demonstrated no further implant disruption (► Fig. 4). A telephone interview with the owner 4 years following surgery revealed the patient remained free of clinical signs.

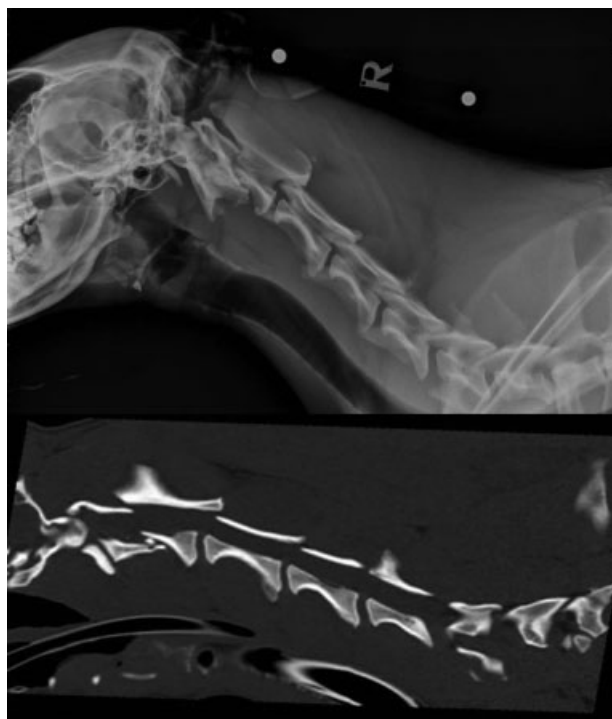
Fig. 5 Preoperative lateral radiograph and sagittal CT image of the cervical spine demonstrating displaced comminuted fracture of the C2 vertebra (case 2).

reconstruction demonstrated a displaced, comminuted fracture of the vertebral body of C2 (→**Fig. 5**).

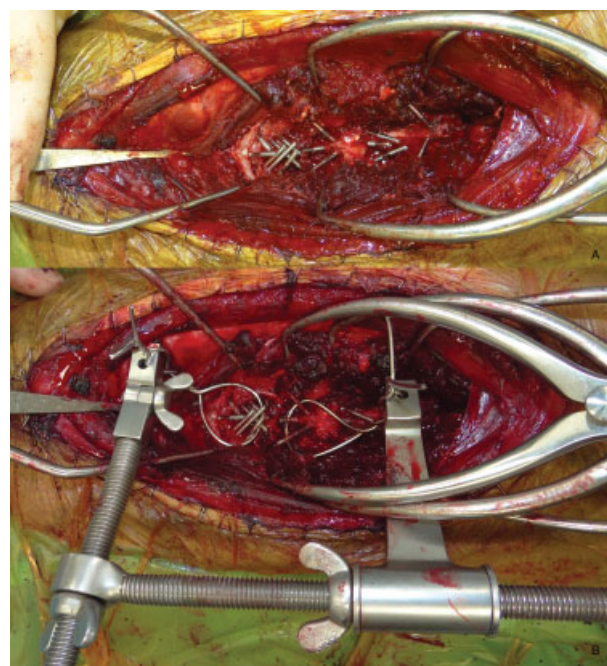
Fig. 6 Intraoperative photograph showing (A) pin placement, and (B) orthopaedic wire and retractor used for axial distraction (case 2). Cranial is to the left of the photograph.

reduce the fracture fragments, by applying traction to the vertebrae. Pins (2.0 mm diameter; IMEX, Longview; $n = 7$) were inserted into C1, two of which passed through the cranial fragment of C2 and through the facet joints into C1. Pins ($n = 3$) were also embedded in the caudal vertebral body of C2 plus in the cranial ($n = 3$) and caudal ($n = 2$) body of C3 (→**Fig. 6**). Orthopaedic wire was passed around the pins

immediately cranial and caudal to the fracture site. These wires were then passed through a multidirectional adjustable jig (Orthopaedic Distractor Ref: 001500; Veterinary Instrumentation, Sheffield, UK; ▶ **Fig. 6**). As described for case 1, absorbable collagen fleece (B. Braun Aesculap) and autogenous cancellous bone graft were placed over the fracture site. PMMA cement (Howmedica Osteonics) was then poured to enshroud the pins and wire. While the cement was solidifying, axial distraction was applied via the wires using the multidirectional jig. After curing, the orthopaedic wire protruding from the cement bolus was excised flush with the contour of the cement and closure was routine.

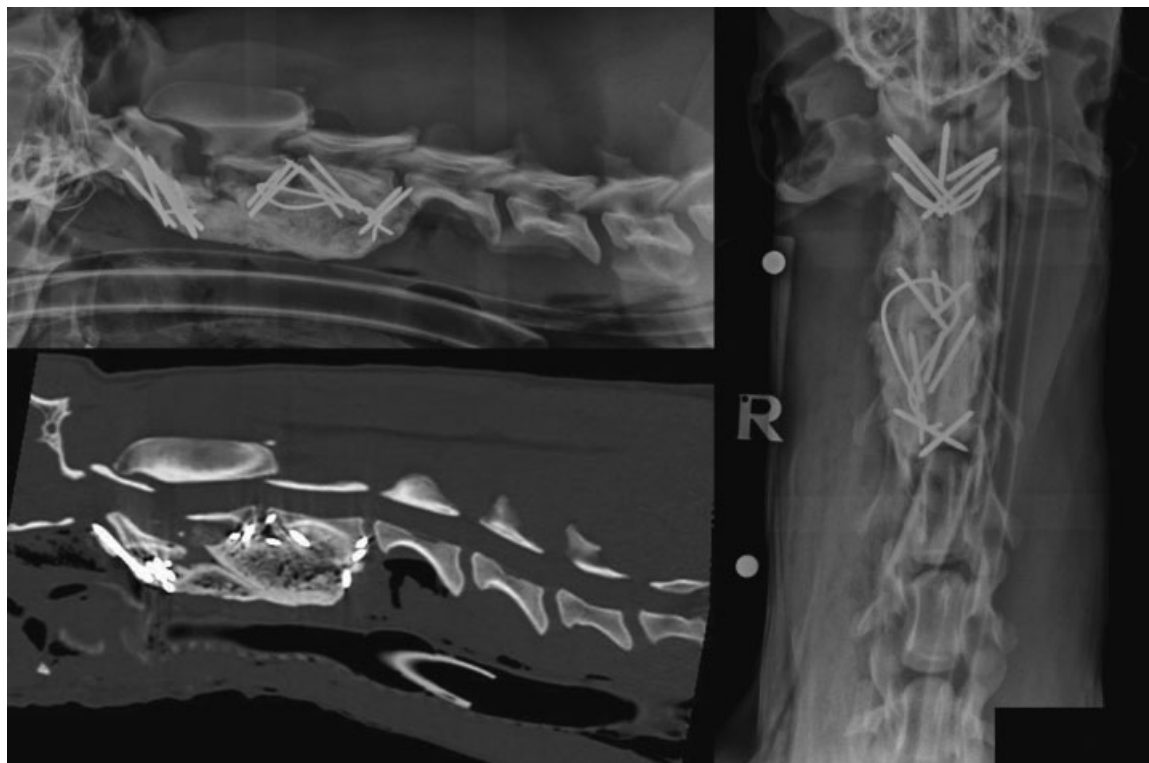
Fig. 7 Immediate postoperative lateral and ventrodorsal radiographs and sagittal CT image of the cervical spine demonstrating fracture reduction and implant position (case 2).

The immediate postoperative radiographs and CT images (▶ **Fig. 7**) confirmed satisfactory fracture alignment to reestablish the spinal canal.

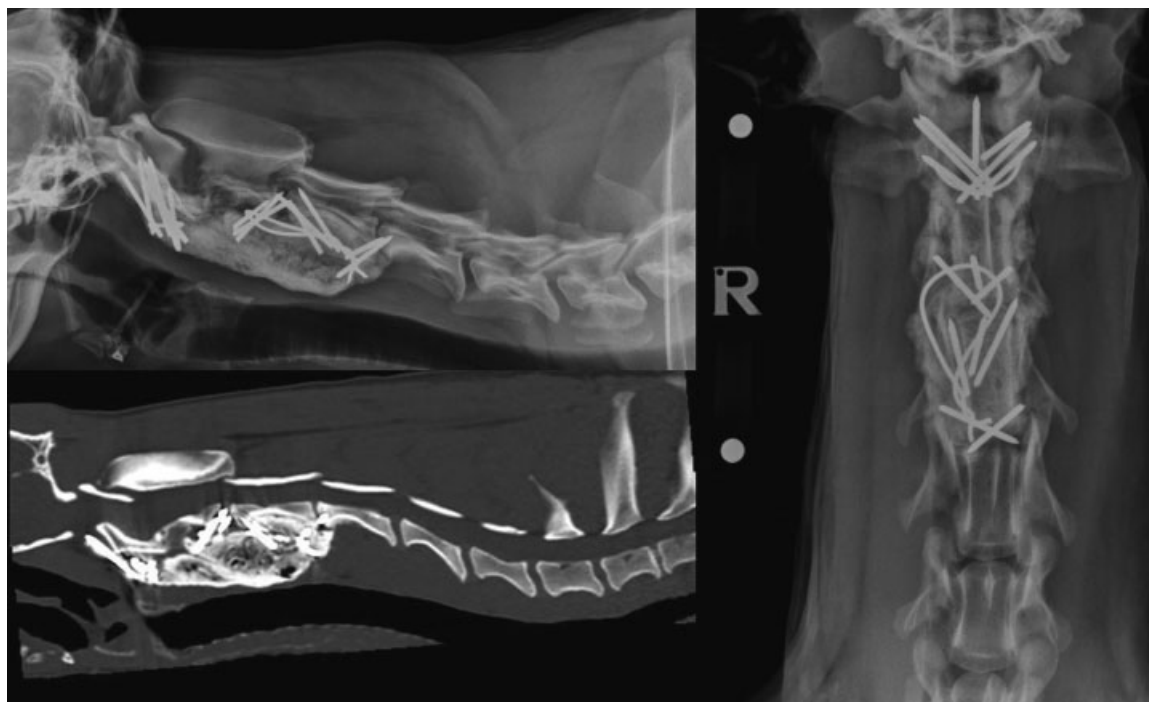
Fig. 8 Twelve weeks postoperative lateral and ventrodorsal radiographs and sagittal CT image of the cervical spine demonstrating fracture union (case 2).

pelvic limbs were mildly reduced, but the thoracic limbs were considered normal. Radiographs and CT demonstrated no implant disruption. There were not any signs of pain on palpation or manipulation of the cervical spine. Radiographs and CT at 12 weeks postoperatively demonstrated osseous union of the fracture (▶ **Fig. 8**) and the degree of ataxia had improved further, but not fully resolved. The patient was returned to the hospital 1 year later for assessment of a pelvic limb lameness due to coxofemoral osteoarthritis secondary to hip dysplasia. No signs of pain were present on palpation or manipulation of the cervical spine and ataxia had resolved. Radiographs and CT of the cervical spine revealed progressive fracture site remodeling and no implant-related complications. A telephone interview with the owner 3 years following surgery revealed the patient remained free of clinical signs.
