Comparison of Shear Strength of Metal and Ceramic Orthodontic Brackets Cemented to Zirconia Depending on Surface Treatment: An *In Vitro* Study

Eur J Dent 2019;13:150–155

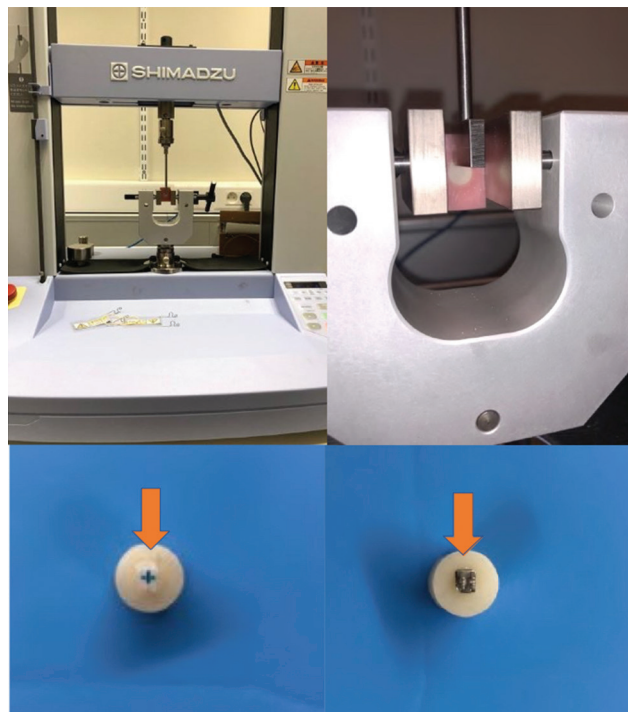
Fig. 1 Universal testing machine (Autograph AGS-X, Shimadzu, 1000 N unit) and direction of stress applied to the brackets.

The shear strength test was conducted using a universal testing machine (Autograph AGS-X; Shimadzu, Osaka, Japan). Shear stress was applied in a downwards direction parallel to the surface of the zirconia block at a speed of 0.5 mm/m (►Fig. 1).

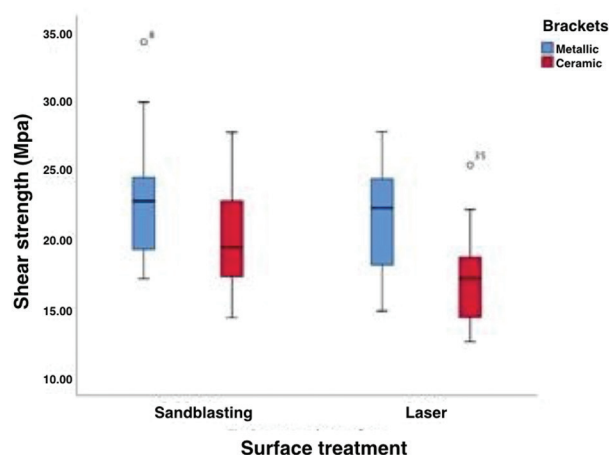
Fig. 2 Graph comparing the shear strength (MPa) of the samples depending on surface treatment and type of bracket.

The values obtained on bracket debonding during shear testing are described in ►Table 2 (►Fig. 2).

Two-way analysis of variance (ANOVA) was conducted to determine whether there existed a statistically significant difference between the groups. The differences were significant between the metal (SMB, LMB) and ceramic (SCB, LCB) bracket groups with regard to shear bond strength, with respectively 23.29 ± 5.34 MPa, 21.59 ± 4.03 MPa, 20.06 ± 4.05 MPa, and 17.55 ± 3.88 MPa. The SMB group (airborne particle abrasion and metal bracket) showed the highest shear bond strength values, whereas the lowest was that of the LCB group (Er:YAG laser and ceramic bracket).

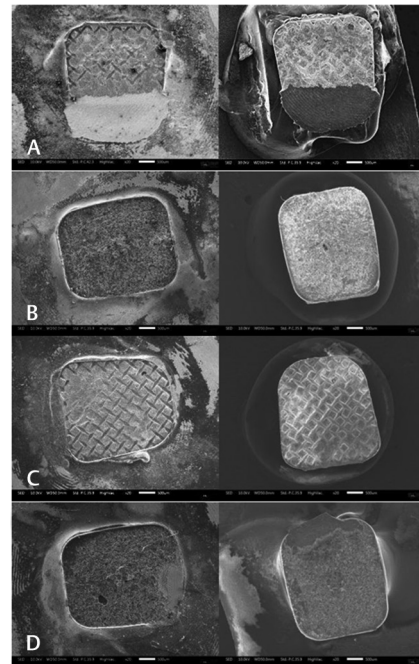
Fig. 3 Bracket base of each group (SMB, SCB, LMB, and LCB) and corresponding surface after debonding on electron microscopy (x20). (A) Sample from SMB group. (B) Sample from SCB group. (C) Sample from LMB group. (D) Sample from LCB group.

The frequency distribution and percentage of ARI scores of the four groups are shown in ►Table 3. A sample of blocks and brackets analyzed and used to evaluate the ARI score is shown in ►Figs. 3 and 4.

The LMB group displayed the lowest mean ARI score, followed by the SMB, LCB, and SCB groups. The groups with ceramic brackets had higher mean ARI scores than those with metal brackets. However, after analysis, there was no statistically significant difference between these groups.

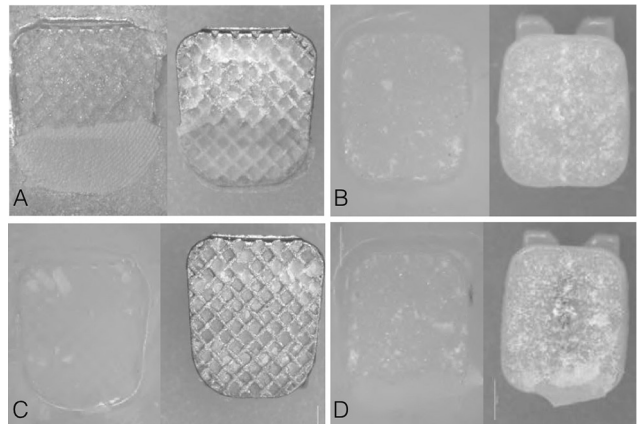
Fig. 4 Bracket base of each group (SMB, SCB, LMB, and LCB) and corresponding surface after debonding on optical microscopy (x20). (A) Sample from SMB group. (B) Sample from SCB group. (C) sample from LMB group. (D) Sample from LCB group.
