An Intraoral Repair Method for Chipping Fracture of a Multi-unit Fixed Zirconia Reconstruction: A Direct Dental Technique

Alfredo Mikail Melo Mesquita¹ Nadin Al-Haj Husain² Pedro Molinero-Mourelle² Mutlu Özcan³

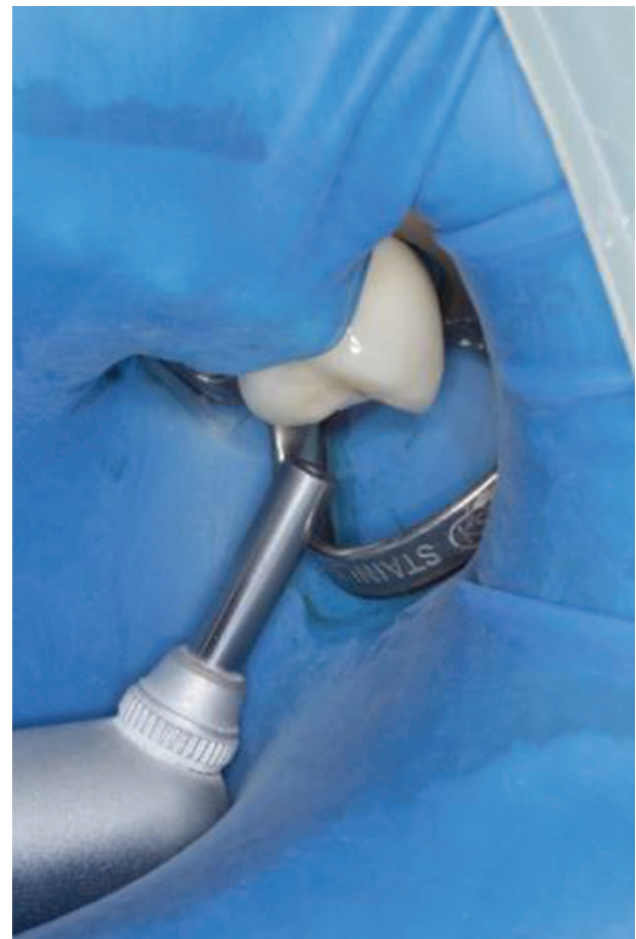
Fig. 2 Air abrasion using a chairside device with silica-coated alumina particles (30 µm, 2.5 bar for 20 seconds).

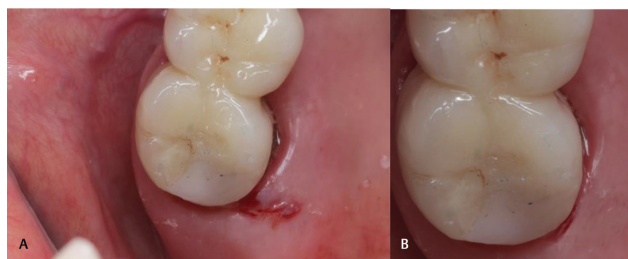
Fig. 7 Final (A) over and (B) closeup view of repaired distal palatal veneering and core fracture.
