Total occlusion of the esophagus following placement of an over-the-scope clip: an unusual complication, and how to solve it

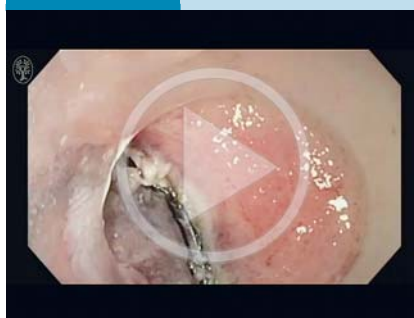
Video 1

Total occlusion of the esophagus following placement of an over-the-scope clip. Attempts to cut the clip using argon plasma coagulation failed, and resulted in severe thermal injury to the surrounding tissue. A DC ClipCutter (Ovesco Endoscopy AG, Tübingen, Germany) was finally acquired to cut through the clip and facilitate removal. A covered stent was placed to bypass the fistula for a few weeks, prior to a new attempt to close the fistula.

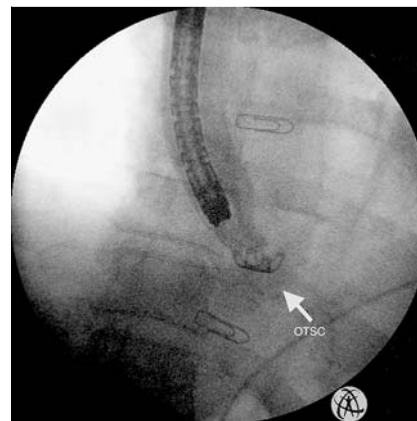
Fig. 1 There was no passage of contrast across the over-the-scope clip (arrow).

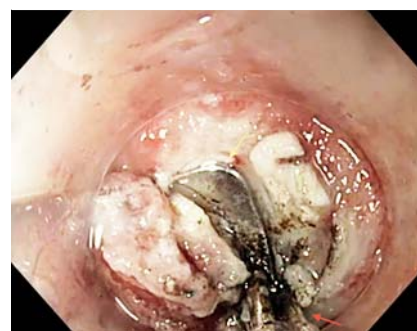
Fig. 2 Cutting the over-the-scope clip (yellow) with the cutting device (red arrow). The surrounding tissue showed severe thermal damage caused by previous attempts to cut the clip using argon plasma coagulation.

The patient fasted for 24 hours while a newly developed and commercialized DC ClipCutter (Ovesco Endoscopy AG) was acquired. By using this cutting device, it was possible to cut the OTSC into four sections (▶ Fig. 2) and remove it (▶ Fig. 3, ▶ Video 1).

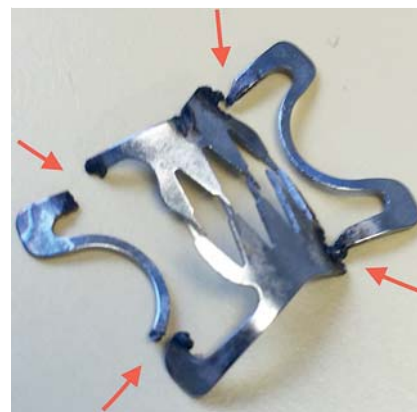
Fig. 3 The over-the-scope clip after cutting (arrows) and removal.

Following removal of the clip, the surrounding tissue was swollen and inflamed, rendering the area temporarily inaccessible for further evaluation and intervention. A covered stent was placed to bypass the fistula for a few weeks, prior to a new attempt to close the fistula.
