# Migrated Peripherally Inserted Central Catheter in the Right Ventricle and Bilateral Pulmonary Arteries: A Case Report

Indian J Radiol Imaging

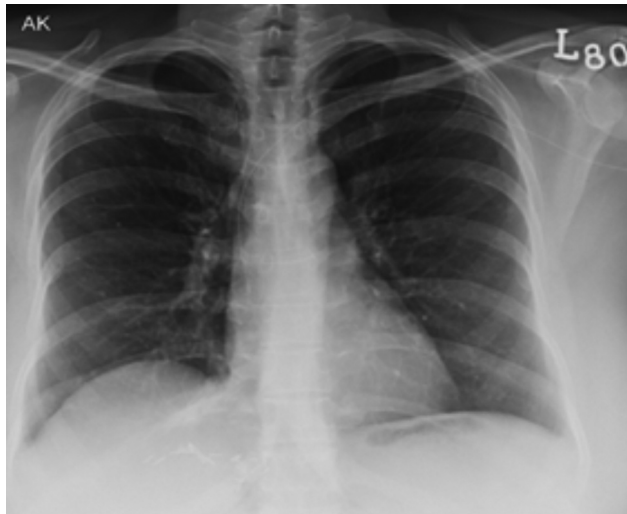
**Fig. 1** Three months old chest X-ray showing the PICC line in position (yellow arrows showing PICC location). PICC, peripherally inserted central catheter.

In a 50-year-old female diagnosed with adenocarcinoma rectum with a PICC seen traversing through left axillary, left brachiocephalic into the SVC visualized in a 3-month-old neonate's X-ray (▶ **Fig. 1**).

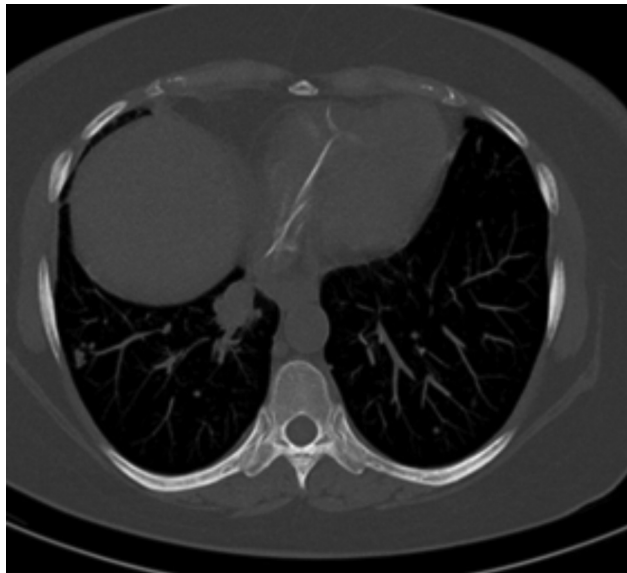
**Fig. 2** HRCT axial view showed the broken PICC line into the right atrium and right ventricle (yellow arrow). HRCT, high-resolution computed tomography; PICC, peripherally inserted central catheter.

The CT findings showed linear hyperdensity forming coils in the right atrium, inferior vena cava (IVC), and extending to right ventricle and further into the pulmonary arteries consistent with PICC line. The proximal end was lying in the right atrium ( ) and distal end coiled up in the main and right pulmonary artery ( **Fig. 3**) and into the left pulmonary artery ( **Fig. 4**) confirmed that PICC line was located within the heart.

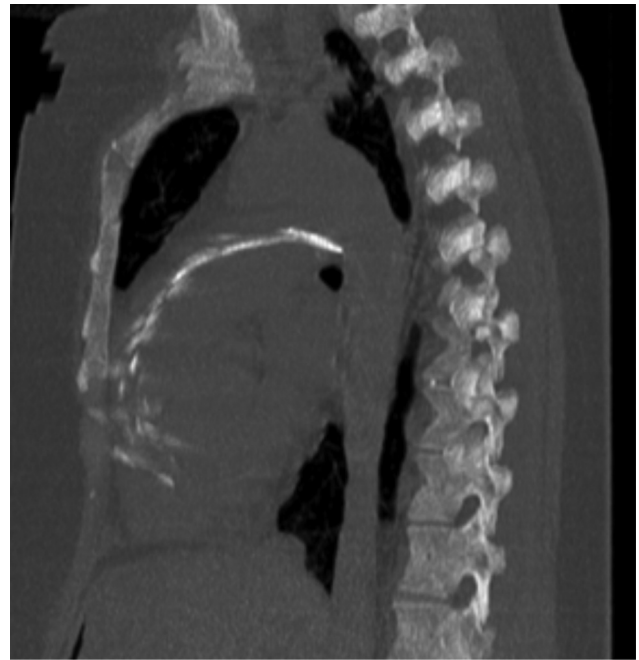
**Fig. 3** HRCT reformatted sagittal section showing broken PICC line into the right ventricle and extending into the main pulmonary trunk (yellow arrow). HRCT, high-resolution computed tomography PICC, peripherally inserted central catheter.

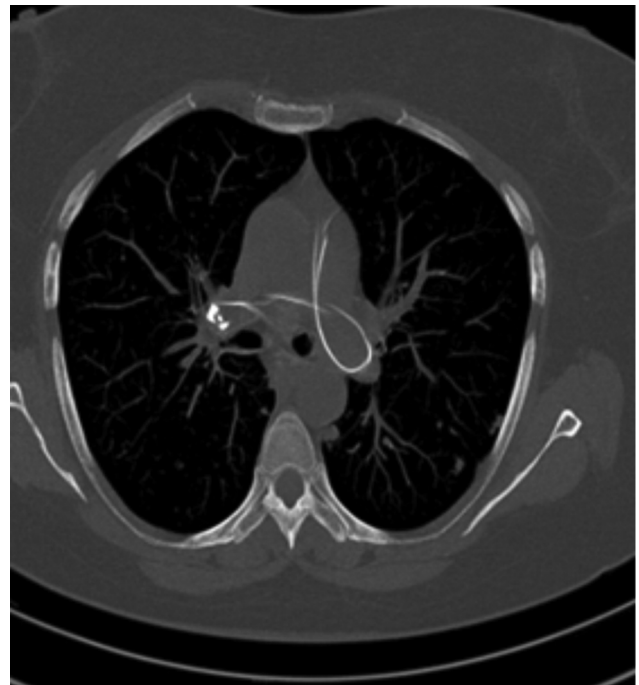
**Fig. 4** HRCT axial cuts demonstrating presence of the coiled PICC line in the left pulmonary artery (yellow arrow). HRCT, high-resolution computed tomography; PICC, peripherally inserted central catheter.

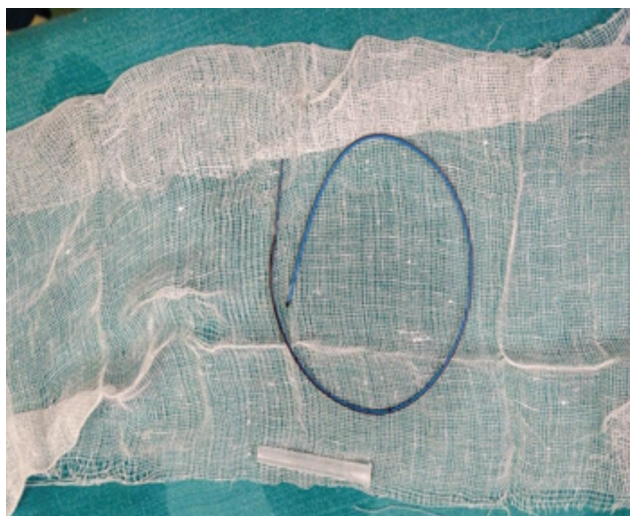
**Fig. 5** Retrieved PICC line. PICC, peripherally inserted central catheter.

using an ultrasound-guided percutaneous right femoral venous approach, a 9-F catheter sheath and snare taken, positioned in right atrium (RA), and the free end in RA is grasped in snare and pulled out through the sheath ( **Fig. 5**). Whole of the broken segment of PICC retrieved.
