# Interventional Closure of a Ruptured Sinus of Valsalva with a Konar-Multifunctional Device

Aorta (Stamford) 2022;10:259–262.

A 14-year-old girl with trisomy 13 presented with signs of respiratory failure. This was caused by the rupture of a sinus of Valsalva aneurysm into the right atrium. A Konar Multifunctional Occluder was used for closure. This is indeed the first report of treatment of this disease with this device.

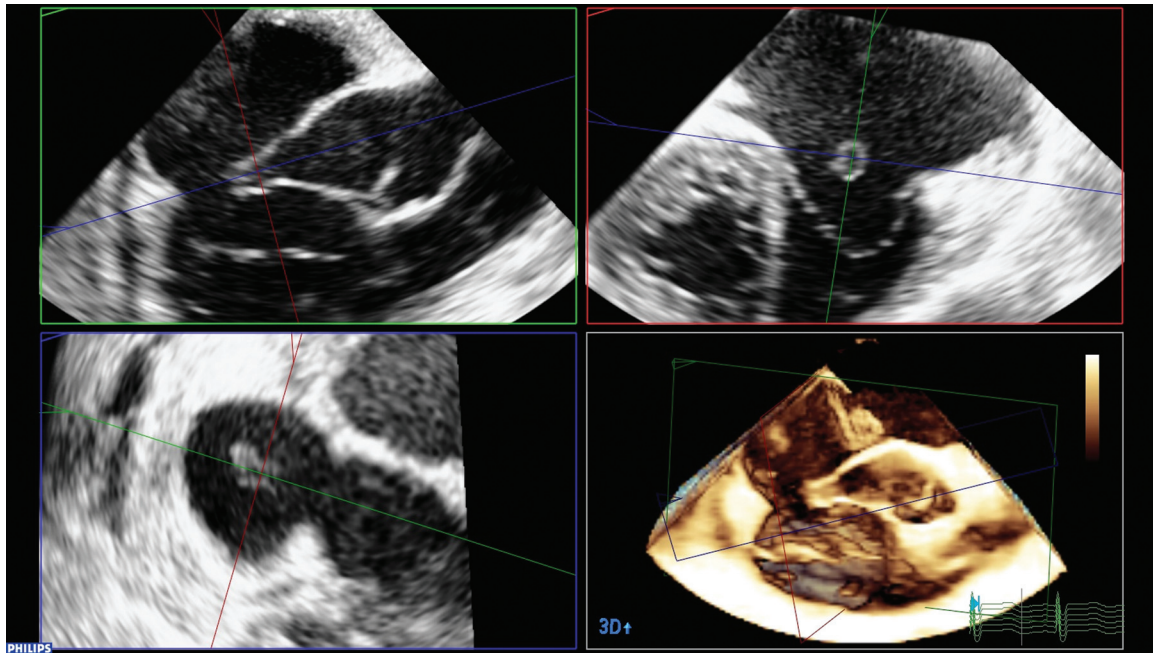
**Fig. 1** Transesophageal echocardiography delineating the anatomy in different planes and three-dimensional view. Note the elongated sinus of Valsalva and the opening toward the right atrium.

Transesophageal echocardiography under general anesthesia depicted the fistula in detail (▶ Fig. 1).

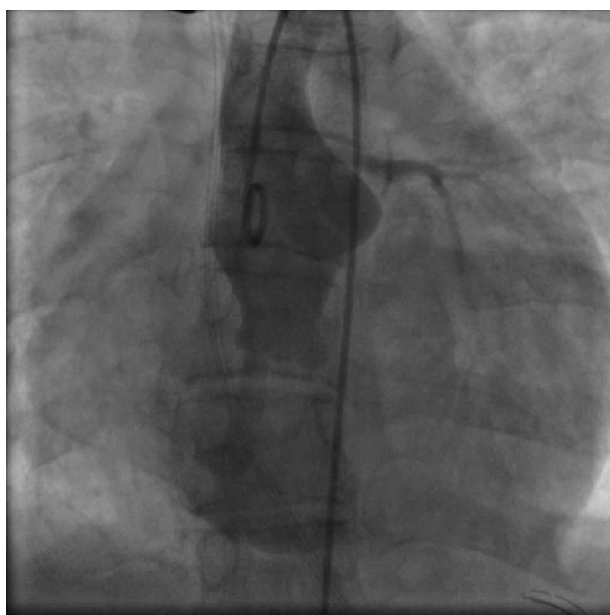
**Fig. 2** Angiography in the ascending aorta shows the abnormally shaped sinus of Valsalva with a connection to the right atrium.

Aortography showed a very unusual shape of the enlarged sinus of Valsalva (▶ Fig. 2) with a connection to the right atrium of approximately 5 mm.

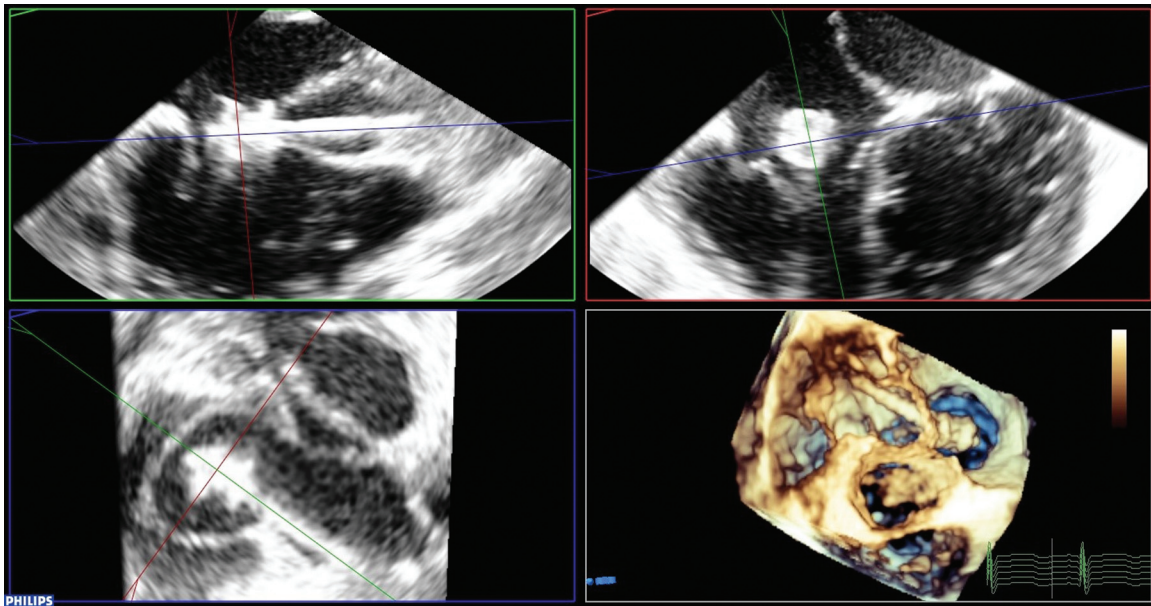
**Fig. 3** Konar multifunctional device within the ruptured aneurysm, same views as ► Fig. 1. The device is still attached to the delivery cable.

This was crossed from the aortic side with a 5F multipurpose catheter (Cordis, Santa Clara, Canada), which was then exchanged with a 5F Launcher (Medtronic, Minneapolis, MN) with an internal diameter of 1.7 mm, which was placed in the inferior vena cava (IVC). Through this, the disk of a Konar Multifunctional Occluder (MFO) device size 8/6 (Lifetech, Shenzhen, China) was deployed in the IVC, and then pulled back against the opening of the ruptured sinus of Valsalva. Special attention was paid to the function of the tricuspid valve and the relation between the disk and the leaflets. The body and attached disk of the device were then deployed within the sinus of Valsalva (▶ Fig. 3). A careful wiggle maneuver was performed. Echocardiography and angiography showed adequate positioning. The device was released. Angiography showed the device in a good position with flow through the metal meshwork of the device (▶ Fig. 4).

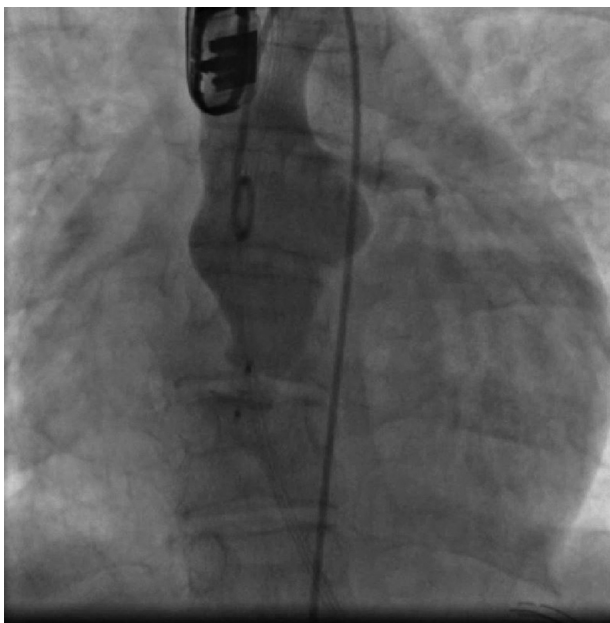
**Fig. 4** Angiography in the ascending aorta shows the device within the fistula. There is still some flow through the metal meshwork of the device.

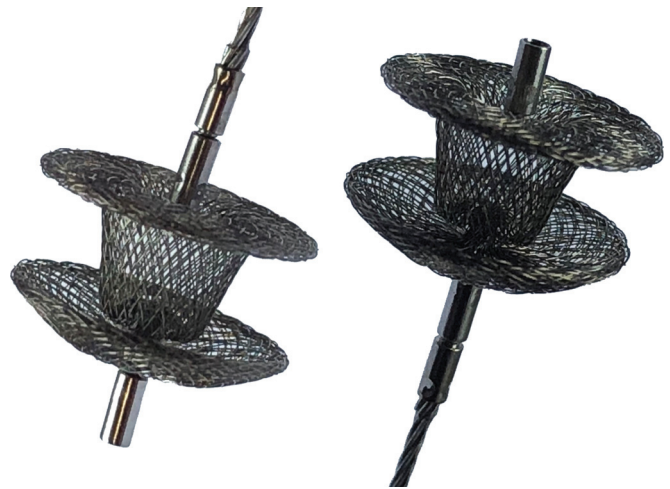
**Fig. 5** Konar Multifunctional device size 8/6. The device can be attached to the delivery cable from both sides.

The Konar MFO (Lifetech, Shenzhen, China) is a double disk device resembling a short (4 mm) duct occluder, with the second disk attached to the body by a small cone-shaped connection. It can be screwed onto the delivery cable from both sides, hence allowing deployment in both directions (► Fig. 5). It comes in various sizes. Smaller sizes without any polytetrafluoroethylene polymer membrane can be delivered through a small delivery sheath or catheter, comparable, that is, to Amplatzer vascular plugs, which have also been used to close such defects.<sup>5</sup> In these, the disks and body of the device have the same diameter. Here, a bigger device would have been necessary. Angulation within the aneurysm could have compromised effectiveness.
