Post-TAVI Follow-Up with MDCT of the Valve Prosthesis: Technical Application, Regular Findings and Typical Local Post-Interventional Complications

Martin Soschynski¹, Fabio Capilli¹, Philipp Ruile², Franz-Josef Neumann², Mathias Langer¹, Tobias Krauss¹

Fortschr Röntgenstr 2018; 190: 521–530

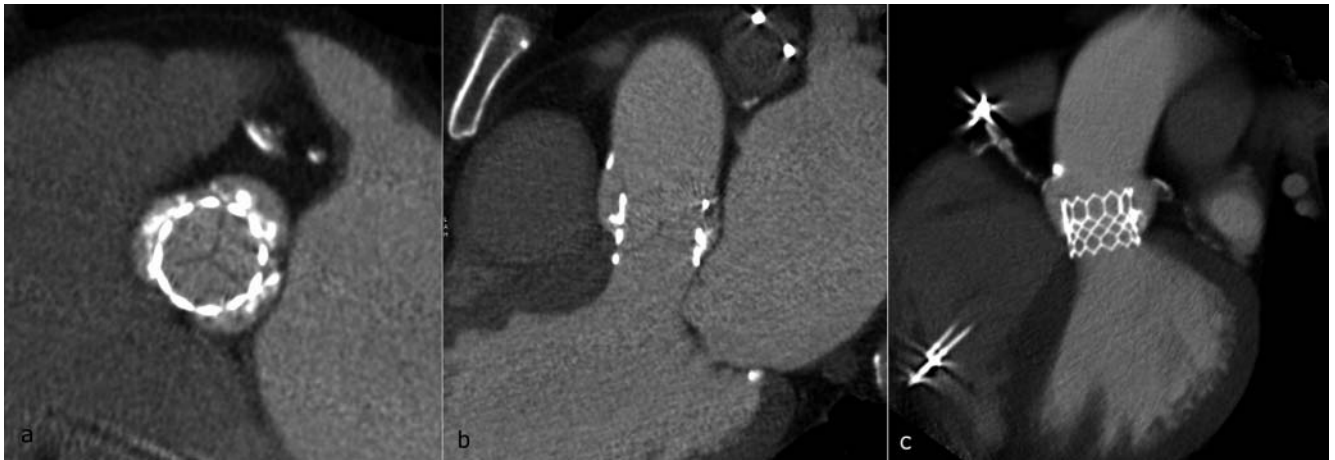
► **Fig. 1** Typical post-interventional MDCT of an Edwards SAPIEN 3-prosthesis in **a** axial and **b, c** parasagittal angulation to the prosthetic valve. **a** In the axial view the native valve leaflets can be seen as fine linear hypodensities at the level of the aortic bulbus. At this level the prosthesis is usually not fully attached to the aortic wall. **b** Parasagittal reconstruction shows the correct craniocaudal position of the prosthesis and complete attachment of the stent to the aortic wall at the level of the aortic annulus. **c** Thick-slab multiplanar reconstruction (MPR) illustrates the stent geometry and the exact implantation position.

The typical post-interventional CT finding for an Edwards SAPIEN 3 prosthesis is shown in ► **Fig. 1a-c**. In the case of balloon-expandable aortic valve prostheses like the Edwards SAPIEN prosthesis, the stent frame is designed to expand fully in a circular fashion so that it presses the calcified original valve against the wall of the aortic root [4].

The entire circumference of the stent should lie against the left ventricular outflow tract (LVOT) (► **Fig. 1b, c**). Massive, asymmetrical calcifications can result in incomplete conformation of the stent to the wall of the LVOT [4].

The prosthesis leaflets of the newly implanted aortic valve are visible on CT as fine, symmetrical, hypodense, arched structures within the lumen (► **Fig. 1a, b**). Thickening of one or more leaflets is to be categorized as pathological.

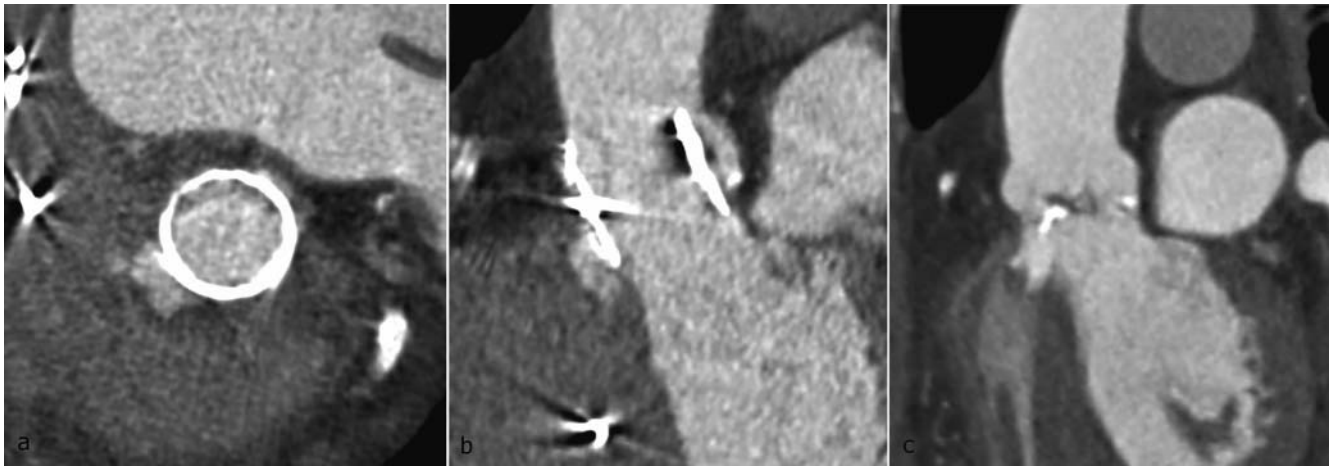
► **Fig. 11** This figure does not show post-interventional annulus rupture. The eccentric pseudoaneurysm shown in **a**, **b** cannot be differentiated from a contained annulus rupture on the basis of the imaging alone. It existed before the intervention (already apparent on the pre-TAVI CT **c**). It corresponds to an old paravalvular abscess after endocarditis which is now perfused as a pseudoaneurysm. In spite of the pseudoaneurysm, TAVI could be performed without any complications. The patient was free of symptoms at the time of post-TAVI CT.

Both the valve prosthesis and the integrity of the aortic root must be assessed. The shape of the aortic root can change post-interventionally from elliptical to round. However, an eccentric aneurysm (pseudoaneurysm, refer to Chapter V, section 6 „Annulus rupture“ with figures) or fluid around the aortic root must not be present [11].
