# Hepatic Perforation: A Complication of Proximal Biliary Stent Migration

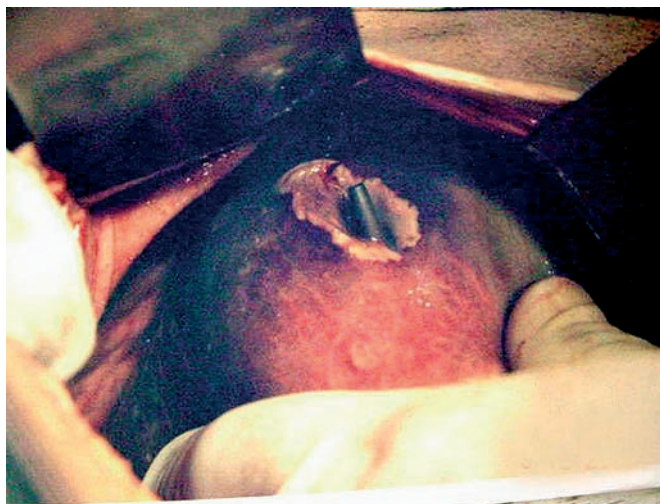
Figure 2 Peroperative photograph showing the hepatic perforation in the anterosuperior part of the right lobe of the liver caused by the migrated stent.
