Multiple breakage of a covered esophageal stent

DOI 10.1055/s-2008-1077406
Endoscopy 2009; 41: E34–E34
© Georg Thieme Verlag KG Stuttgart · New York ·
ISSN 0013-726X

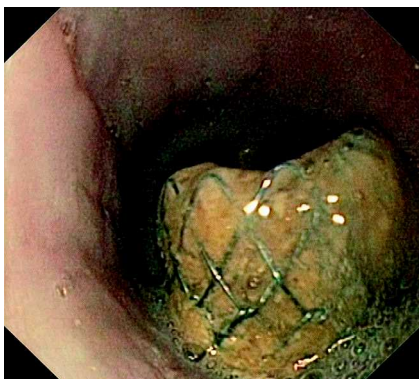
Fig. 1 Endoscopy showing an unusual oblique position of the proximal stent end.

Endoscopy now showed that the esophageal stent was in a horizontal position and occluded with food particles (▶ **Fig. 1** and **2**). When the proximal end of the stent was grasped, it proved, surprisingly, to have broken into five fragments, which were removed without problems (▶ **Fig. 3**). Once the fragments were removed, the esophageal passage was free. No further intervention was necessary, and to date the patient has not complained again of recurrent dysphagia. Repeat endoscopy 2 months later showed complete tumor remission.

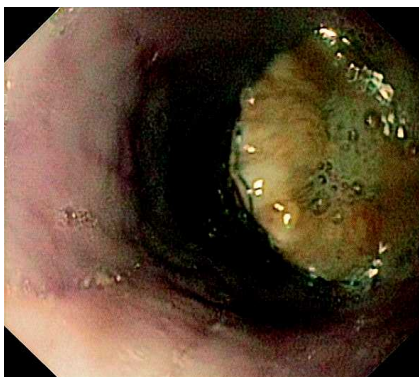
Fig. 2 Another view of the proximal end of the fully occluded stent.

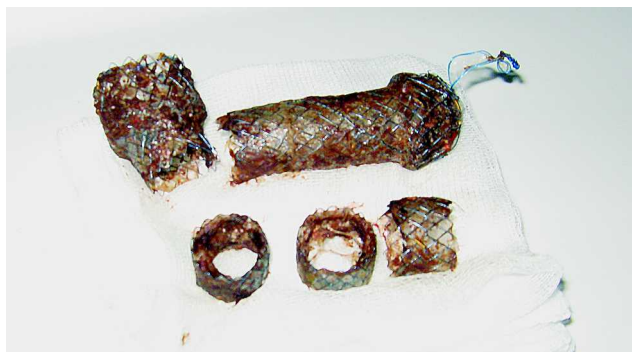
Fig. 3 Extracted stent fragments.
