Imaging of common breast implants and implant-related complications: A pictorial essay

Amisha T Shah, Bijal B Jankharia

Department of Breast Imaging, Dr. Jankharia's Imaging Centre, Mumbai, Maharashtra, India

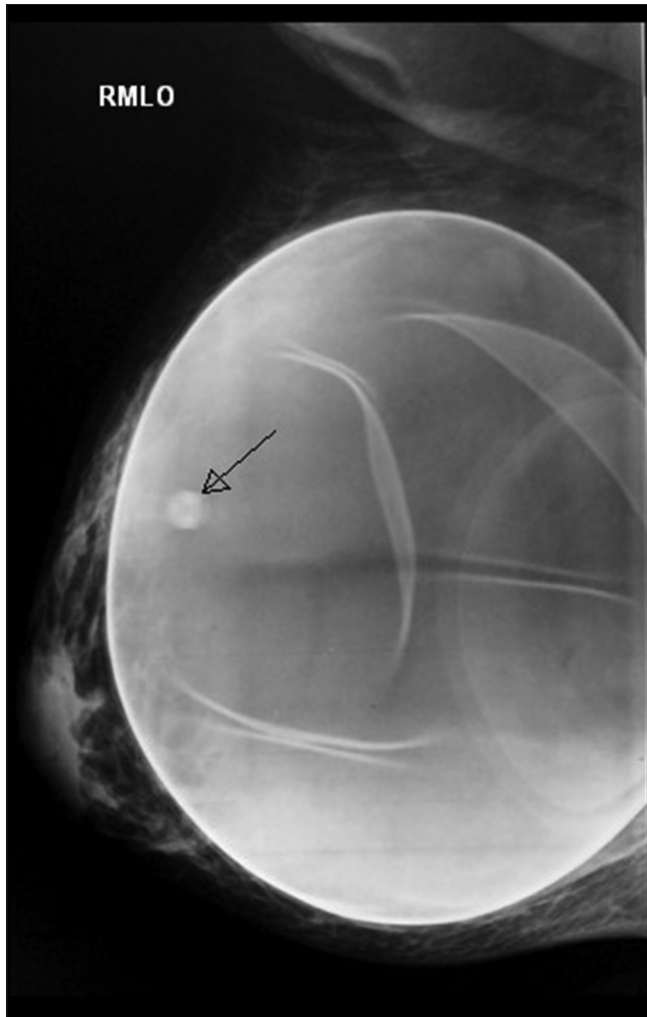
Figure 1: Mammogram showing single lumen saline breast implant. Right mediolateral oblique (MLO) view showing less radiodense saline implant. A valve is seen as a round density with a slightly lucent center superimposed on the implant (arrow)

Breast implants may have a single lumen or double lumen. Most commonly encountered are single lumen implants which contain either silicone or saline as the filling [Figures 1 and 2]. Other variations such as double lumen (silicone on the inside with an outer saline component) [Figure 3], reverse double lumen (saline on

On mammography, saline implants appear as oval masses with a dense outer silicone envelope and a less radio-opaque center. Often a valve is visible, which is used to fill the saline implant [Figure 1]. Normal membrane foldings may be seen, as also partially the glandular tissue may be seen through the implant depending on the penetration used.

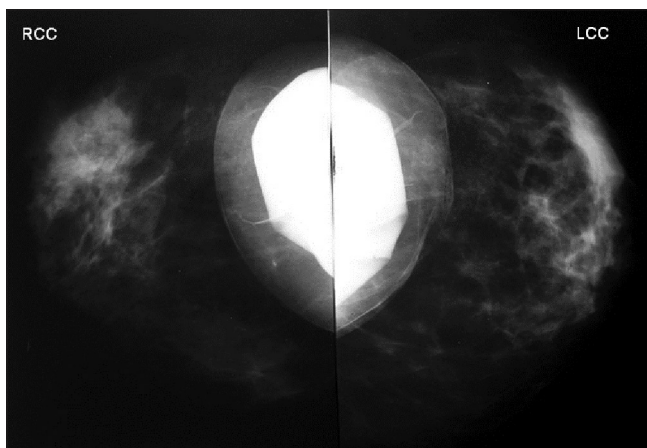
Figure 3: Mammogram showing double lumen breast implants. Bilateral craniocaudal (CC) views showing double lumen breast implants with an inner silicone lumen and saline on the outside

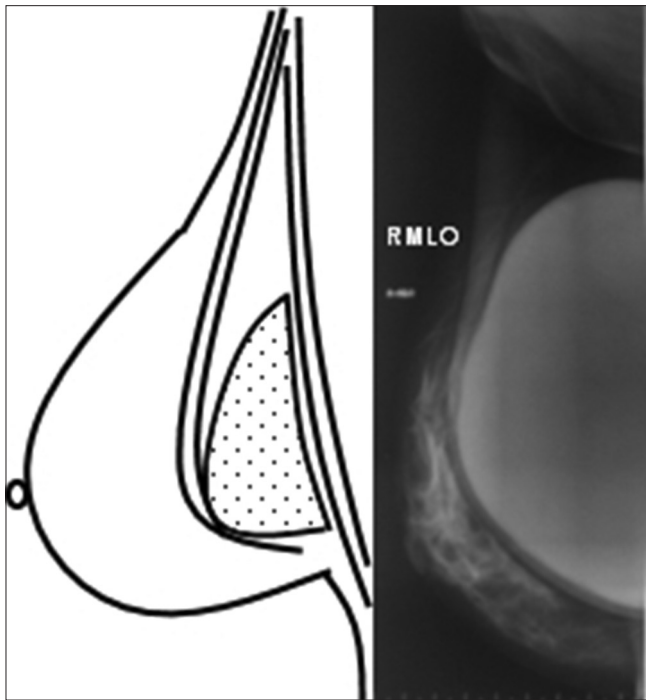
Figure 5: Schematic representation and mammogram showing a retropectoral silicone breast implant. The pectoralis major muscle overlies the implant in the diagram. In the right mediolateral oblique (MLO) view, the pectoralis major muscle is seen anterior to the implant

may also be encountered. All implants have an outer silicone membrane or shell. After placement, a thin fibrous capsule normally forms around the prosthesis as a physiological response to foreign body (encapsulation). The main surgical planes for implant placement are subglandular (in front of pectoralis major muscle) or retropectoral (behind the pectoralis major muscle) planes [Figures 4 and 5].

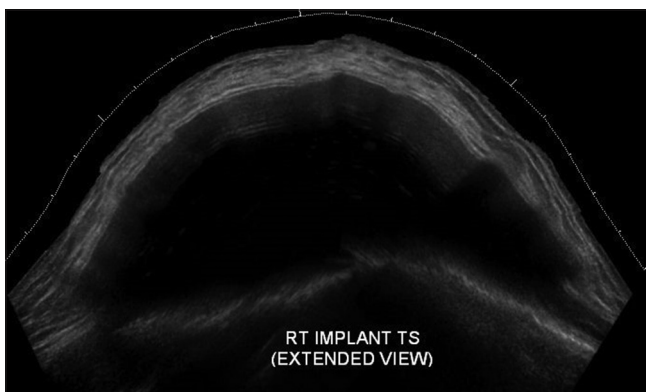
Figure 7: Ultrasound image (extended field of view) of a woman with intact implant depicting an ellipsoid shape of the implant with an anterior convex shape of the anterior and posterior margins of the implant

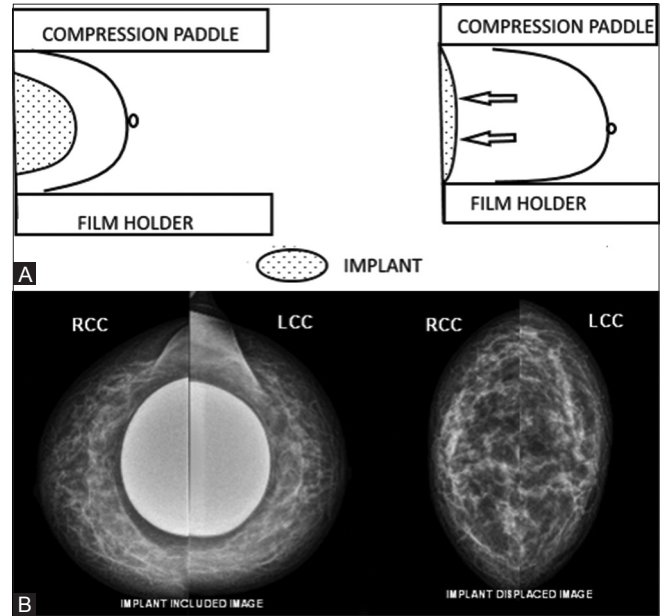
Figure 6 (A and B): Schematic diagram showing Eklund technique (A). The displacement technique introduced by Eklund to facilitate mammography in women with implants allows slightly more tissue to be visualized with displacement (arrows) (on the left) than with standard compression mammography (on the right). Bilateral craniocaudal (CC) views showing implant included and implant displaced images (B)

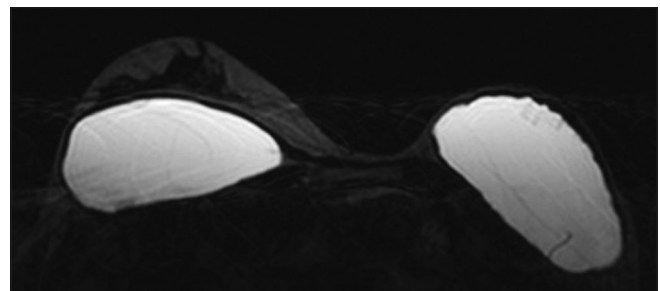
Figure 11: Bilateral breast MRI of a woman with Poland syndrome. Right sided retropectoral and left sided subglandular silicone gel implants placed for cosmesis in the patient with Poland syndrome. Note the absence of left breast tissue and chest wall muscle

Implants placed for congenital abnormalities such as Poland syndrome may have an asymmetric appearance and should not be confused with malpositioning [Figure 11].

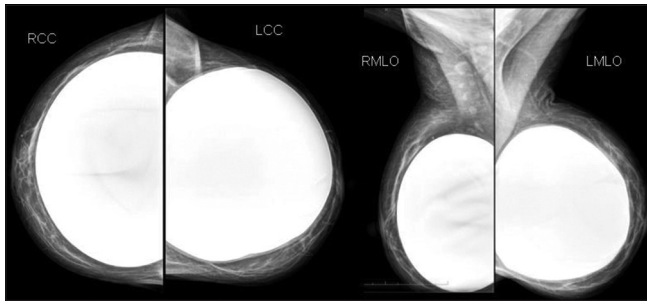
Figure 12: Bilateral mammography of a woman with left implant showing capsular contracture craniocaudal (CC) and mediolateral oblique (MLO) views. Bilateral craniocaudal (CC) and mediolateral oblique (MLO) views showing subglandular silicone gel implants. The left implant is spherical in shape as compared to the right implant

Capsular contracture is the most common delayed complication noted in patients with smooth-walled silicone prosthesis. It is the abnormal constriction of the fibrous capsule that surrounds the breast implant resulting in hardening and deformity of the implant. Predominantly a clinical diagnosis, it presents with a distorted, tough and sometimes painful breast. On mammography, the implant may appear spherical rather than oval in shape with transverse diameter measuring less than two times the anteroposterior diameter of the implant^[8] [Figure 12].

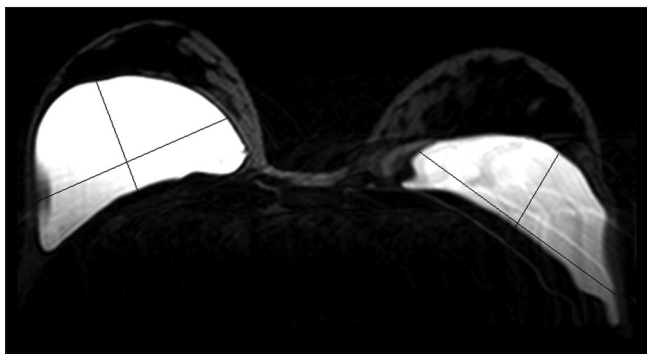
Figure 14: Bilateral breast MRI of a woman with capsular contracture of right implant. Axial STIR image demonstrates subglandular silicone gel implants. The left implant is oval in shape with transverse diameter more than anteroposterior diameter. Note the spherical shaped right implant with an increased anteroposterior diameter compared to its transverse diameter suggestive of capsular contracture

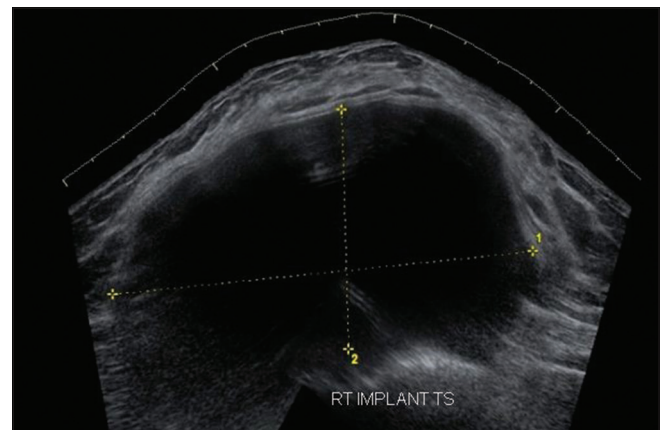
Figure 13: Transverse ultrasound image of a woman with capsular contracture of right implant. The implant appears spherical in shape with an increased anteroposterior diameter

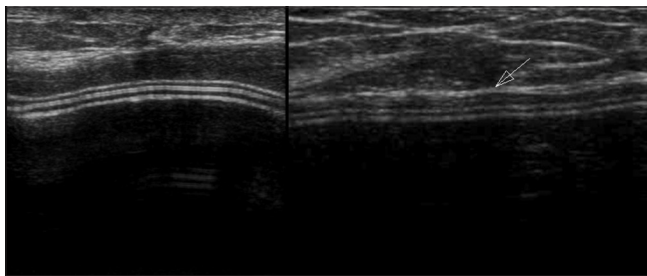
Figure 16: Transverse ultrasound image of a woman with capsular contracture. The image on the left shows normal thickness of the fibrous capsule. The image on the right shows increased thickness of the fibrous capsule (arrow) suggestive of capsular thickening in a patient with capsular contracture

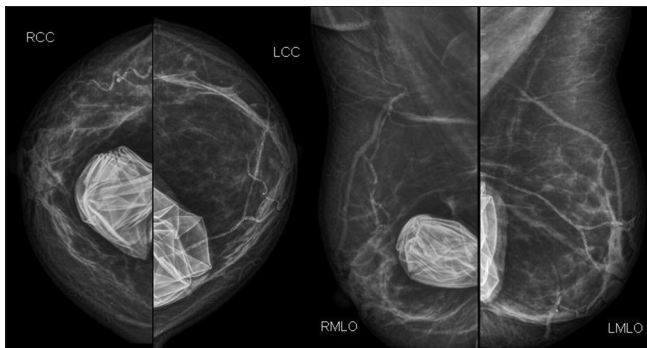
Figure 18: Bilateral craniocaudal (CC) and mediolateral oblique (MLO) views showing bilateral subglandular saline implants with collapsed and folded implant envelope

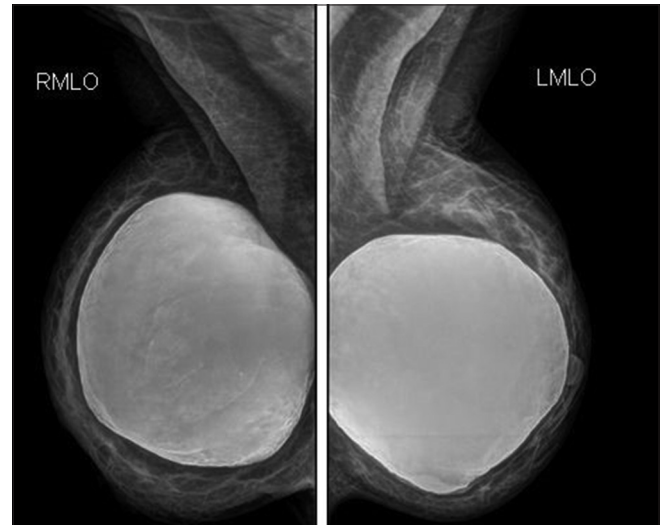
Figure 17: Bilateral mediolateral oblique views. Bilateral subglandular silicone gel implants are visualized with calcifications adherent to the fibrous capsule. The left breast implant shows a bulge inferiorly

It may develop unusual areas of bulging, irregularity, or tenting. On USG and MRI, loss of the normal triangular configuration of the implants may be seen with an increased anteroposterior diameter of the implant [Figures 13 and 14]. Thickening of the echogenic fibrous capsule and increase in the number of radial folds [Figures 15 and 16] may be noted. Peri-implant calcifications may be seen [Figure 17].

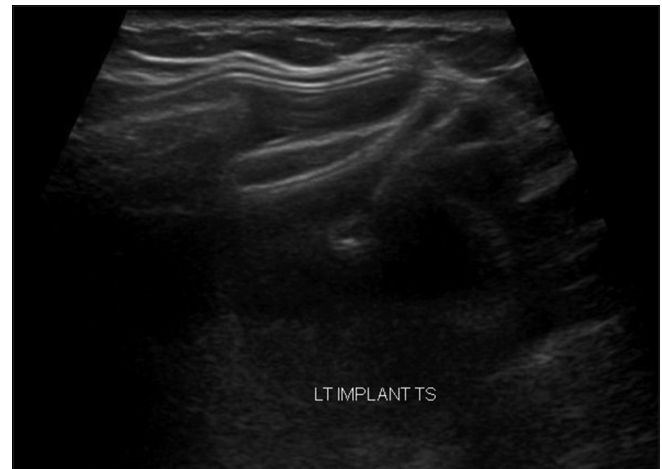
Figure 19: Transverse ultrasound image of a woman with intracapsular rupture. The ultrasound image shows stacked echogenic lines corresponding to collapsed envelope of silicone implant termed the “step ladder” sign. This imaging finding is most reliable for intracapsular rupture

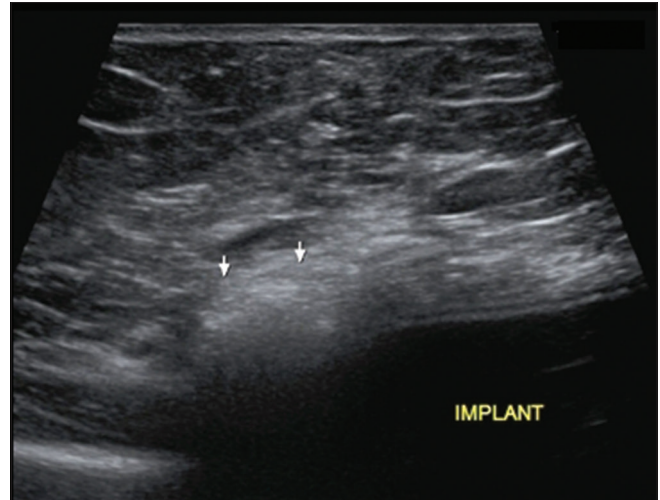
Figure 25: Transverse ultrasound image shows the classic “snowstorm sign” of extracapsular rupture. An echogenic mass (arrows) with dirty posterior shadowing is seen
