Effect of incorporation of silane in the bonding agent on the repair potential of machinable esthetic blocks

Hanaa Zaghloul¹, Dina Wafik Elkassas², Mohamed Fouad Haridy³

Objective: To investigate the repair potential of CAD/CAM (computer-aided design/computer-aided manufacturing) ceramic and composite blocks using a silane-containing bonding agent with different repair protocols. **Materials and Methods:** Twenty-four discs were constructed from CAD/CAM ceramic and composite blocks. The discs were divided into six groups according to surface pre-treatment employed; GI: Diamond stone roughening (SR), GII: SR+ silanization (SR+S), GIII: Hydrofluoric acid etching (HF), GIV: HF+ silanization (HF+S), GV: Silica coating (SC), GVI: SC+ silanization (SC+S). Silane-containing bonding agent (Single Bond Universal adhesive, 3M ESPE) was applied to the pre-treated discs. Prior to light curing, irises were cut from tygon tubes (internal diameter = 0.8 mm and height = 0.5 mm) and mounted on each treated surface. Nanofilled resin composite (Filtek Z350^{XT}, 3M ESPE) was packed into the cylinder lumen and light-cured ($n = 10$). The specimens were subjected to microshear bond strength testing (

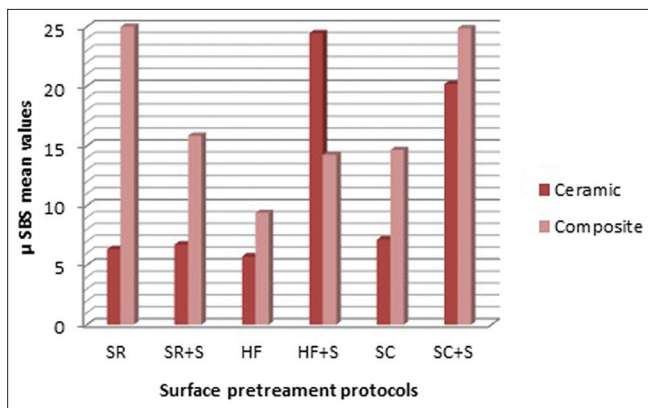
Figure 1: Bar chart representing the μ -SBS mean values of all tested groups

Means and standard deviations (SD) of μ -SBS values in MPa of all tested groups are displayed in Table 3. A bar chart representing the μ -SBS mean values of all tested groups is presented in Figure 1. For ceramic discs, additional silanization step resulted in significant increase in the μ -SBS mean values in HF and SC-treated groups, while insignificant increase was found for SR group. For composite discs, additional silanization step significantly increased the μ -SBS of SC-treated group and significantly decreased μ -SBS for SR group. Meanwhile, it did not affect HF group.

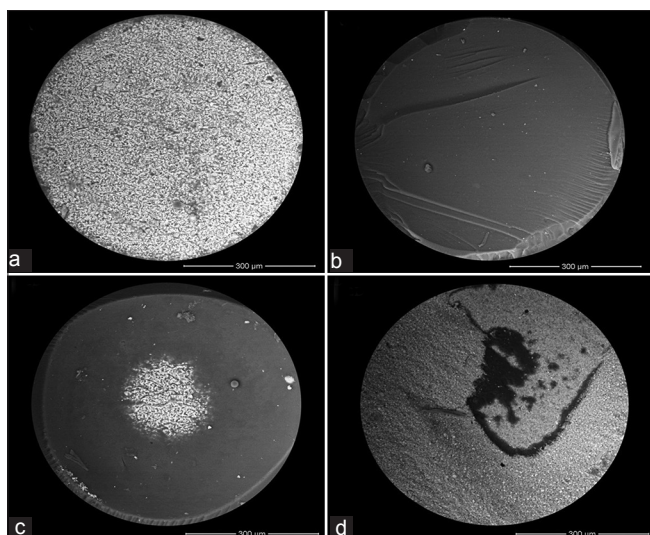
Figure 2: SEM photos of representative specimens from ceramic. (a) adhesive failure in HF group, (b) cohesive failure in HF+S group, (c) mixed failure in HF+S group, (d) mixed failure in SC+S group

Percentage of failure modes for all tested groups is presented in Table 4. For the ceramic discs, the predominant mode of failure for the discs pre-treated with SR, SR+S, and HF [Figure 2a] was adhesive failure at the interface. The highest percent of cohesive failure (50%) was evident in HF+S-treated group [Figure 2b]. In the same group, 40% of the specimens showed mixed mode of failure [Figure 2c]. In the SC+S groups, 50% of specimens showed mixed modes of failures [Figure 2d].

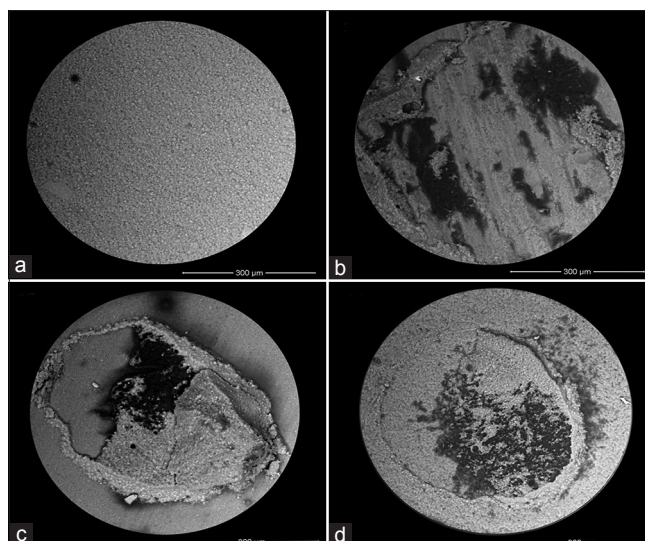
Figure 3: SEM photos of representative specimens from indirect resin composite. (a) adhesive failure in HF group, (b) mixed failure in SR group, (c and d) mixed failure in SC+S group

For the composite blocks, higher percentage of mixed modes of failures compared to the ceramic groups is evident. In HF group, 90% of the specimens showed adhesive failure [Figure 3a]. In both SR [Figure 3b] and SC+S groups [Figure 3c and 3d], 70% of the specimens showed mixed mode of failures. Figure 3b shows pieces of the new composite were found inside the grooves made by the diamond stone.

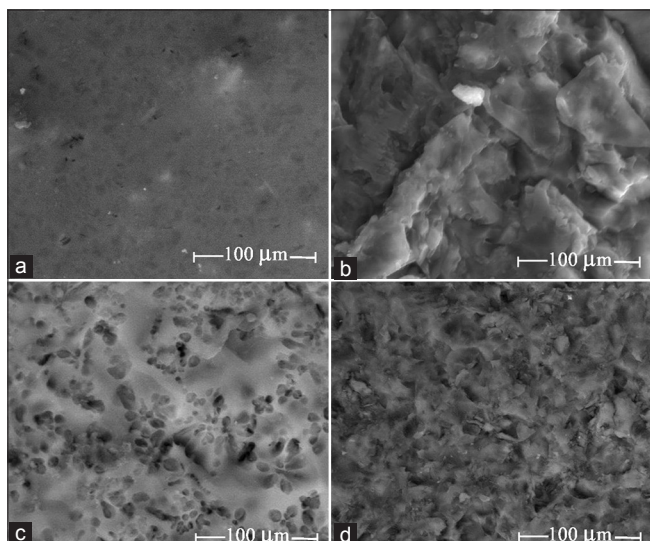
Figure 4: SEM photos representing the surface topography of ceramic blocks (a) Control, (b) Diamond stone roughening, (c) Hydrofluoric acid etching, (d) Silica Coating. SR revealed uneven surfaces with pits and porosities [Figure 4b]. HF etching revealed micro-involutions and recess areas created by etching the glass ceramic [Figure 4c]. In SC group, micromechanical retentive features were evident (4D) with the presence of attached silica/alumina particles

SEM analysis showed different surfaces topographies on both ceramic [Figure 4] and composite [Figure 5] surfaces; A: Control and following different

pre-treatment protocols, B: SR, C: HF etching, and D: SC. SR revealed uneven surfaces with pits and porosities on both ceramic [Figure 4b] and indirect resin composite [Figure 5b] surfaces. However, the existence of the grinding marks was more evident on the composite surfaces compared to the ceramic alternative. HF etching of the ceramic surface revealed micro-involutions and recess areas created by etching the glass ceramic [Figure 4c]. On contrary, HF treatment of the indirect resin composite surfaces [Figure 5c] was associated with partial degradation of the resin matrix and little evidence of microprositities and undercuts. In SC group, micromechanical retentive features were evident on both the ceramic (4D) and indirect resin composite (5D) surfaces. The presence of attached silica/alumina particles was also noted.

SiO₂ layer penetrates and was embedded onto the substrate surface.^[17] Thus, creating retentive surface textures along with an increase in the percentage Si exposed at the surface as depicted in Figures 4d and 5d. This made the additional silanization step typically required. An intermediate silane application forms covalent bonding between the silica-coated layer and repaired resin composite.^[17,26]

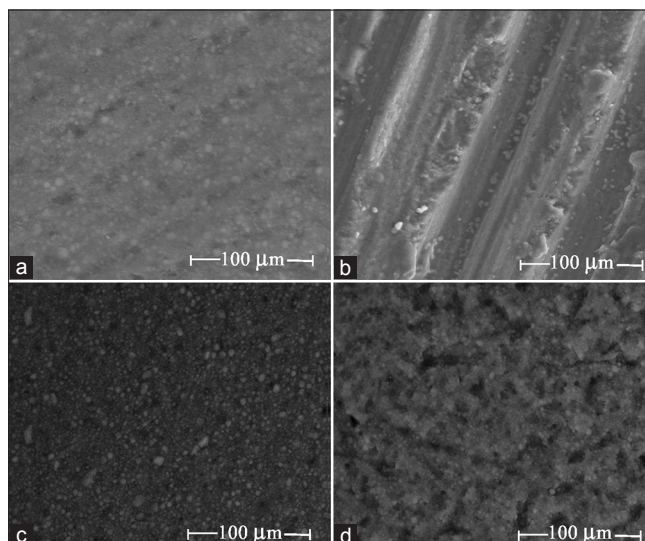
Figure 5: SEM photos representing the surface topography of composite blocks. (a) Control, (b) Diamond stone roughening, (c) Hydrofluoric acid etching, (d) Silica Coating. SR revealed uneven surfaces with pits and porosities with the existence of the grinding marks from diamond stone [Figure 5b]. HF etching was associated with partial degradation of the resin matrix and little evidence of microprossities and undercuts [Figure 5c]. In SC group, micromechanical retentive features were evident with the presence of attached silica/alumina particles [Figure 5d]
