# Kirschner Wire Migration after the Treatment of Acromioclavicular Luxation for the Contralateral Shoulder – Case Report\*

Rev Bras Ortop 2019;54:202–205.

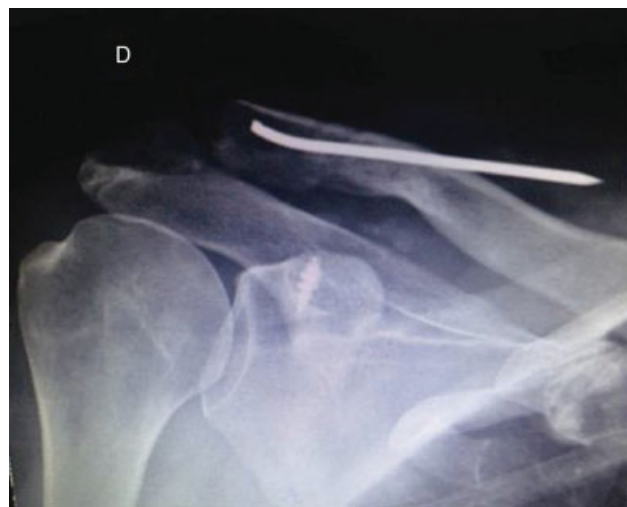
**Fig. 1** Fifteen days postsurgery, right shoulder.

Four days after the trauma (►Fig. 1), the acromioclavicular dislocation was surgically treated using ligatures with anchor wires, coracoacromial ligament transfer, and fixation with Kirshner wires from the acromion to the clavicle.

At the 12-day follow-up visit, the migration of the Kirschner wire to the acromion was identified. The patient was informed of the need for a more frequent follow-up and that the wire would be removed 45 days after the surgery. At the 20- and 30-day follow-up visits, radiological findings remained similar to the ones observed at the 12-day visit, with no migration progress.

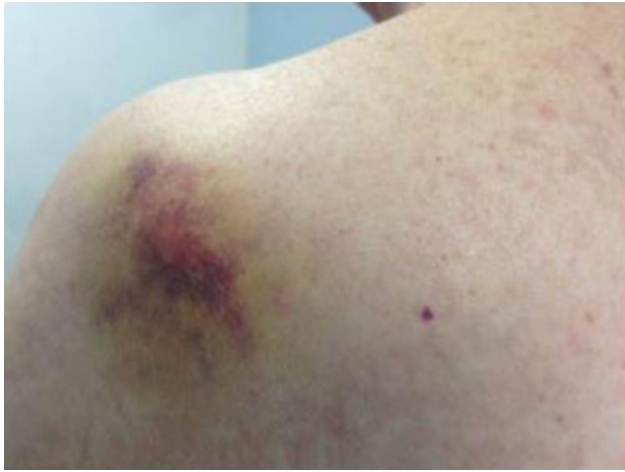
**Fig. 2** Hematoma and a small skin protuberance, left shoulder, 9 months after the procedure.

The patient did not show up for his 6-month visit. Nine months after the surgical treatment, the patient started to present with pain on the left shoulder (contralateral side), reduced arc of movement, ecchymosis, and a protrusion (►Figs. 2 and 3). Bilateral radiographs showed that the Kirschner wire originally from the right shoulder was in the left shoulder (►Figs. 4 and 5).

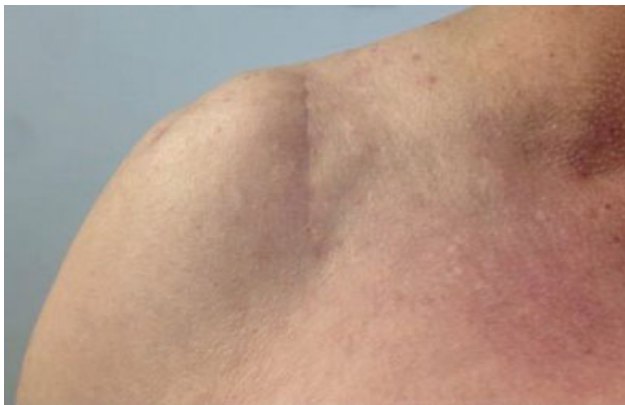
**Fig. 3** Surgical approach, 9 months after the procedure.

Thus, a new surgical procedure was performed to remove the metallic wire from the left shoulder.

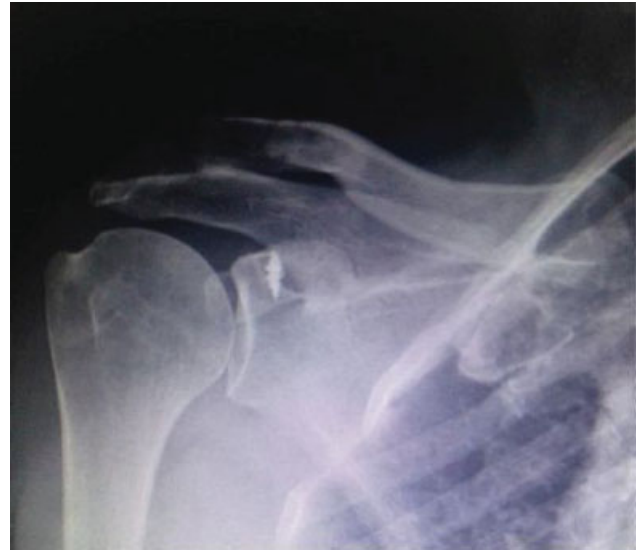
**Fig. 5** Nine months postsurgery, right shoulder.

The present case was followed-up with serial radiographs; moreover, the metal wire was folded to difficult its migration, the patient was properly oriented when the metal wire migration was noticed and at the end of the treatment period. However, the fold at the distal end of the wire did not reach the necessary angulation to prevent migration, allowing this complication to occur.
