Mediastinitis due to perforation by a metal stent after endoscopic ultrasound-guided hepaticogastrostomy: a rare complication

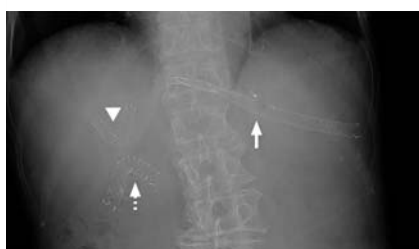
► **Fig. 1** Radiographic image following endoscopic ultrasound-guided biliary drainage performed 3 months previously for hilar biliary obstruction due to recurrent pancreatic cancer after pancreaticoduodenectomy. Two metal stents were used in the procedure: one was inserted into the hilar biliary obstruction site to bridge the right and left hepatic ducts (arrowhead); the second was placed from intrahepatic bile duct segment 2 to the stomach (arrow). The length of the intra-gastric portion of the stent was about 7 cm. The dotted arrow shows a metal stent placed for afferent loop syndrome.

A 75-year-old woman presented with intermittent vomiting for 2 days. She had undergone EUS-HGS 3 months previously for obstructive jaundice caused by post-resection recurrence of pancreatic head cancer (► **Fig. 1**). The EUS-HGS had been performed from the stomach to intrahepatic bile duct segment 2 using a covered SEMS that was 8 mm in diameter and 12 cm in length (bare-end, Niti-S biliary S-type; Taewoong Corporation, Seoul, South Korea). A computed tomography (CT) scan demonstrated that the SEMS had perforated the mediastinum beyond the digestive tract wall (► **Fig. 2**).

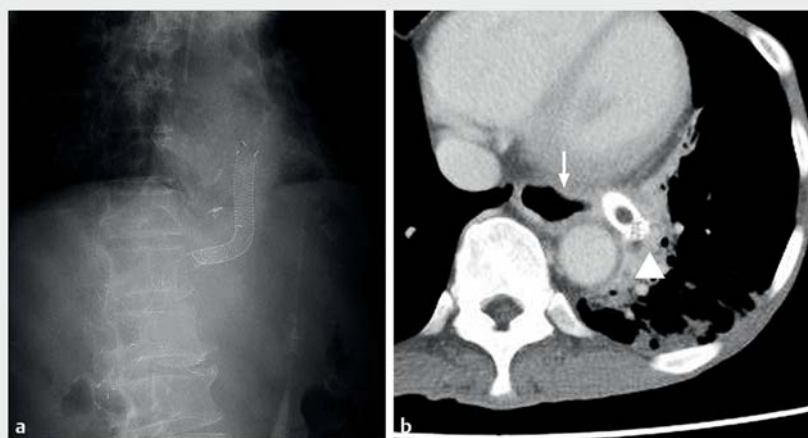
► **Fig. 2** The migrated metal stent is revealed on: **a** a radiographic image showing an intra-gastric portion of the metal stent pointing upward, indicating its migration into the esophagus; **b** a computed tomography image showing a part of the stent penetrating the mediastinum (arrowhead). An arrow indicates the esophagus.

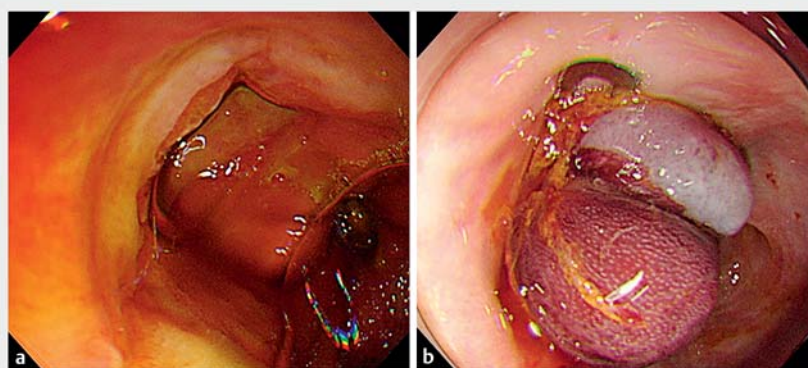
► **Fig. 3** Endoscopic images showing: **a** the perforation site, which could be observed after the stent had been pushed back into the stomach; **b** the perforation site following its successful closure using an over-the-scope clip.

After introducing a gastroscope, we pushed the SEMS back into the stomach using biopsy forceps and identified the site of perforation (► **Fig. 3 a**; ► **Video 1**). We closed the perforation site using an over-the-scope clip (Ovesco Endoscopy GmbH, Tübingen, Germany) with the simple suction method because it was difficult to grasp both edges of the site

using the dedicated forceps (► **Fig. 3 b**). Subsequently, argon plasma coagulation was used to trim an intragastric portion of the SEMS to prevent it penetrating the esophageal wall again. Radiographic imaging showed no extravasation of contrast medium and revealed closure of the perforation site 12 days later. The patient recovered well.

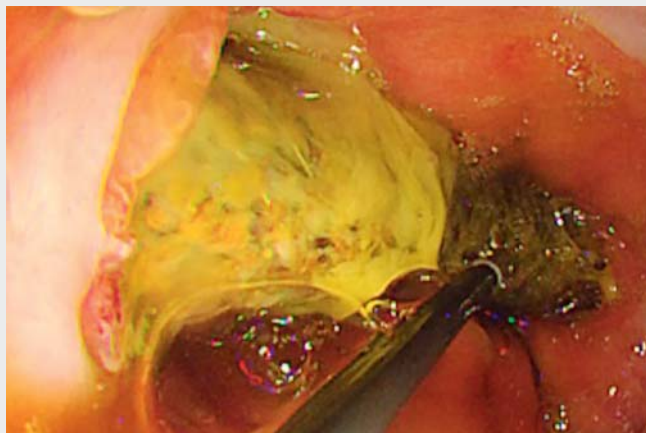
Video 1 We experienced a case of mediastinitis due to perforation by a long metal stent that had been placed during endoscopic ultrasound-guided hepaticogastrostomy 3 months previously and had migrated into the esophagus. This was managed by pushing the stent back into the stomach, clip closure of the perforation, and the subsequent shortening of the stent using argon plasma coagulation.
