Endoscopic choledochenterostomy using a new blunt-ended endoscopic ultrasound-guided access device

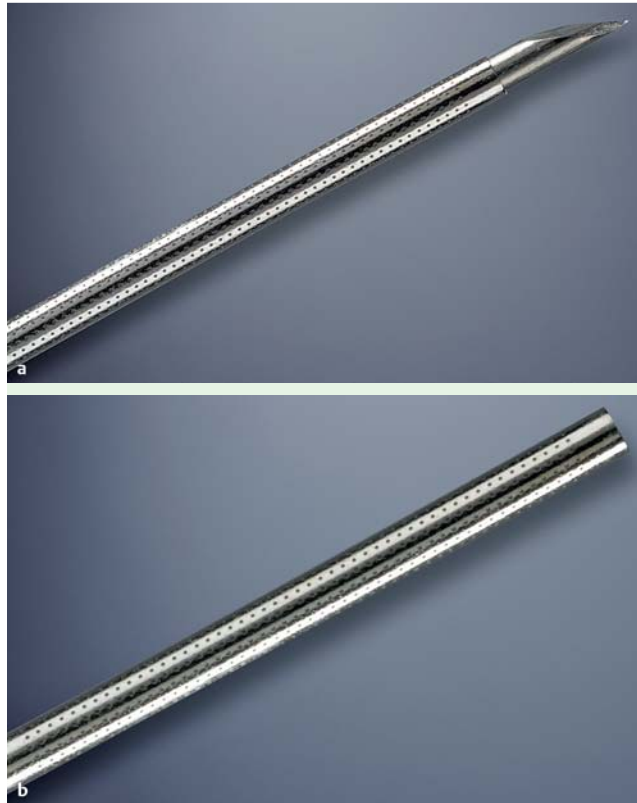
Fig. 2 Dimpled (echogenic) access metal sheath: **a** the needle-tipped sheath; and **b** with the sharp stylet removed (Cook Medical).

The following two brief cases represent early examples of using a novel blunt-ended access device (● **Fig. 2**) that contains a sharp needle-tipped stylet (Cook Medical, Winston Salem, North Carolina, USA) to rescue failed biliary stenting.

The needle stylet is withdrawn after duct access has been obtained, and wire exchange is then done through the blunt-ended metal sheath, which has less potential for damaging the wire coating and the duct wall.

In both cases the wire exchanges were smooth, without trauma or stripping of the wire coating, arguably representing a major improvement over the conventional needles in this regard. The needle puncture did not appear any more difficult than with a traditional 19-G needle; echogenicity of the sheath appeared excellent (● **Video 1**). Care must be taken to ensure the catheter tip, and not just the tip of the
