Pancreatico-gastric anastomotic insufficiency successfully treated with endoscopic vacuum therapy

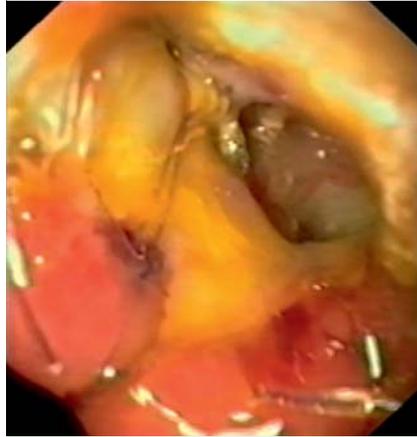
Fig. 1 Anterior aspect of pancreatico-gastric anastomotic leakage in a 65-year-old man with duodenal adenocarcinoma treated with an adapted Kausch–Whipple operation with gastro-pancreatic anastomosis.

We carried out an adapted Kausch–Whipple operation with gastro-pancreatic anastomosis in a 65-year-old male patient with duodenal adenocarcinoma (pT3, pN0, M0, R0). On postoperative day 2 we observed substantial discharge of air and biliary fluid from the perianastomotic drain. Initial endoscopy showed a semi-circular dehiscence of the pancreatico-gastric anastomosis (● Fig. 1). The post-pyloric anastomosis was intact. There was no general abdominal guarding in the spontaneously breathing and hemodynamically stable patient.

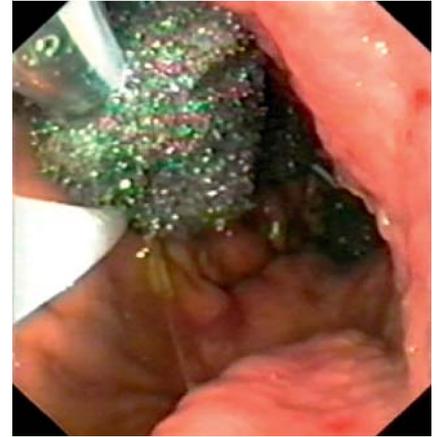
Fig. 2 Placement of vacuum drainage system.

An intraluminal vacuum drainage system (● Fig. 2) constructed from a long open-pore polyurethane foam (length 12 cm and diameter 2 cm) and a gastric tube (B. Braun Endo-SPONGE, Melsungen, Germany; Ventrol, 14Ch × 120 cm, Covidien, Dublin, Ireland) was placed over the anastomosis. We have described the procedure in previous publications [1]. Applying a continuous negative pressure of 125 mmHg (V.A.C. Freedom, Kinetic Concepts, Inc. San Antonio, Texas, USA) resulted in the intended collapse of the stomach around the vacuum drainage system and complete evacuation of all digestive fluids (● Fig. 3).

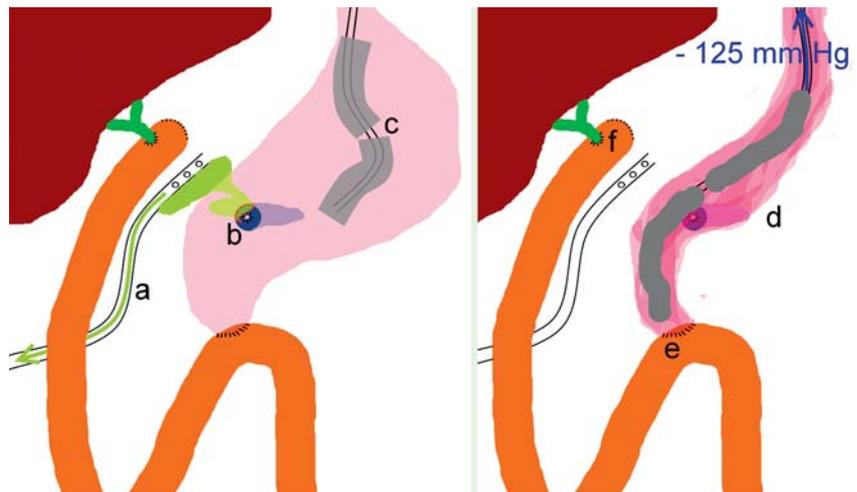
Fig. 3 a Perianastomotic drain with discharge of air and digestive fluids. b Leakage from the pancreatico-gastric anastomosis. c Vacuum drainage system. d Application of negative pressure and collapse of the stomach around the vacuum drainage. e The gastro-jejunoanastomosis. f The biliodigestive anastomosis.

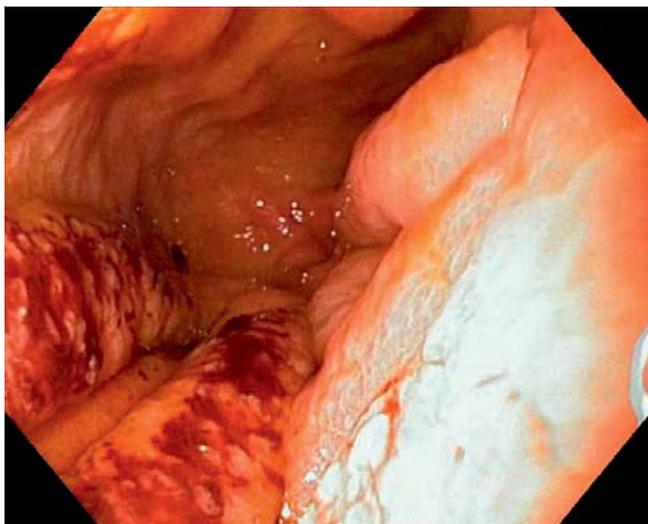
Fig. 4 Mucosal erosion pattern after removal of vacuum drainage system on day 8.

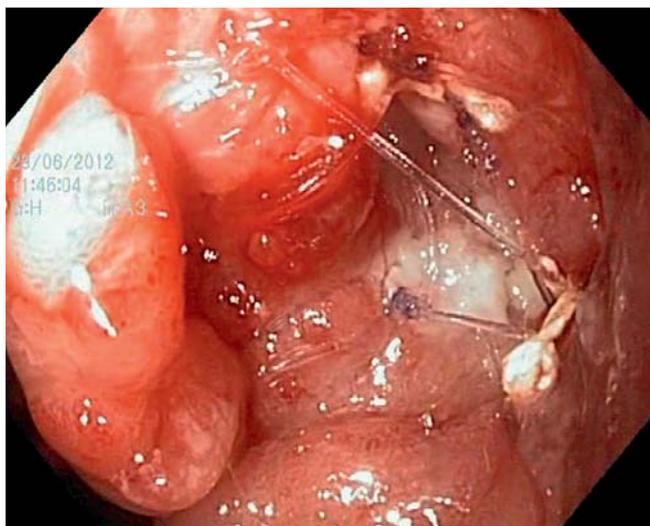
Fig. 5 Pancreatico-gastric anastomosis with no signs of leakage 3 days after vacuum therapy.

leakage and the patient was switched to full liquid oral nutrition. Follow-up endoscopy 3 and 7 days after therapy (● Fig. 5) showed no recurrence of the anastomotic dehiscence. The patient was put on full oral nutrition and the perianastomotic drain was removed. Another follow-up endoscopy of the asymptomatic
