Pancreatic stent migration into the bile duct causing cholangitis

DOI <http://dx.doi.org/10.1055/s-0033-1344773>
Endoscopy 2013; 45: E324–E325
© Georg Thieme Verlag KG
Stuttgart · New York
ISSN 0013-726X

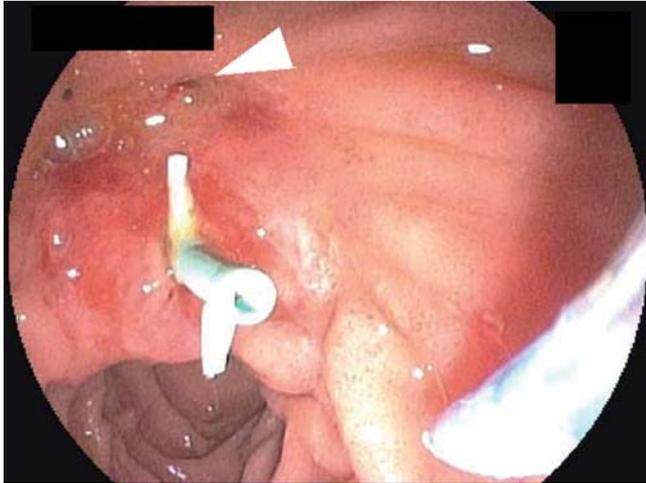
Fig. 1 Endoscopic view of the second portion of the duodenum in a 71-year-old woman with history of surgical sphincteroplasty for a benign ampullary stricture and recurrent episodes of acute pancreatitis. The pancreatic duct stent sits in the pancreatic duct; the arrowhead indicates the location of the biliary opening.

A 71-year-old woman with history of surgical sphincteroplasty for a benign ampullary stricture presented with recurrent episodes of acute pancreatitis. An endoscopic retrograde cholangiopancreatography (ERCP) showed the common bile duct outlet separated from the ampulla, and distal stenosis of the ventral pancreatic duct. A pancreatic sphincterotomy was carried out, followed by the placement of a straight plastic 5-Fr \times 3 cm stent into the pancreatic duct (**Fig. 1**). Post procedure computed tomography, carried out for abdominal pain, showed the pancreatic stent lying within the head of the pancreas (**Fig. 2 a**). An abdominal radiograph obtained 10 days later showed the stent in the area of the hepatic flexure, suggesting spontaneous distal migration (**Fig. 3**). After 2 months, the patient presented with cholangitis. Abdominal CT revealed a bright linear object extending from the common hepatic duct to the right intrahepatic biliary tree (**Fig. 2 b**). An ERCP was done and the 5-Fr \times 3 cm plastic pancreatic duct stent was removed from the right intrahepatic biliary tree using a biliary extraction balloon catheter. Distal spontaneous migration is common among 5-Fr \times 3 cm pancreatic duct stents that do not have a flange on the pancreatic duct side; the migration rate is up to 96.7% by day 3 [1]. Proximal migration occurs in up to 5% of cases [2]. We present an unusual case of pancreatic stent migration where the stent migrated distally into the duodenum and then migrated into and far up the biliary tree, causing cholangitis. Surgical sphincteroplasty probably allowed entry of the straight stent into the biliary tree. We suggest the use of single-pigtail pancreatic duct stents in patients with altered ampullary anatomy to decrease the risk of such occurrences.

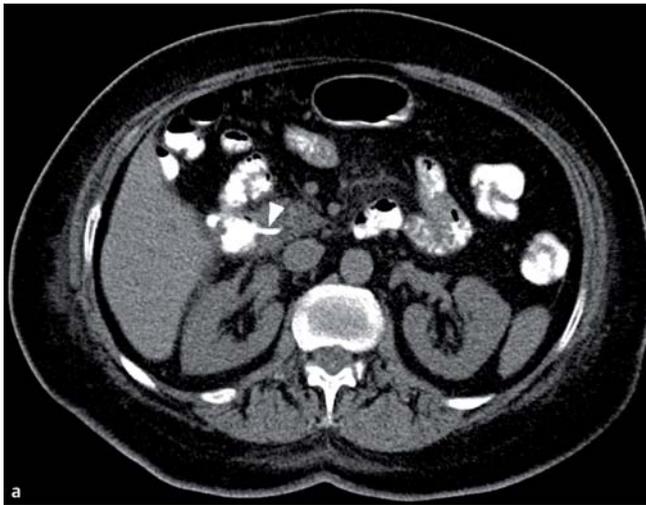
Fig. 2 a Computed tomography (CT) scan of the abdomen on the day of the procedure shows the pancreatic duct stent at the head of the pancreas. **b** After 2 months, the stent was seen within the right intrahepatic duct.

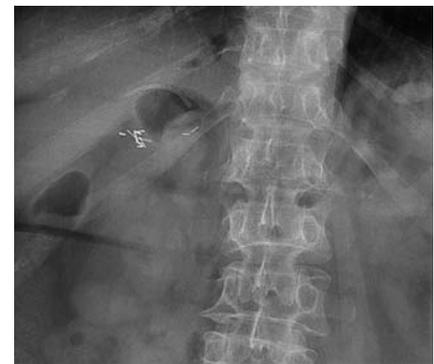
Fig. 3 X-ray of the abdomen 10 days after pancreatic stent placement.
