Fistula Formation 6 Years after Removal of Infected Pacemaker Leads

Thorac Cardiovasc Surg Rep 2015;4:49–51.

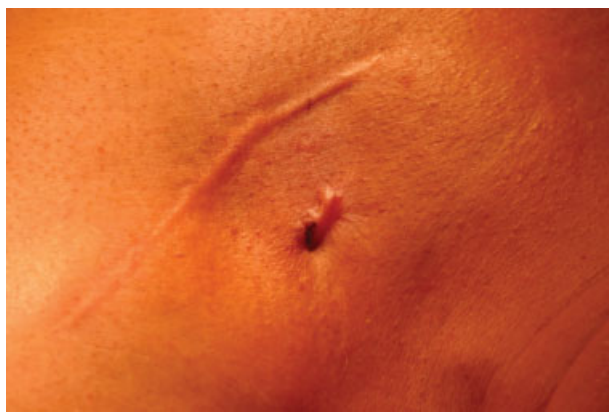
Fig. 1 In addition to the scar of the old permanent pacemaker pocket the ulceration of the fistula is obvious.

In early 2013, the patient was readmitted to the hospital with same complaints. There were local swelling, tenderness, and purulent secretion. Signs of systemic infection could not be detected. We suspected an 8-cm-long fistula between the lead remnant under the left collarbone, seen 6 years ago, and the skin surface (▶ Fig. 1). Based on this assumption, we decided to resect the fistula and remove the fragment.

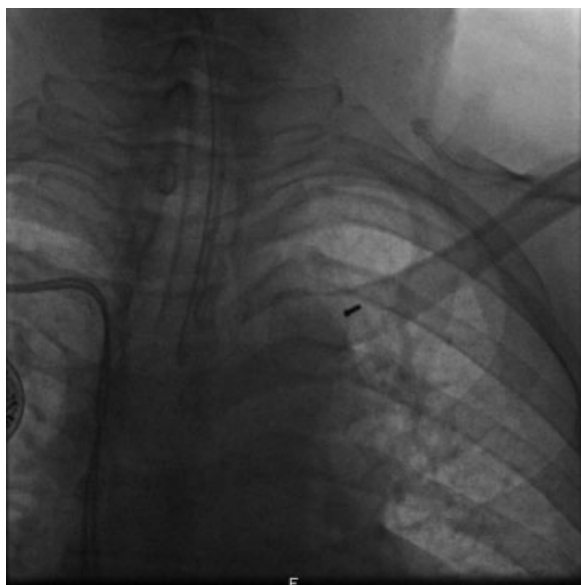
Fig. 2 Chest X-ray: Under the left clavicle, the remaining electrode tip is visible. In addition, the endotracheal tube and the right-side permanent pacemakers are shown.

The procedure was performed under general anesthesia. In the first step, the lead tip was localized by fluoroscopy and the area in which the fragment was projected was marked on the skin surface (▶ Fig. 2). We used Siemens Artis Zeego multiaxis system (Siemens Healthcare, Erlangen, Germany) for screening to permit localization in several angulations. The next step was to explore the fistula by a small probe, followed by spindle-shaped cutting of the same. Because of severe

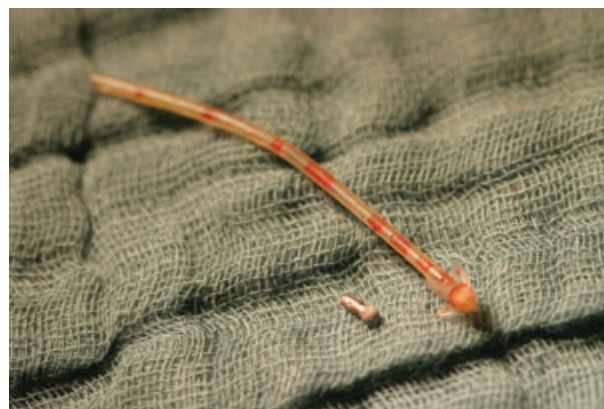
Fig. 4 The removed lead remnant and electrode tip.
