# Bone cement for ossicular rebridging after otic capsule sparing fracture

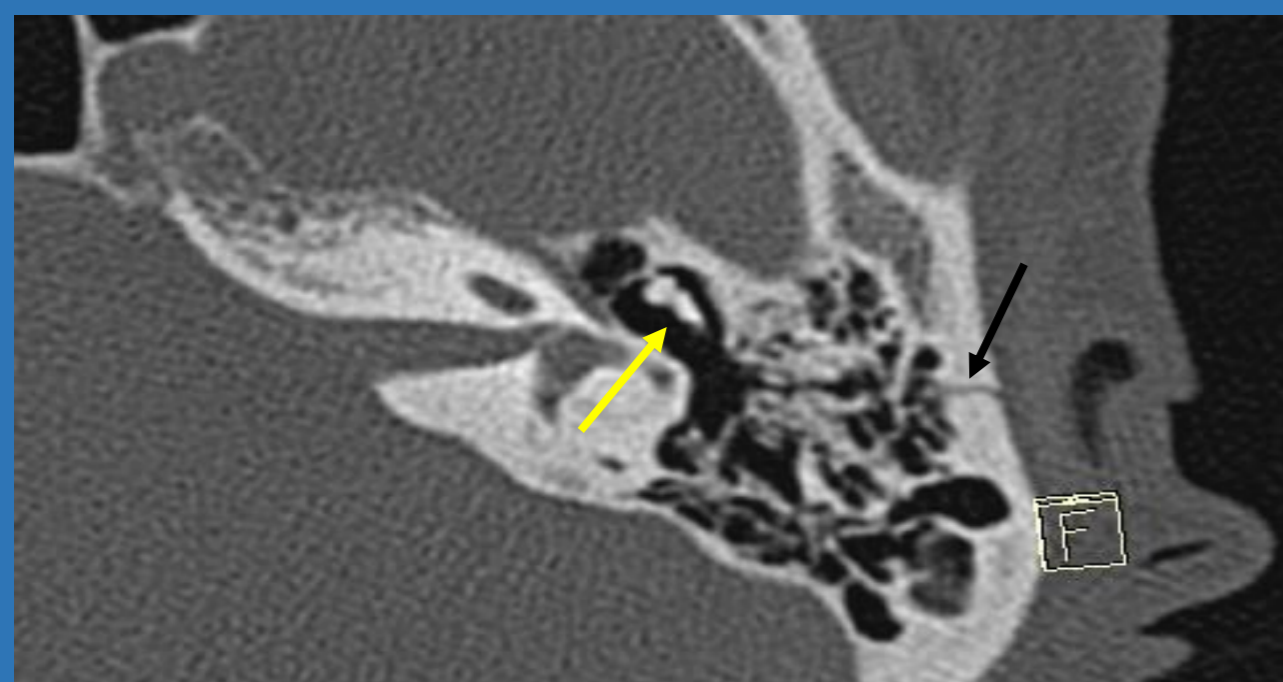
Fig.1. Cone beam computed tomography showing the fracture line of the left temporal bone (black arrow). The yellow arrow displays the incus and malleus, which normally resemble a scoop of ice cream in a cone.

A 42-year-old male presented with long standing conductive hearing loss some 3 months after a head injury. The audiogram revealed an air-bone gap of 46 dB on the diseased side. Pure-tone air and bone conduction thresholds were 76 dB and 30 dB, respectively. Cone beam computed tomography (CT) detected an atypical fracture of the left temporal bone, communicating with the left external ear canal. (Fig.1) The 3D visualization with CT virtual endoscopy suggested injury in the area of the stapes.

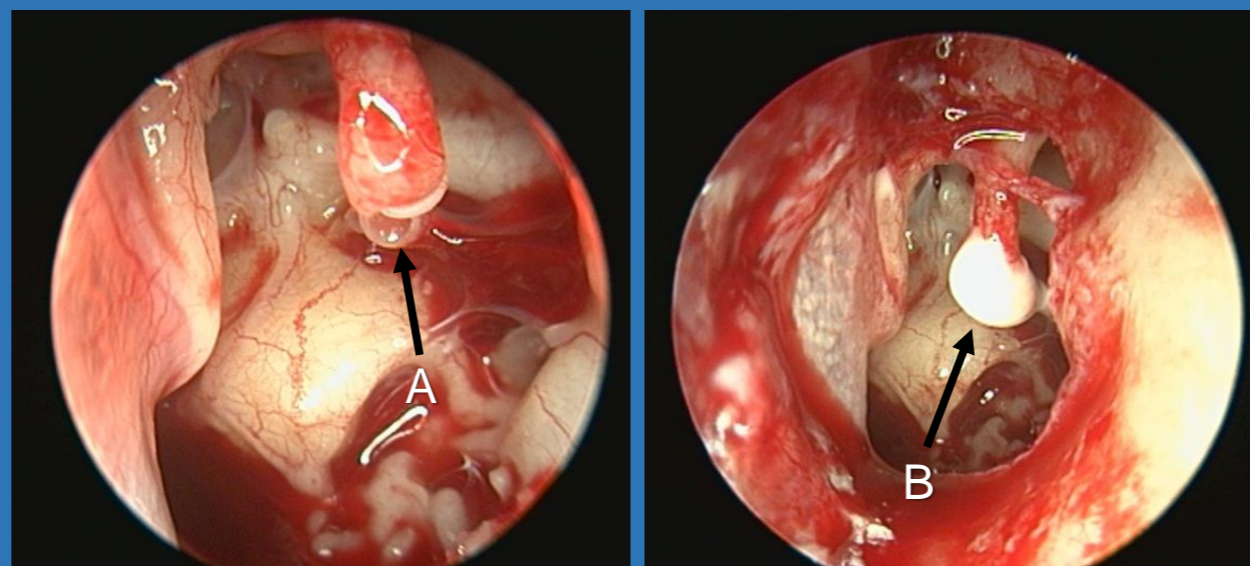
Fig. 2. Intraoperative images after elevation of tympanomeatal flap. A - disruption of the incudostapedial joint, B - bridging of the gap with hydroxyapatite bone cement.

Intraoperatively, disruption of the incudostapedial joint was discovered without signs of any other trauma to the ossicles. Under general anesthesia, rebridging with hydroxyapatite bone cement was undertaken. (Fig.2) Mobility of the ossicular chain was established.

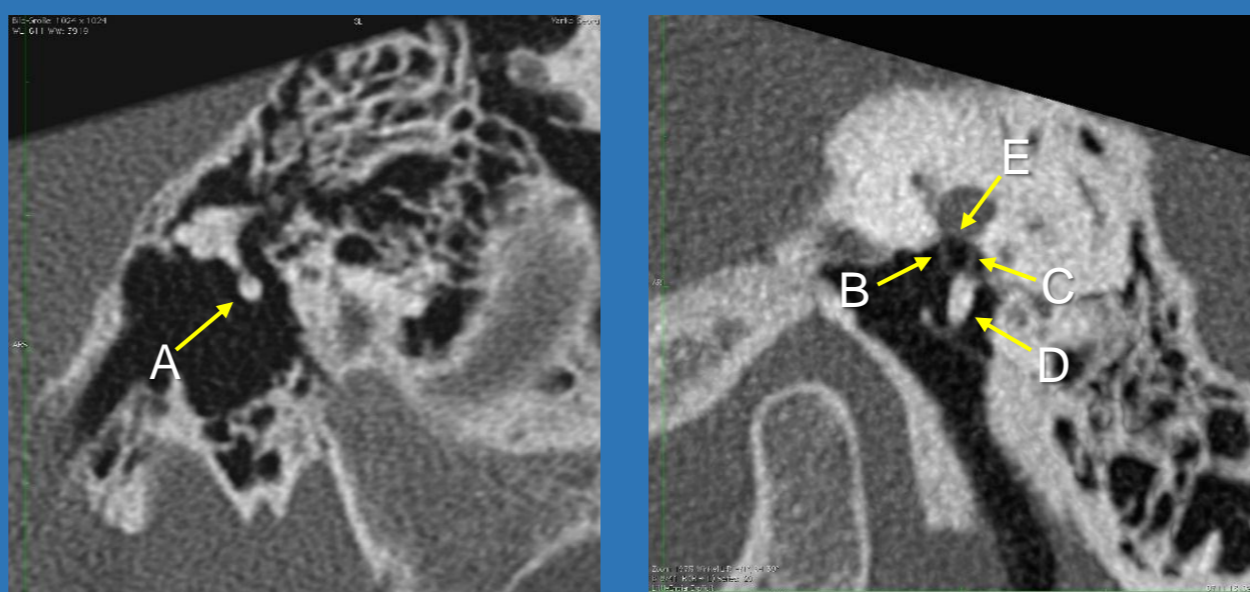
Fig. 3. Follow-up CT scan 2 months after the surgery. A - *articulatio incudostapedialis*, B - *crus anterior stapedis*, C - *crus posterior stapedis*, D - hydroxyapatite bone cement, E - *foramen ovale*.

No intra-, early or late postoperative complications or side effects were observed. The patient's hearing improved immediately upon removal of the intracanal packing on day 7 after the surgery. One month postoperatively, the air-bone gap decreased to 19 dB. Over 27 dB of hearing were regained. Follow-up CT examination revealed the incudostapedial joint without any signs of dislocation. (Fig.3)
