Effect of SiO₂ Nanoparticles Addition on the Flexural Strength of Repaired Acrylic Denture Base

Eur J Dent 2020;14:19–23

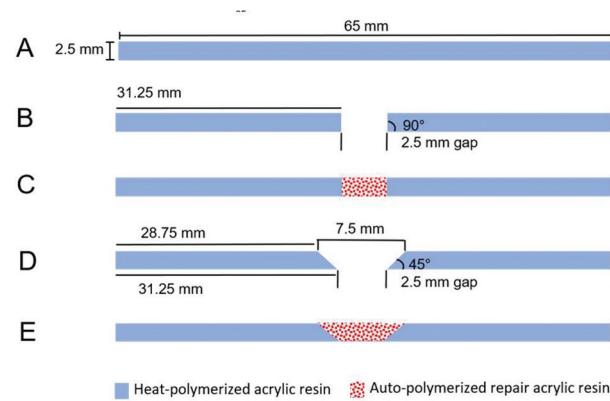
Fig. 1 Illustrated diagram for acrylic resin specimen dimensions, preparation, and repair. (A) Intact specimen; (B) butt joint preparation; (C) repaired butt joint specimen; (D) bevel joint preparation; and (E) repaired bevel joint specimen.

specimens were fabricated according to the methodology described in previous studies.^{3,12} Once polymerized, finished, and polished, they were stored in distilled water at 37°C for 1 week. Following that, specimens were prepared and standardized for repair as stated by Gad et al³ and illustrated in ►Fig. 1, where specimens were sectioned and prepared with two surface designs; butt (90 degrees) and bevel (45 degrees) repair surfaces with 2.5 mm repair-gap measured at the intaglio side. Specimens per surface design were randomly categorized into four groups according to nano-SiO₂ concentration in the repair resin (►Table 1).

assembled in the mold insuring a repair gap of 2.5 mm at the intaglio side. Prepared repair resin with the different nano-SiO₂ concentrations was mixed independently according to manufacturer instructions and packed into the repair gap. The polymerization was done in a pressure vessel for 15 minutes at two bars and 55°C. After polymerization, the specimens were retrieved and tungsten carbide bur (HM 79GX-040 HP; Meisinger, Centennial, CO, United States) was used to remove excess resins, followed by polishing using progressively finer grits of silicon carbide papers (320, 400, and 600). Pumice (Steribim Super; Bego, Wilhelm-Herbst-Strabe, Germany) was mixed with water and used for final polish with soft bristle brush. A digital caliper was utilized to evaluate repaired specimens' dimensions. After that, the specimens were stored in distilled water for 48 hours at 37°C prior to testing.

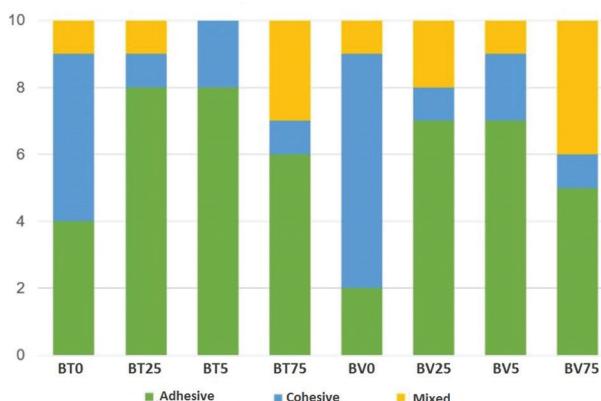
Fig. 2 Nature of failure of fractured specimens.

As shown in ►Fig. 2, for butt joint (BT0) and bevel joint (BV0), cohesive failure was more dominant. While for all modified groups (BT25, BT5, and BT75) and (BV25, BV5, and BV75), adhesive failure was more prevalent.

Other confirming finding of the effect of reinforcement on the repair material is that the unreinforced groups failed mainly with cohesive type of fracture. While for reinforced groups, the most common failure type was adhesive, indicating that the incorporation of nano-SiO₂ into repair resin increased the strength of repair material itself making the denture base/repair resin junction the weakest point, necessitating more focus on the interface. The attention could be directed toward chemical, mechanical, or combination technique of modification with intermediate coupling agents in addition to repair material reinforcement.²³
