# Effect of SiO<sub>2</sub> Nanoparticles Addition on the Flexural Strength of Repaired Acrylic Denture Base

**Objective** The objective of this study was to evaluate the effect of nano-SiO<sub>2</sub> addition on the flexural strength (FS) of repaired acrylic denture base.

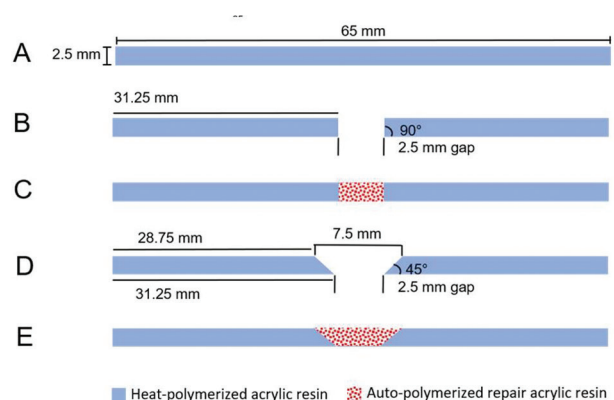
**Fig. 1** Illustrated diagram for acrylic resin specimen dimensions, preparation, and repair. (A) Intact specimen; (B) butt joint preparation; (C) repaired butt joint specimen; (D) bevel joint preparation; and (E) repaired bevel joint specimen.

specimens were fabricated according to the methodology described in previous studies.<sup>3,12</sup> Once polymerized, finished, and polished, they were stored in distilled water at 37°C for 1 week. Following that, specimens were prepared and standardized for repair as stated by Gad et al<sup>3</sup> and illustrated in **Fig. 1**, where specimens were sectioned and prepared with two surface designs; butt (90 degrees) and bevel (45 degrees) repair surfaces with 2.5 mm repair-gap measured at the intaglio side. Specimens per surface design were randomly categorized into four groups according to nano-SiO<sub>2</sub> concentration in the repair resin (**Table 1**).

A metal mold with internal dimensions of 65 × 10 × 2.5 mm was used for repair procedure standardization. To repair the sectioned specimens, repair surfaces were treated with monomer for 120 seconds<sup>22</sup> and then each pair of a specimen was

assembled in the mold insuring a repair gap of 2.5 mm at the intaglio side. Prepared repair resin with the different nano-SiO<sub>2</sub> concentrations was mixed independently according to manufacturer instructions and packed into the repair gap. The polymerization was done in a pressure vessel for 15 minutes at two bars and 55°C. After polymerization, the specimens were retrieved and tungsten carbide bur (HM 79GX-040 HP; Meisinger, Centennial, CO, United States) was used to remove excess resins, followed by polishing using progressively finer grits of silicon carbide papers (320, 400, and 600). Pumice (Steribim Super; Bego, Wilhelm-Herbst-Strabe, Germany) was mixed with water and used for final polish with soft bristle brush. A digital caliper was utilized to evaluate repaired specimens' dimensions. After that, the specimens were stored in distilled water for 48 hours at 37°C prior to testing.

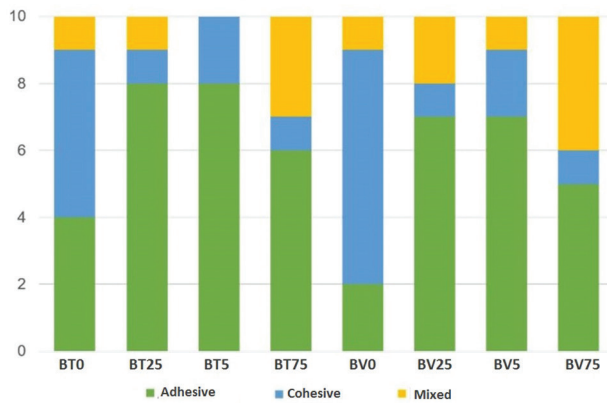
As shown in **Fig. 2**, for butt joint (BT0) and bevel joint (BV0), cohesive failure was more dominant. While for all modified groups (BT25, BT5, and BT75) and (BV25, BV5, and BV75), adhesive failure was more prevalent.

Fig. 2 Nature of failure of fractured specimens.

SEM analysis for the different types of fracture modes revealed that adhesive fracture was present at the edge profile of repaired surface, while cohesive fracture happened within repair material. A mixed type of fracture was clearly present as the fractured surface displayed two types of materials, denture base resin and repair resin with different percentages. SEM examinations for fractured surfaces revealed that the control group specimens exhibited rough surfaces with few lamellae like structures as well as smooth background. According to the topography of fractured-surfaces of nano-SiO<sub>2</sub> containing specimens, more lamellae and deep pits were noticed suggesting ductile mode of fracture. Images also showed homogeneous distribution of nano-SiO<sub>2</sub> within the resin matrix at low concentrations. The amount of particle aggregation increased as the percentage of nano-SiO<sub>2</sub> increased in the polymer matrix with signs of particle agglomeration resulting in cluster formation.

Other confirming finding of the effect of reinforcement on the repair material is that the unreinforced groups failed mainly with cohesive type of fracture. While for reinforced groups, the most common failure type was adhesive, indicating that the incorporation of nano-SiO<sub>2</sub> into repair resin increased the strength of repair material itself making the denture base/repair resin junction the weakest point, necessitating more focus on the interface. The attention could be directed toward chemical, mechanical, or combination technique of modification with intermediate coupling agents in addition to repair material reinforcement.<sup>23</sup>
