Imaging Artifacts on Synthesized Mammogram: What a Radiologist should Know!

Indian J Radiol Imaging 2022;32:555-561.

Synthesized mammogram is a new technique that involves reconstruction of a twodimensional (2D) image from the tomosynthesis images rather than separate acquisition of a standard 2D mammogram. The advent of a synthesized mammogram (s2D) has helped in reducing radiation exposure. The technique of back projection used in reconstruction makes the appearance of these images different from a standard 2D mammogram. Because this is a relatively new technique, it is associated with a learning curve. Hence, it is important for the new radiologists and technicians to be aware of certain common artifacts encountered while using s2D images, which may hinder interpretation. In this pictorial review, we would like to highlight the common artifacts encountered while reading synthesized mammographic images.

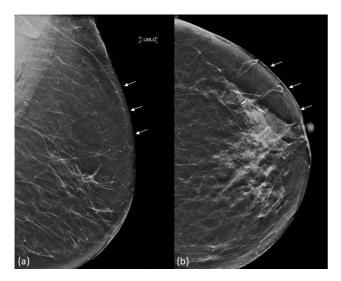
Fig. 2 Burned skin line artifact: (a) s2D image does not show the normal skin line along the upper half of the image (arrows). (b) In a different patient, the normal skin line (arrows) along the breast is well visualized.

This artifact can be occasionally seen at the edge of the breast and appears as areas of irregularity or loss of the skin and superficial tissue resolution on the tomosynthesis and s2D images (**Fig. 2**). It is usually seen in large or dense breasts where the high-dose X-rays travelling the skin and superficial tissue in the periphery undergo very little attenuation and this amount of radiation reaching the detector elements results in a burnt out effect, which results in inadequate characterization of skin calcifications.⁹ Improving breast compression can help get rid of these artifacts.⁸

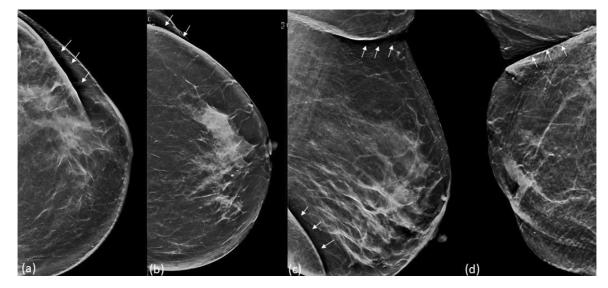
Fig. 3 Dark regions near skin folds (a-d): Skin folds appearing as dark areas impairing the evaluation of the underlying breast parenchyma.

Large skin folds are seen as dark regions or shadows near the line of transition (**-Fig. 3**) as a consequence of the image-processing filters used in the s2D software. These can result

in sudden changes in the pixel values on the image obscuring important findings. Proper positioning of the patient can help avoid these large skin folds.

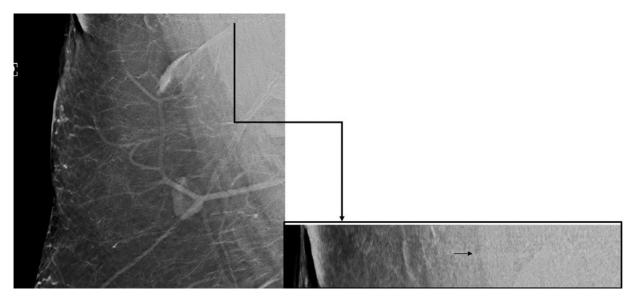
Fig. 5 Bright band on top of MLO image (arrow) and magnified view shown in the inset. These bright bands do not limit evaluation.

As the angle of projection changes during the tube rotation, the top-most part of the breast and pectoral tissue is not present in all slices causing a narrow horizontal bright band to appear at the topmost section of the MLO images (~Fig. 5).

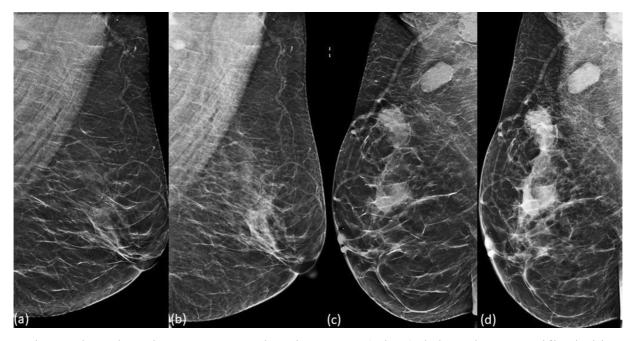
Fig. 6 Change in the ACR breast density category on synthesized mammogram (s2d, MG): The breast shows scattered fibroglandular parenchyma, Category B on conventional MG (a), whereas it can be categorized as category A on the s2D image (b). This might affect the interpretation in certain settings as seen in a female with irregular high-density masses and axillary lymph nodes on standard MG (c), which are seen as equal density lesions on s2D image (d). These can be missed or misinterpreted as glandular parenchyma in relatively denser breasts if not correlated with tomosynthesis slices.

Due to the reconstruction algorithm used, the breast appears less dense on the s2D view as compared with the conven-

tional mammogram image (**Fig. 6**). This may result in alteration in the categorization of the ACR category to the breast.

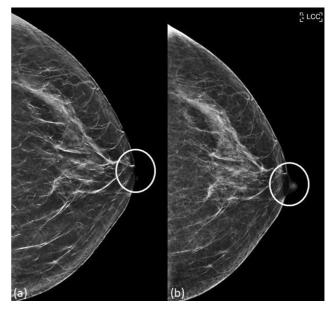
Fig. 9 Non-visualization of the nipple on s2D vs. standard mammogram: (a) s2D image showing non-visualization of the nipple-areola complex (circle). (b) Corresponding standard 2D mammogram showing the nipple areolar complex well.

As compared with the standard 2D mammogram image, the nipple-areolar complex may be partially or completely non-visualized on the s2D images causing its incomplete evaluation (**- Fig. 9a**). It might be based on the same mechanism as burnt skin artifact.

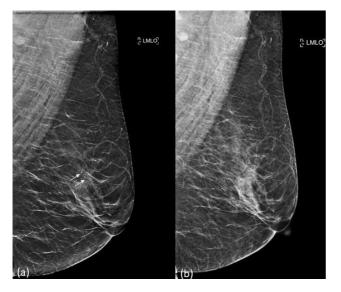
Fig. 11 False-positive calcifications: (a) s2D image showing areas of punctate calcification (arrows), which are not seen on the corresponding conventional mammogram image (b).

On DBT images, normal tissue structures such as ligaments and vessels may falsely appear to be calcified (**\succFigs. 10** and **11**).¹¹ The s2D images may display an increase in the number of microcalcifications, which may not be visible on the corresponding conventional 2D images.¹² These may

represent bright spots due to causes other than calcification. This is because the algorithms used in s2D inherently have the tendency to cause the enhancement of real calcifications to assist radiologists to spot them easily. This also causes pseudo enhancement of bright spots other than calcifications. It is recommended that calcification clusters that appear ambiguous on s2D image must be confirmed with the tomosynthesis slices. If a bright spot suspected to be calcification is not seen on the corresponding tomosynthesis slices, it is unlikely to be calcification.¹²
