Missed intranasal wooden foreign bodies on computed tomography

Abstract

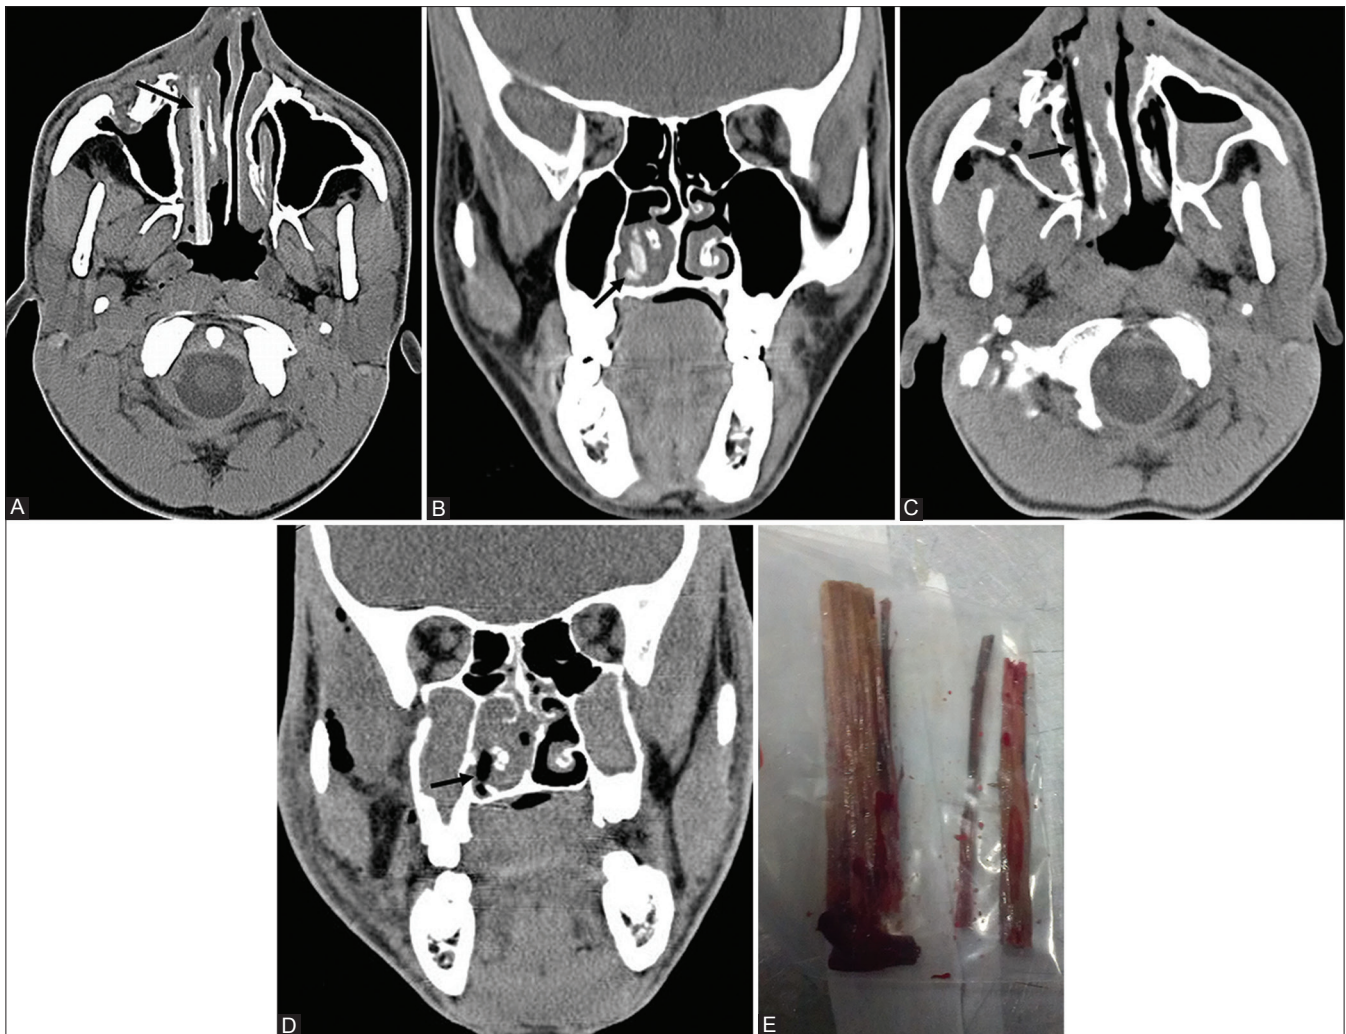
Figure 1 (A-E): A 16-year-old boy with chronic right-sided mucopurulent nasal discharge and history of facial trauma 8 months back. CT PNS axial and coronal images (A and B) reveal well-defined hyperdense cylindrical foreign bodies (arrow) in the right inferior meatus, surrounded by hypodense secretions. Previous CT PNS axial and coronal images (C and D) acquired after trauma reveal well-margined cylindrical air attenuation lesions (arrow) at the same site. Surgical specimen (E) shows multiple wooden foreign bodies

and adhesions in the right inferior meatus. A repeat CT scan [Figures 1a and b] showed three hyperdense cylindrical foreign bodies (white arrow) in the right inferior meatus, surrounded by hypodense secretions. On review of previous CT [Figure 1c and d], well-marginated cylindrical hypodense lesions [Hounsfield Units (HU) -272], which resembled air density, were noted in the right inferior meatus, surrounded by hypodense secretions (white arrow). On comparison, these corresponded to the hyperdense cylindrical foreign bodies noted in the recent scan. A provisional diagnosis of retained intranasal wooden foreign bodies was made. At surgery, three wooden pieces [Figure 1e] were found in the inferior meatus covered with granulation tissue, which were completely removed. Postoperatively, the patient reported significant resolution of his symptoms and is doing well on follow-up.

intranasal air. However, the presence of well-margined geometrical shape to the apparent air attenuation structure should arouse suspicion of an intranasal wooden foreign body. In addition, as noted in our case, the HU of the wooden pieces (HU -272) was relatively less compared to that of air (-900 to -1000). Retrospective viewing of the CT images at wider window settings (like bone window and lung window) helped in better differentiation of the wooden foreign bodies from air. Image viewing using a combination of coronal and axial planes, slice thickness of 3 mm, window width (WW) of 3000, and window level (WL) of 500 is recommended for detection of intranasal wooden foreign bodies. Ho *et al.* have noted that a WW of 1000 HU and WL of -500 HU (lung window) is optimal for the detection of wooden foreign bodies on CT.^[7]
