Imaging of cartilage repair procedures

Darshana Sanghvi, Mihir Munshi, Dinshaw Pardiwala¹

Departments of Radiology, ¹Orthopaedics, Kokilaben Dhirubhai Ambani Hospital, Andheri (W), Mumbai, Maharashtra, India

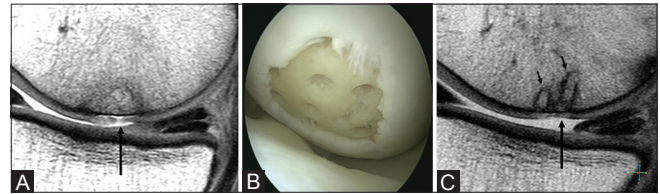
Figure 1 (A-C): Microfracture technique, MOCART score 70. (A) Sagittal PD image shows full-thickness osteochondral injury following trauma. (B) Intraoperative image shows small holes in the subchondral bone created by a pick introduced through arthroscopic portal. The procedure is performed to promote multipotential bone marrow stem cells to form fibrocartilage. (C) Postoperative follow-up MRI shows formation of new repair tissue (long arrow). The repair tissue is congruent with native cartilage. Tracts of microfractures in subchondral bone (small arrows)

Bone Marrow Stimulation/microfracture Technique [Figures 1 and 2]

It involves using an awl or a pick to create holes at the site of the chondral defect. The purpose of the surgery is to expose the subchondral pluripotential marrow stem cells to form fibrocartilaginous repair tissue. The drilling allows formation of a fibrin clot which acts as a scaffold for reparative tissue formation.

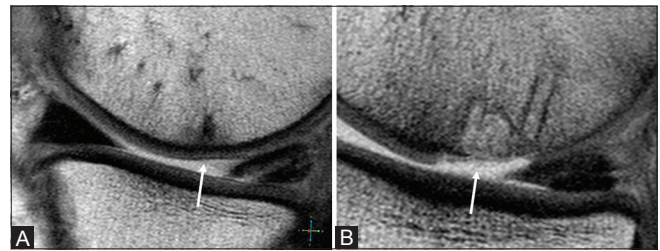
Figure 2 (A, B): Microfracture technique in two different patients. (A) Follow-up MRI shows adequate fill of the cartilage defect by reparative tissue which is normal in signal and congruent with the adjacent native cartilage; MOCART score is 95. (B) Follow-up MRI in a different patient shows incomplete filling of the defect and exposure of subchondral bone; MOCART score is 30

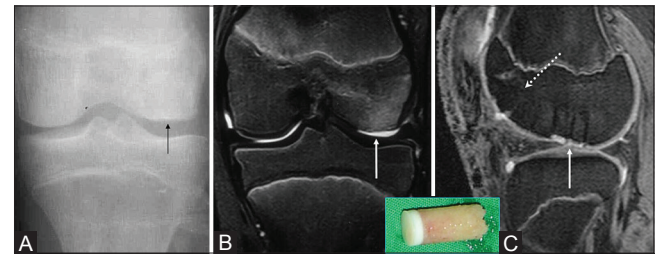
Figure 3 (A-C): Mosaicplasty after bike accident in a 13-year-old boy. (A) Radiograph shows flattening of the lateral femoral condyle (arrow). (B) Coronal Short Tau Inversion Recovery (STIR) MRI shows osteochondral lesion (arrow). (C) Osteochondral plugs (inset) were harvested from non-weight-bearing surface (dotted arrow) and transplanted at site of defect (solid arrow) at weight-bearing articulating surface. Postoperative sagittal Proton Density (PD) image shows excellent congruity of repair tissue (solid arrow) with parent cartilage. The repair tissue shows normal thickness, signal and smooth surface

This entails harvesting osteochondral plugs from a non-weight-bearing area and transplanting at the site of the cartilage defect in the weight-bearing segment [Figures 3

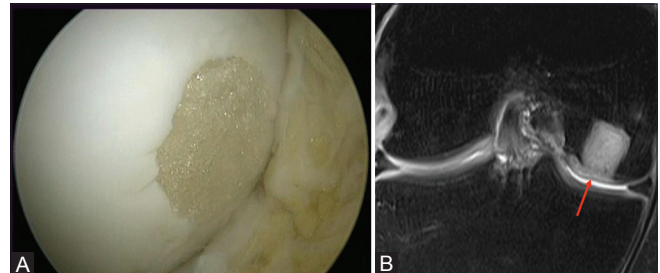
Figure 5 (A, B): Synthetic osteochondral scaffold. (A) Arthroscopic image. (B) Coronal STIR MRI shows adequate incorporation of synthetic graft with a MOCART score of 90

These involve using artificial osteochondral scaffolds to replace the focal defects of bone and cartilage [Figures 5 and 6]. The technique is similar to mosaicplasty, except that there is no need for graft harvest. The advantage of this technique is the absence of donor site morbidity associated with OATS. The disadvantage of the present generation of artificial scaffolds is the risk of immune reactions, early graft resorption with collapse, and incomplete graft resorption.^[8]

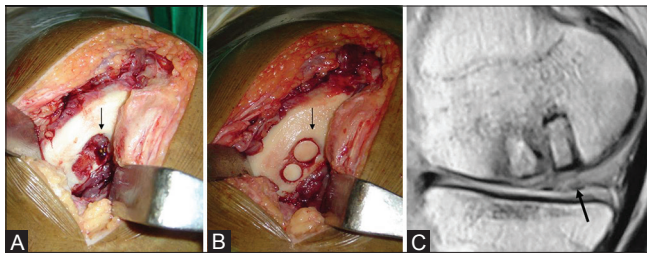
Figure 4 (A-C): Mosaicplasty with poor MOCART score of 55. (A) Intraoperative image shows large osteochondral lesion (arrow) of medial femoral condyle. (B) Osteochondral plugs (arrow) have been placed in the lesion. (C) Postoperative sagittal T2W MRI shows graft subsidence (arrow) and poor congruity with the adjacent parent cartilage

be demonstrated on MRI include plug loosening, graft protuberance [Figures 4 and 11], graft depression, and collapse in mosaicplasty. ACI can be complicated by graft hypertrophy [Figure 11]^[10-12] within 6 months after the procedure. The harvest site is also evaluated for surface incongruity. Immune response leading to graft rejection is a complication [Figure 6] encountered more commonly with synthetic grafts and cadaveric allografts. In case of allografts, CT and conventional radiographs are used to assess topographical restoration [Figure 7], progressive stages of allograft union and healing [Figure 8], status of overlying articular margin, and can demonstrate allograft collapse in failed cases.

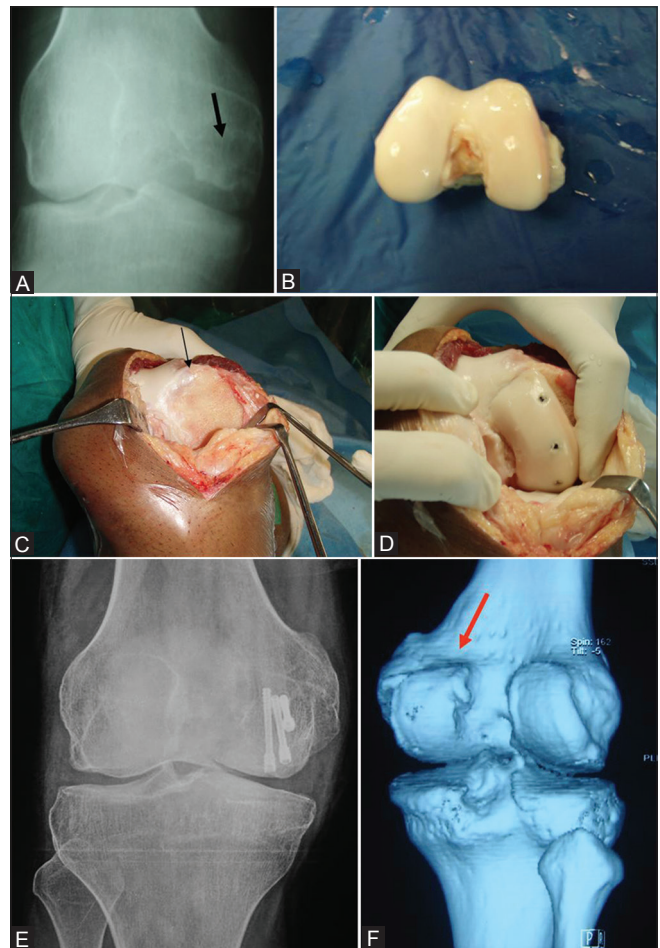
Figure 7 (A-F): Osteochondral allograft transplantation. (A) Radiograph shows medial femoral condyle avascular necrosis with collapse, flattening, and deformation. (B) Photo of cadaveric allograft. (C) Arthrotomy to expose the articular defect before transplantation. (D) A size- and shape-matched sectoral osteochondral allograft has been transplanted. (E and F) Follow-up postoperative radiograph and 3D CT shows graft union and topographic restoration

This involves the transplantation of osteochondral grafts harvested from a cadaver into the cartilage defect via an arthrotomy. This technique is indicated in large or sectoral osteochondral defects. The harvested osteochondral allograft is matched with the size and contour of the chondral defect [Figures 7 and 8]. The advantage in this technique is that the cartilage is hyaline cartilage and not just reparative fibrocartilage. Moreover, this

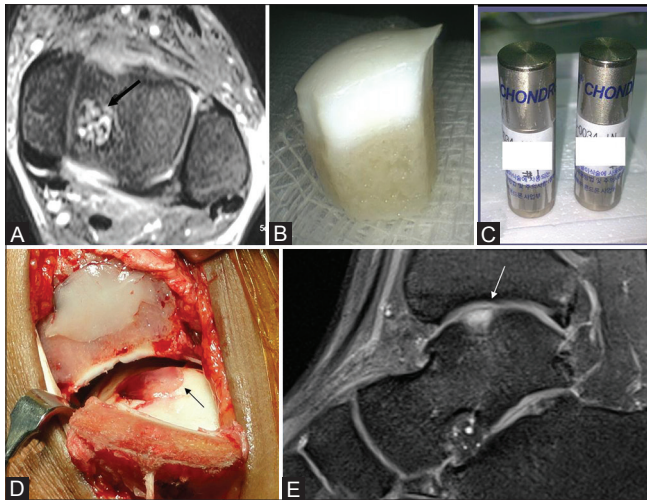
Figure 10 (A-E): ACI for talar osteochondral lesion (A). In stage 1 of the procedure, cartilage biopsy specimen (B) was obtained from a remote area and chondrocytes were harvested *in vitro* (C). In stage 2 of the procedure, the harvested chondrocytes were implanted (arrow in D). Postoperative 3-month follow-up MRI shows adequate integration of the graft (arrow in E)

In this two-stage technique, in the first stage, a cartilage biopsy is obtained from a non-weight-bearing segment and the chondrocytes are cultured for 3-6 weeks *in vitro*.^[9] In the second stage of the procedure, the cultured chondrocytes are implanted via an arthrotomy into the cartilage

defect [Figures 9-11]. The current generation of fibrin-ACI uses an injectable delivery system, whereas earlier ACI techniques required periosteal flaps and collagen matrix for cell delivery.

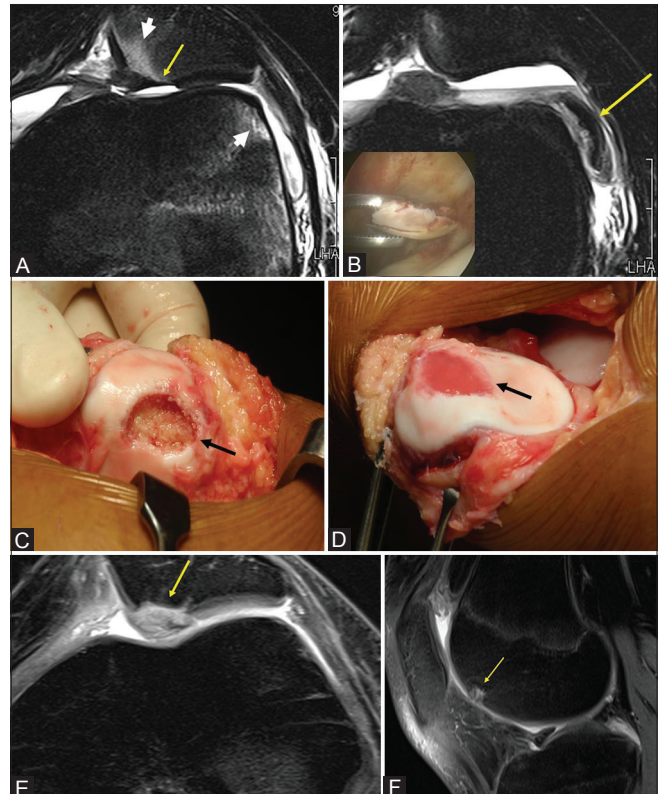
Figure 11 (A-F): Patellofemoral dislocation treated with ACI; MOCART 85. (A) MRI shows patellar osteochondral lesion (arrow) and bone contusions (arrowheads). (B) Corresponding loose osteochondral fragment. Inset shows arthroscopic fragment removal; cartilage biopsy for harvesting chondrocytes was performed at same setting from non-weight-bearing lateral femoral condyle (stage 1 surgery). (C) Open ACI 6 weeks later (stage 2), intraoperative image shows debrided defect (D). Post ACI image shows grafted chondrocytes filling defect. (E) Post ACI MRI shows hypertrophied repair tissue. (F) Cartilage harvest site
