MRI imaging of displaced meniscal tears: Report of a case highlighting new potential pitfalls of the MRI signs

Magnetic resonance imaging (MRI) has been found to be an excellent imaging tool for meniscal injuries. Various MRI signs have been described to detect displaced meniscal injuries, specifically the bucket-handle tears. Although these signs are quite helpful in diagnosing meniscal tears, various pitfalls have also been reported for these signs. Double anterior cruciate ligament (ACL) sign refers to presence of a linear hypointense soft tissue anterior to the ACL, which represented the flipped bucket-handle tear of the meniscus. Disproportional posterior horn and flipped meniscus signs represent asymmetrically thickened horns of the menisci due to overlying displaced meniscal fragments. We report a case wherein MRI of the knee showed tear and displacement of the medial patellofemoral ligament (MPFL) and vastus medialis complex, medial collateral ligament (MCL), and posterior cruciate ligament (PCL) mimicking these signs. To our knowledge, internally displaced MPFL and MCLs have not been described as mimics for displaced meniscal fragments.

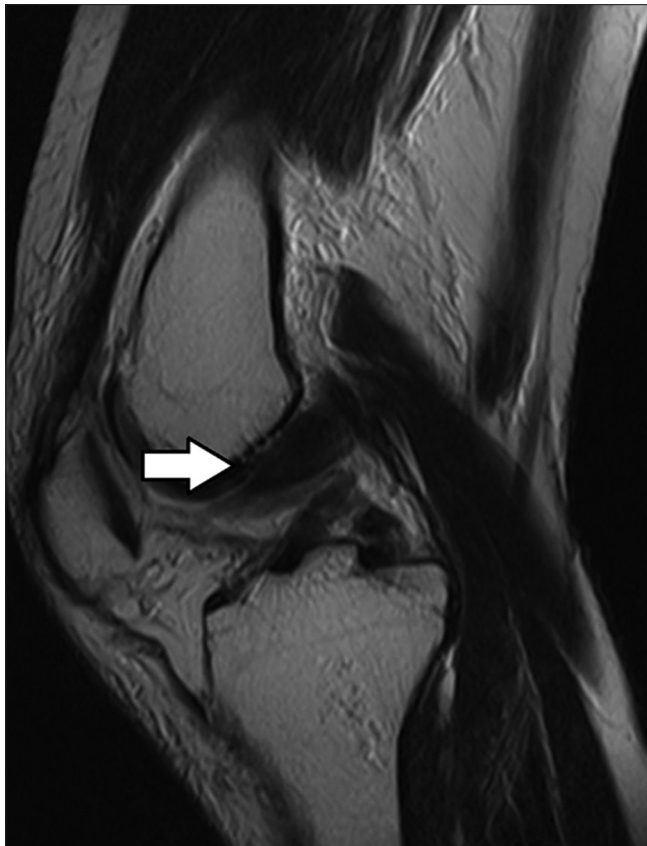
Figure 1: T2W sagittal image through the intercondylar fossa showing a thick “band-like” soft tissue (arrow) anterosuperior to the ACL, mimicking the double ACL sign

giving a “double ACL sign” [Figures 1 and 2]. Additionally, wedge-shaped soft tissues were seen on sagittal T2W sequences overlying the posterior horns of medial meniscus, resembling “disproportional posterior horn sign” or a “flipped (posterior) meniscus sign” [Figures 3 and 4]. These findings raised the suspicion of displaced meniscal tears.

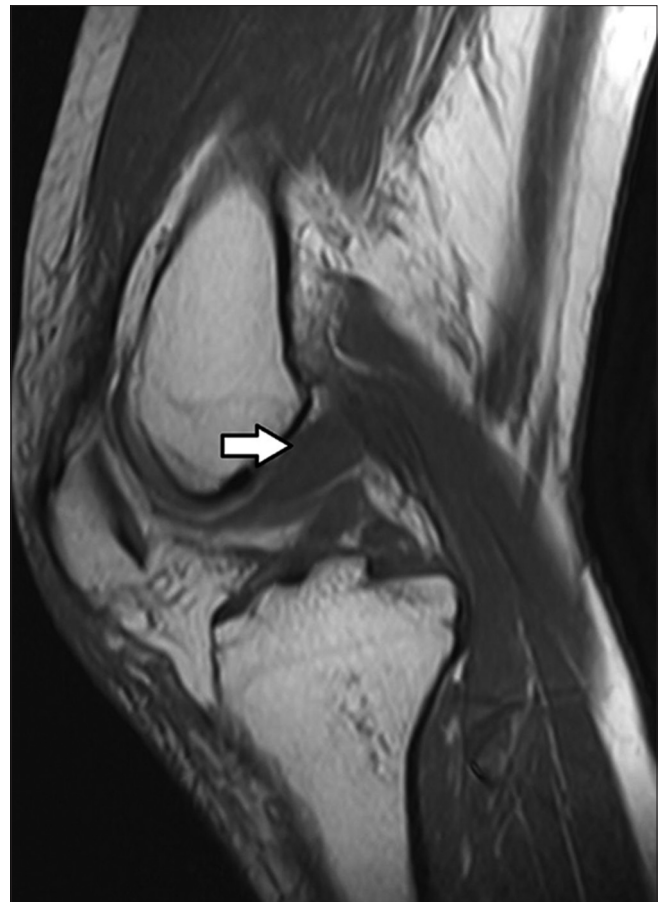
Figure 2: T1W sagittal image at the same level as Figure 1 showing the thick band-like soft tissue (arrow) isointense to the anterior cruciate ligament

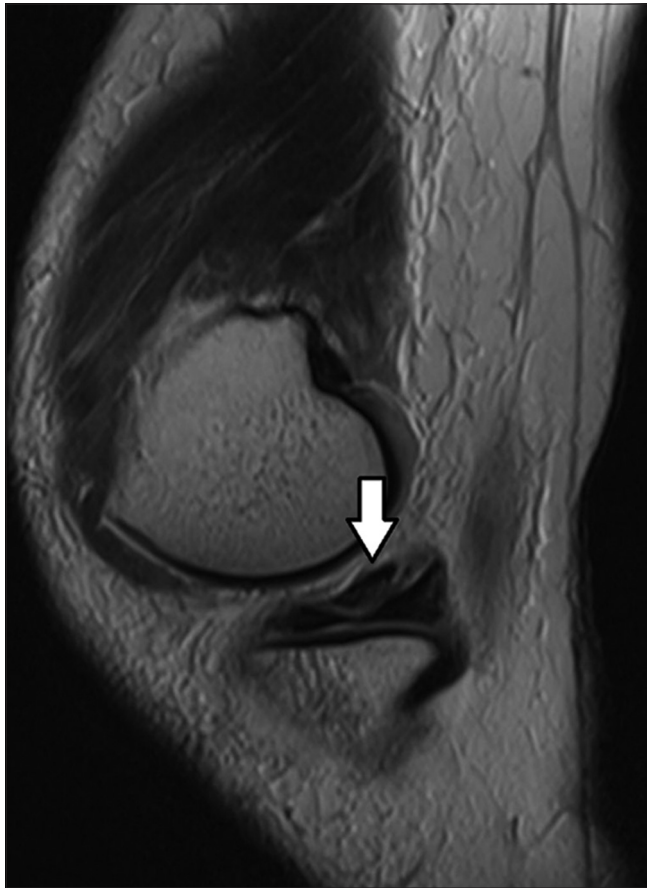
Figure 3: T2W sagittal image through the medial aspect of the knee joint showing a wedge-shaped soft tissue (arrow) superior to the body and posterior horn of medial meniscus, resembling the “posteriorly flipped meniscus sign”

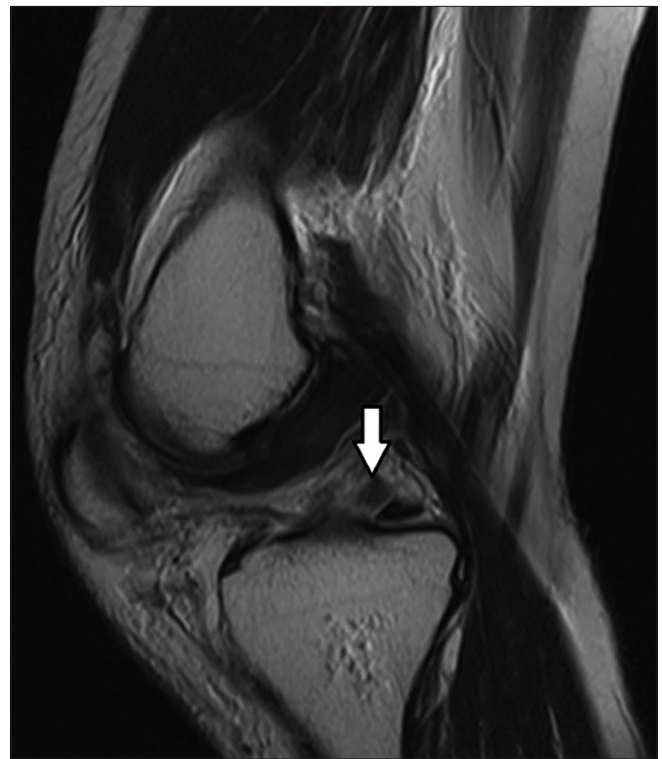
Figure 4: T2W sagittal image through the intercondylar fossa of the knee joint showing a small triangular soft tissue (arrow) seen superior to the posterior horn of medial meniscus, resembling the disproportional posterior horn sign

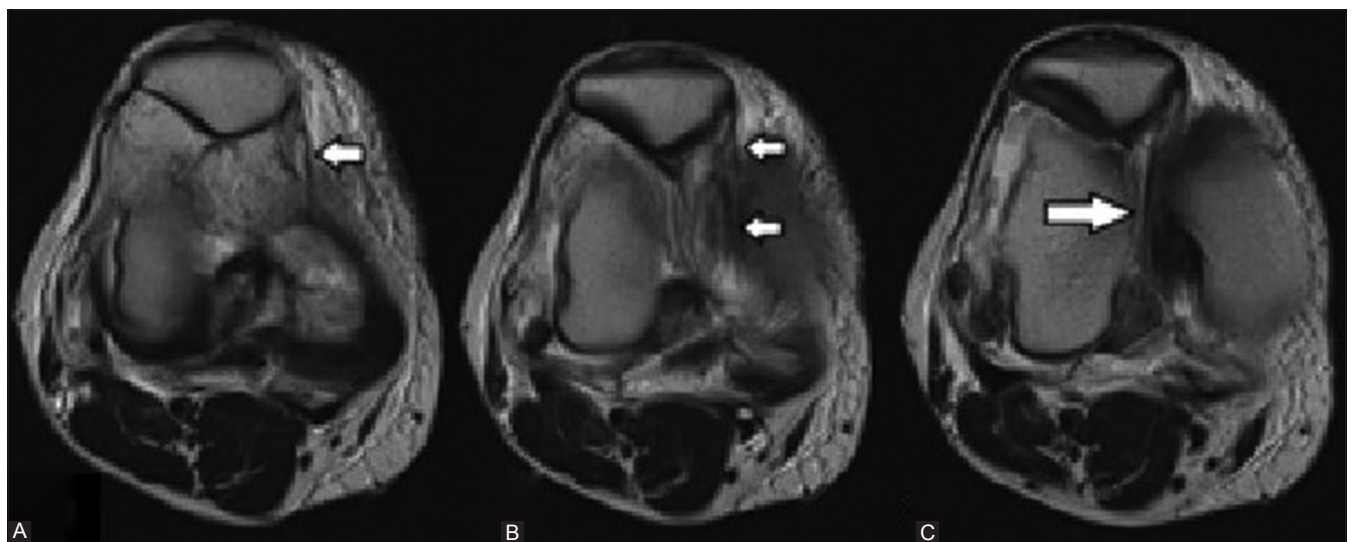
Figure 5 (A–C): Consecutive T2W axial images at the level of patellofemoral joint showing torn medial patellofemoral ligament which is displaced internally (arrow), causing a fallacious double ACL sign

On careful evaluation, these “signs” were found to be misleading. The “double ACL sign” was due to torn medial patellofemoral ligament (MPFL) and vastus medialis complex being displaced into the joint space [Figures 5A-C].

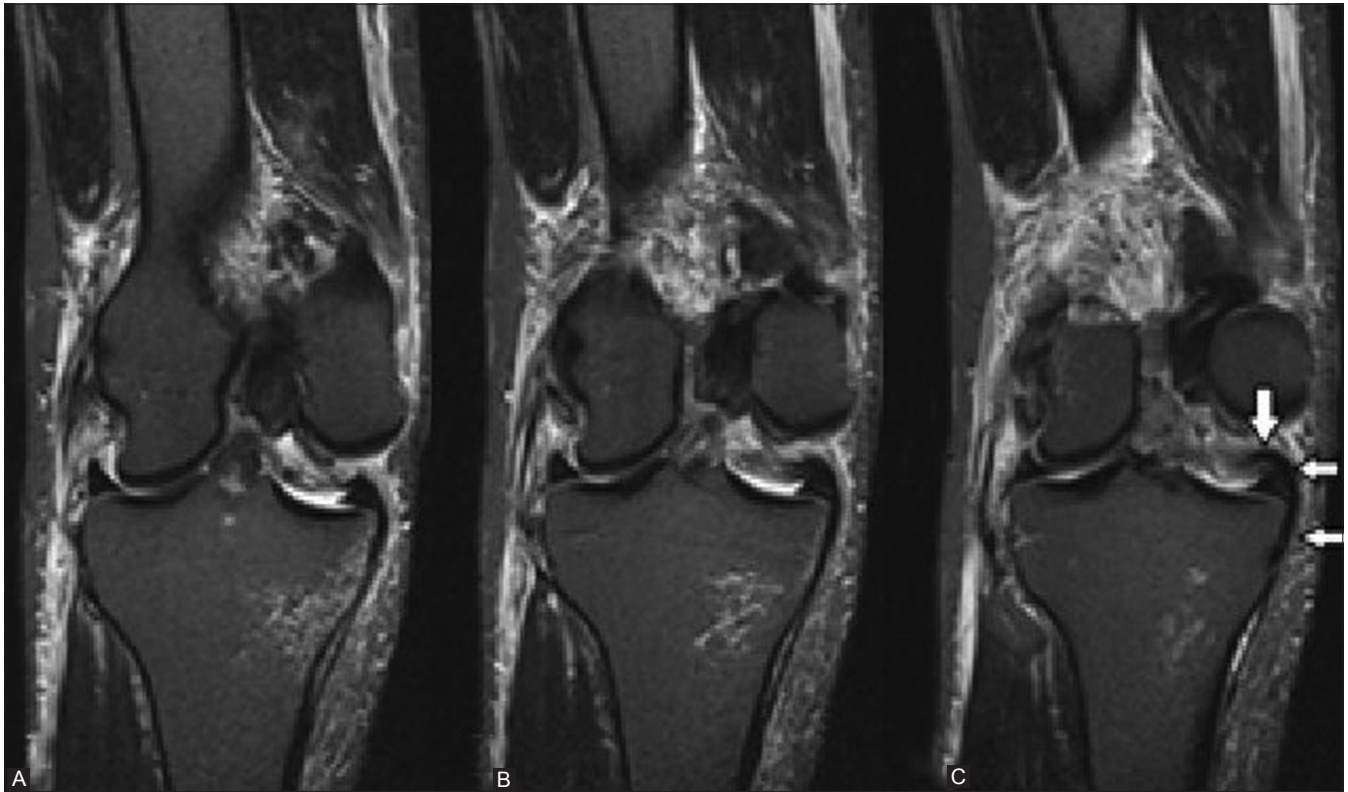
Figure 6 (A–C): Consecutive STIR coronal images showing complete tear of the femoral attachment of medial collateral ligament. The torn ligament is seen internally displaced and lying superior to the medial meniscus (arrows)

On coronal STIR sequences, it was observed that the medial collateral ligament (MCL) was completely detached from its femoral attachment and displaced into the medial joint space. It was seen lying over the body of medial meniscus [Figures 6A-C]. Also, the proximal end of the torn PCL was seen lying over the posterior horn of medial meniscus (demonstrated through consecutive images in Figures 7A-C). These structures led to the appearance of “thick” posterior horn of medial meniscus.
