Diagnostic accuracy of dual energy CT in the assessment of traumatic bone marrow edema of lower limb and its correlation with MRI

Department of Radiodiagnosis, Era's Lucknow Medical College and Hospital, Lucknow, Uttar Pradesh, India

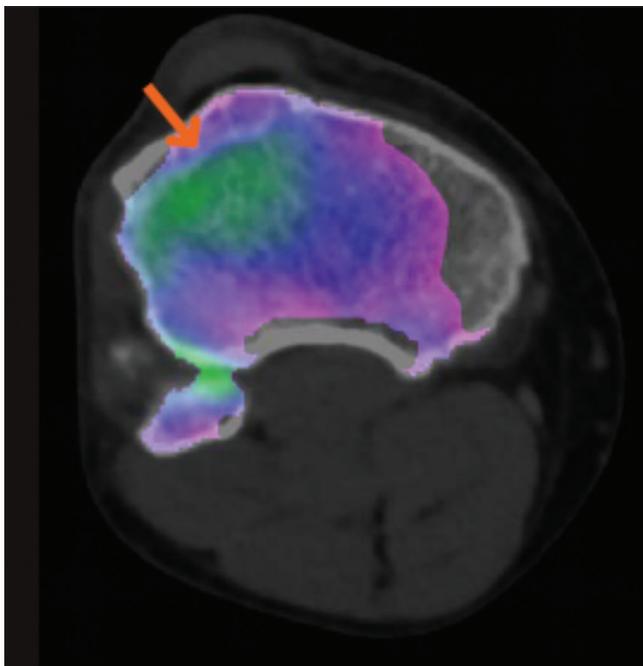
Figure 1: An axial DE VNCa image depicts bone marrow edema (arrow) on the lateral aspect of the upper right tibia

The difference in attenuation at fractured site and adjacent site among the patients enrolled in the study was found to be 151.03 ± 35.03 , which was considered statistically significant. Subjective interpretation by DECT based on attenuation found bone marrow edema in 45.0% cases [Figures 1, 2A, 2B, 3A and 3B] while in rest of the cases no edema was found [55.0%; Table 3].

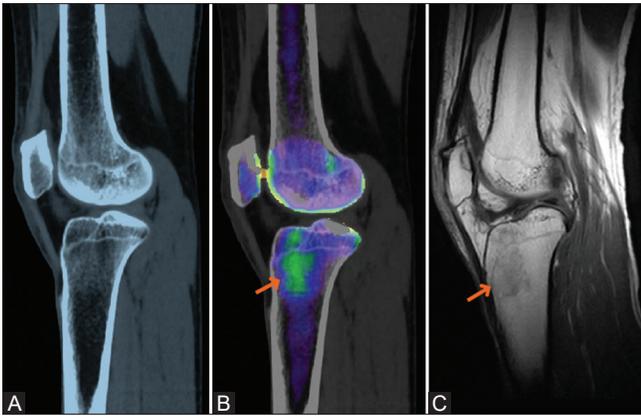
Figure 2 (A-C): (A) Sagittal views of a CT image of the right knee joint of a patient with bone marrow edema on the lateral aspect of the proximal tibia. (B) Sagittal views of a DE VNCa image of the right knee joint show bone marrow edema (arrows) on the lateral aspect of the proximal tibia. (C) Sagittal views of a T1-weighted MR [C] image of the right knee joint show bone marrow edema (arrows) on the lateral aspect of the proximal tibia

On MRI evaluation, bone marrow edema was found to be present in 42.5% cases only [Figures 2C And 3C] while in rest of the cases (57.5%) edema was not found [Table 4].

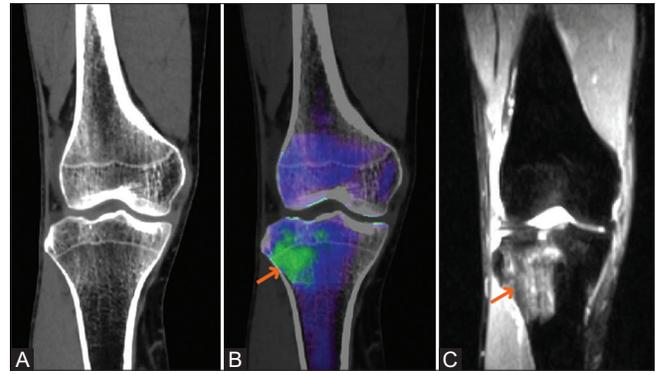
Figure 3 (A-C): (A) Coronal views of a CT image of the right knee joint of a patient with bone marrow edema on the lateral aspect of the proximal tibia. (B) Coronal views of a DE VNCa image of the right knee joint show bone marrow edema (arrows) on the lateral aspect of the proximal tibia. (C) Coronal views of a STIR MR image of the right knee joint show bone marrow edema (arrows) on the lateral aspect of the proximal tibia
