Polyurethane-Coated Breast Implants Revisited: A 30-Year Follow-Up

Original Article

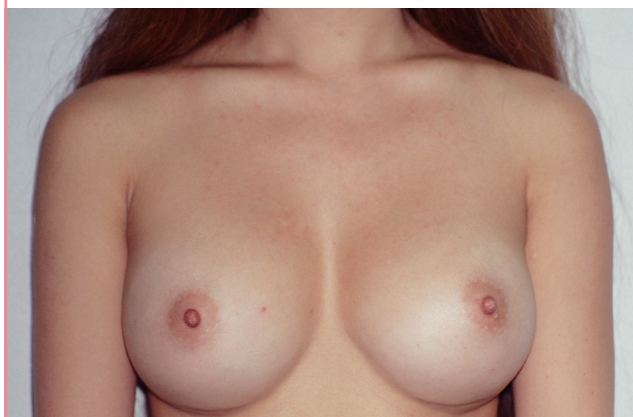
Fig. 1. Anterior view eight years post-surgery

A patient is shown demonstrating no contracture eight years after submuscular augmentation with 350 mL round Meme implants, placed through inframammary incisions.

From 1981 to 1991, 764 polyurethane-coated silicone gel implants were inserted in 382 patients. Of this group, all 382 patients were seen at a one-week follow-up, 378 were seen at four weeks; 322 were seen at six weeks, and 288 were seen at six months after surgery. No patient during this follow-up period experienced capsular contracture. A normal postoperative patient eight years after surgery experienced no capsular contracture, as shown in Figs. 1 and 2.

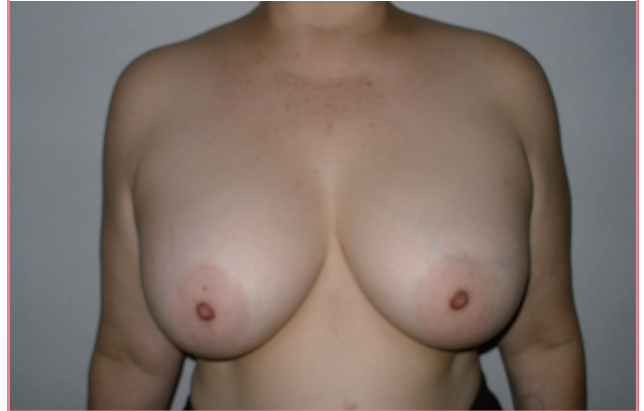
Fig. 3. Anterior view 29 years post-surgery with grade III contracture

A patient is shown demonstrating grade III contracture 29 years after subglandular augmentation with 400 mL Replicon implants, placed through inframammary incisions.

Among the 288 patients (75.4%) who returned for their six-month follow-up visit, soft breasts (Baker I) were noted in all patients. Of the 76 patients who eventually underwent reoperation, as described in Table 1, all patients demonstrated soft breasts with no contracture (Baker I) at their six-month follow-up visit. After this period, 67 patients continued to show no contracture (Baker I) and nine patients experienced capsular contracture of different degrees. Baker II/III contracture was noted in two of the nine patients at nine and 10 years after surgery. One of the patients with grade III contracture is shown 29 years after surgery in Figs.

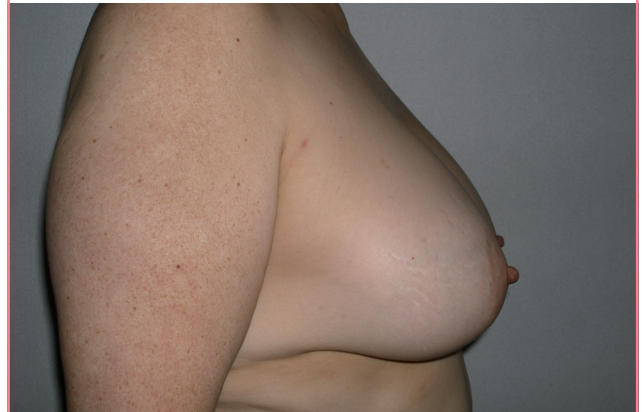
**Fig. 4. Lateral view 29 years post-surgery**

A lateral view is shown of the same patient as in Fig. 3.

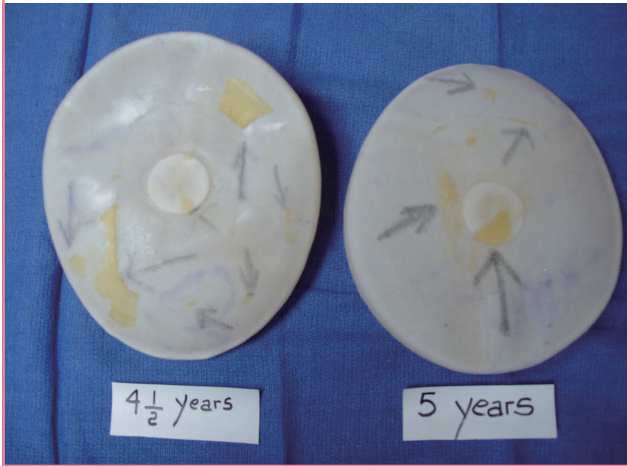
Fig. 5. Polyurethane implants four to five years post-surgery

Explantation up to five years after breast augmentation surgery demonstrates that macroscopic remnants of polyurethane are present on the surface of all implants.

Macroscopic evidence of polyurethane was noted on the surface of implants upon explantation up to five years after the original operation (Fig. 5). Beginning at six years after the operation, the polyurethane gradually disintegrated and eventually disappeared, as shown in Fig. 6. In contrast, polyurethane was present microscopically within all capsules during the entire observation period of 30 years.

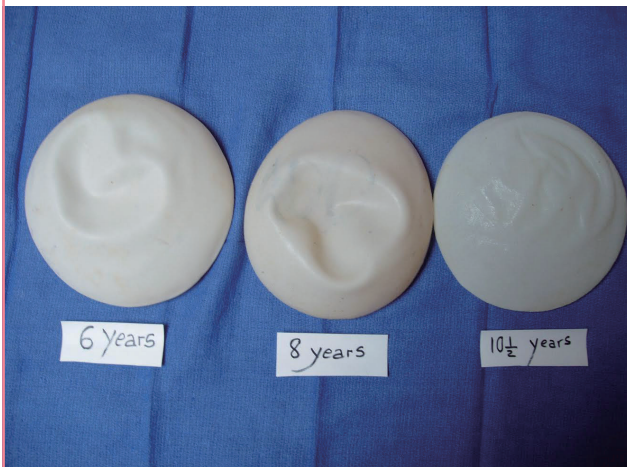
Fig. 6. Polyurethane implants six to 10 years post-surgery

Beginning at six years after the operation, no macroscopic presence of polyurethane on the surface of implants can be observed. This is also demonstrated at eight and 10 years after the operation.

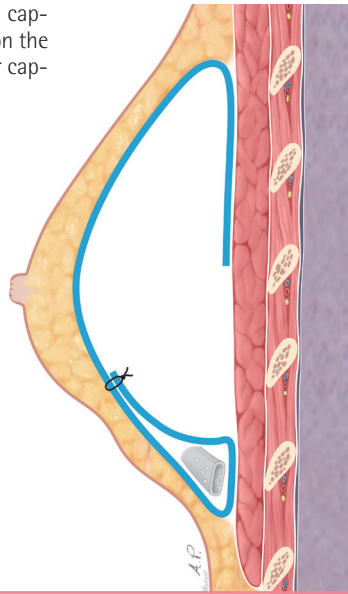
Fig. 9. Capsulorrhaphy technique

This image demonstrates the capsulorrhaphy technique used on the patient in Fig. 8 to correct her capsular ptosis.
